MATERIAL SELECTION FOR REPAIR OF DAMAGED PROCESS PIPING IN HIGH-TEMPERATURE SULFIDATION SERVICE IN THE NO. 4 CRUDE UNIT

December 12, 2012

Edwin H. (Ned) Niccolls
Sr. Consulting Materials Engineer
Chevron Fellow

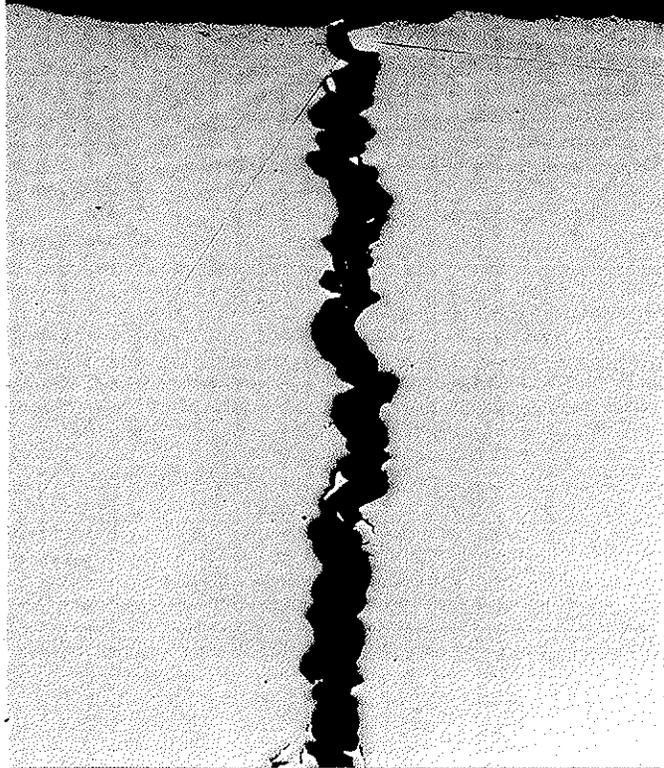
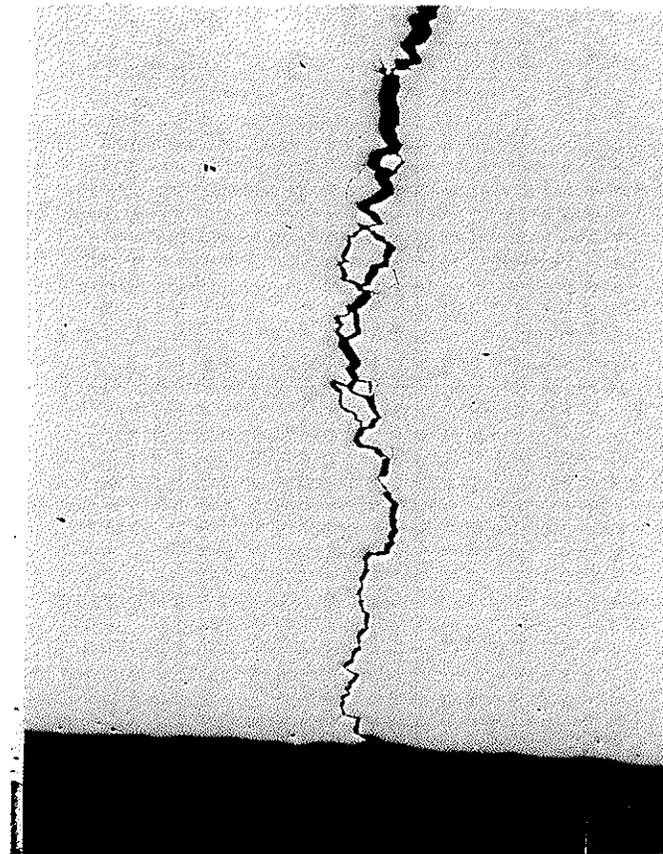
A longitudinal cross section containing both circumferential cracks was cut from the pipe. Figure 1 shows photomicrographs taken at the ID and OD of a crack extending through the pipe wall. Apparently the cracking started at the OD since the crack is more open there. Also, several other cracks starting at the OD and not extending through the wall were found within a 1/4 inch of the crack shown in Figure 1. The tip of one of these cracks is shown in Figure 2. This crack appears to be intergranular and tightly closed.

FIGURE 1. Cross section of circumferential crack extending through pipe wall. unetched 50X.

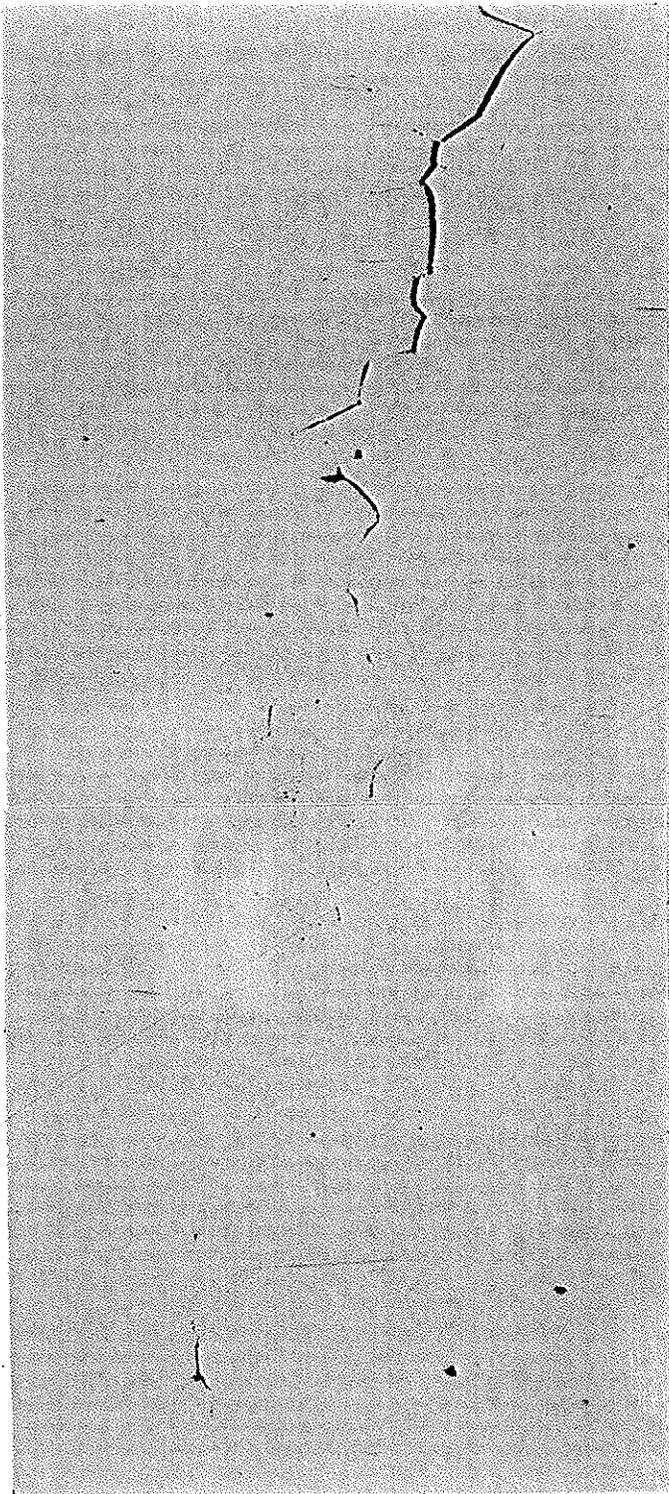
FIGURE 2. Cross section of crack tip not extending through pipe.
unetched 250X.

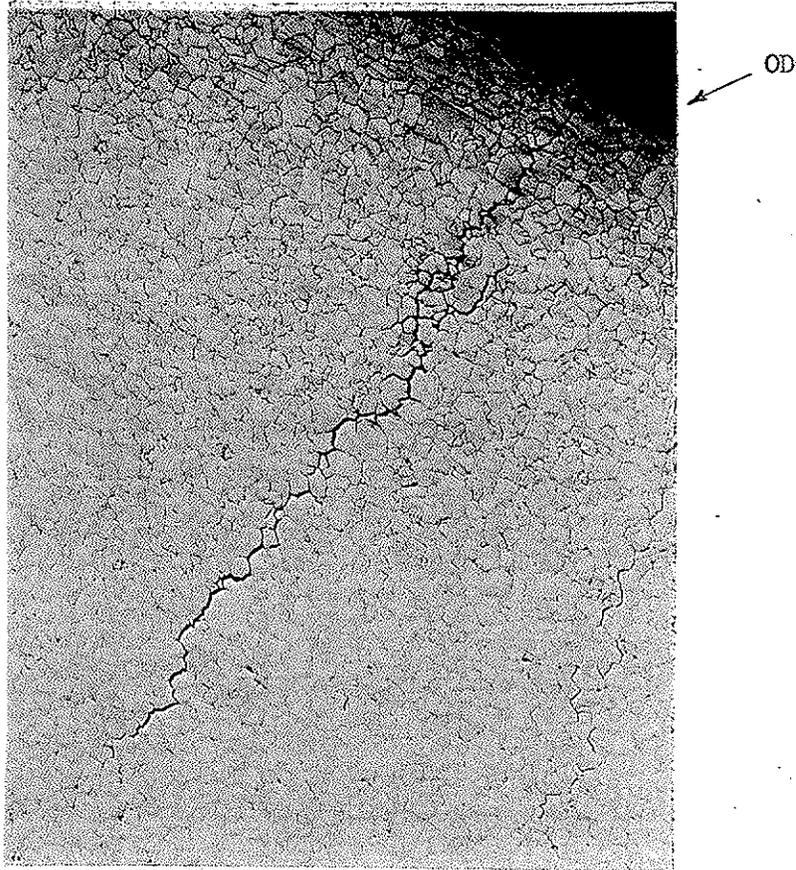
Figure 3 shows an etched cross sections of one of the cracks not extending through the pipe wall. This photomicrograph clearly indicates that the cracking is intergranular. The photomicrograph in Figure 4 shows that carbides have precipitated at the grain boundaries, which suggests that the Type 316L stainless steel pipe has been sensitized.

FIGURE 3. Cross section of crack not extending through pipe.

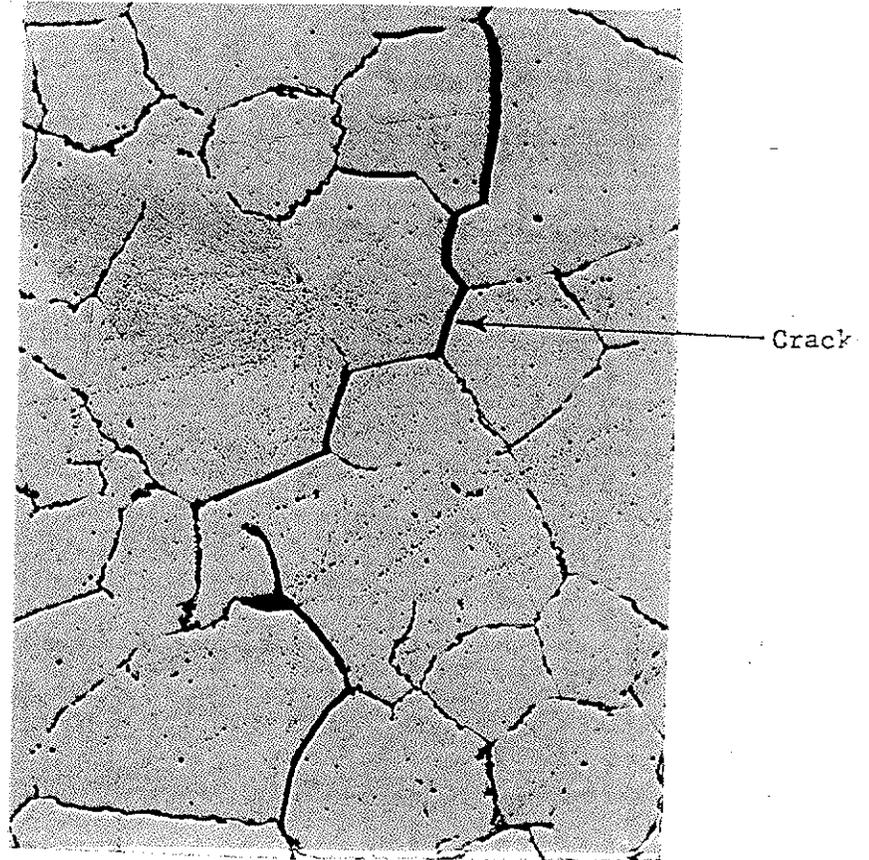
Sensitization is the harmful precipitation of chromium carbides in a nearly continuous network around the metal grains of an austenitic stainless steel. The chromium content of these carbide particles is theorized to be so disproportionately high with respect to the metal itself, that a thin surrounding envelope is depleted of its chromium content. This reduces the thin envelope to non stainless steel behavior, and renders it susceptible to subsequent intergranular corrosion. The temperature range in which sensitization occurs is from about 800F to 1650F. Sensitization is a time-temperature effect which is most rapid from about 1250F to 1350F.

FIGURE 4. Cross section of crack tip showing carbide precipitates at grain boundaries.

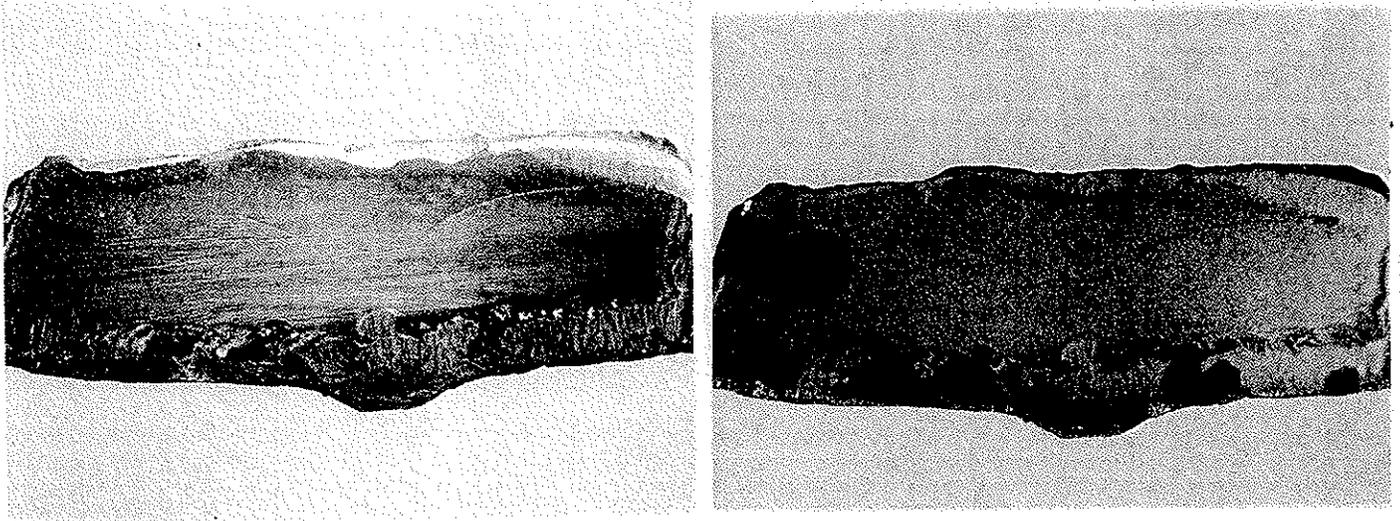
After cleaning with a solvent to remove tar, the ID of the cracked piece from the line appeared as shown in Figure 1. Several cracks are visible. Similar examination of the OD found only one short crack that could be observed visually but that was not picked up by dye penetrant inspection, even after the piece was warmed to 125F. The cracks are either very tight or are plugged with scale and vacuum resid. All cracks are away from weld zones.

FIGURE 1. Photographs of ID of vacuum bottoms line showing cracks on cleaned metal surface (left) and penetrant inspected surface (right). Weld in line is at bottom of picture. Dye check did not reveal all cracks, indicating that cracks are tight and/or filled with vacuum resid.

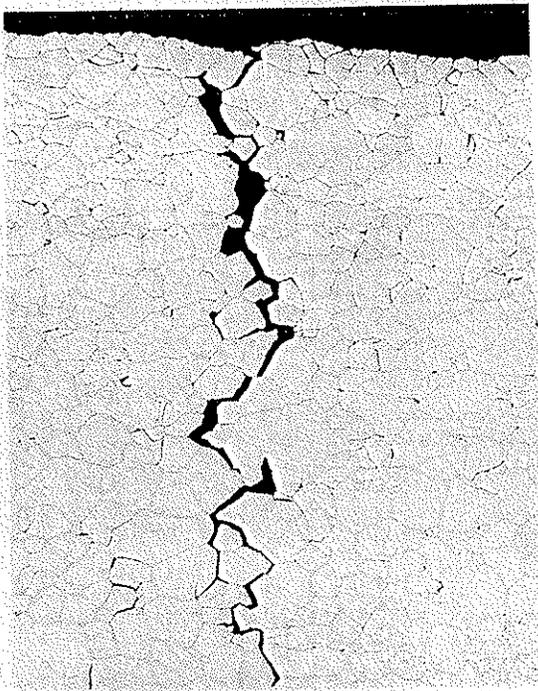
Metallographic examination of a cracked portion of the pipe wall found that cracks were entirely intergranular and originated at the line ID, as shown in Figure 2. No cracks were observed in weldmetal or in weld heat affected zones. Huey tests of two pipe samples, one near the cracks and the other 30" away from the weld, found that the entire section of pipe was severely sensitized. Corrosion rates measured in the Huey tests, listed in Table 2 were virtually identical for both samples. Figures 3 and 4 suggest that weld heat affected zones are not as severely sensitized as pipe material.

FIGURE 2. Light etch of cracked pipe cross section shows that crack is entirely intergranular and that material is probably severely sensitized.

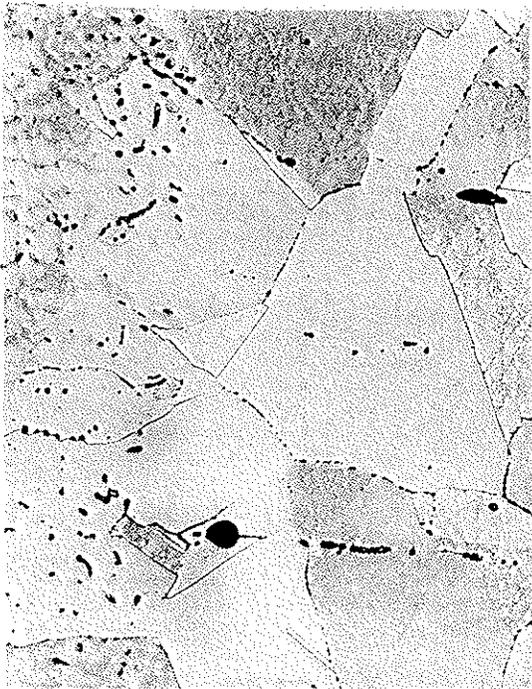
FIGURE 3.

HAZ of pipe weld is partially ditched after A262 etch for 30 sec.

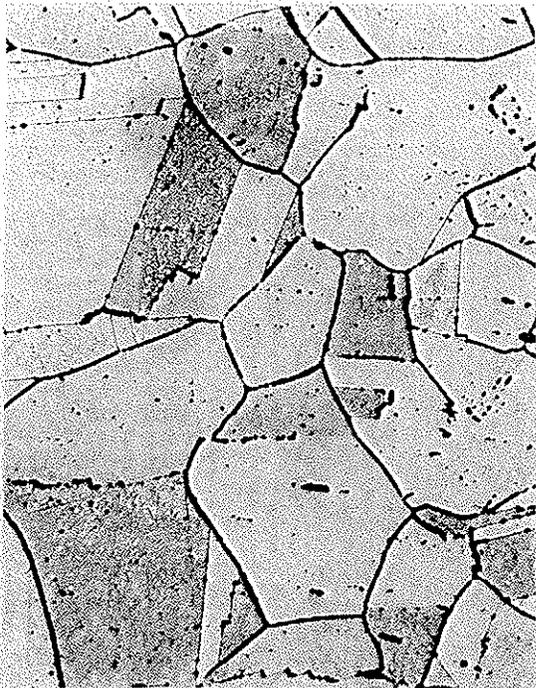
FIGURE 4. Pipe material away from heat effects of welding is severely ditched after identical etching treatment as Figure 3. Huey tests show this part of pipe is severely sensitized.

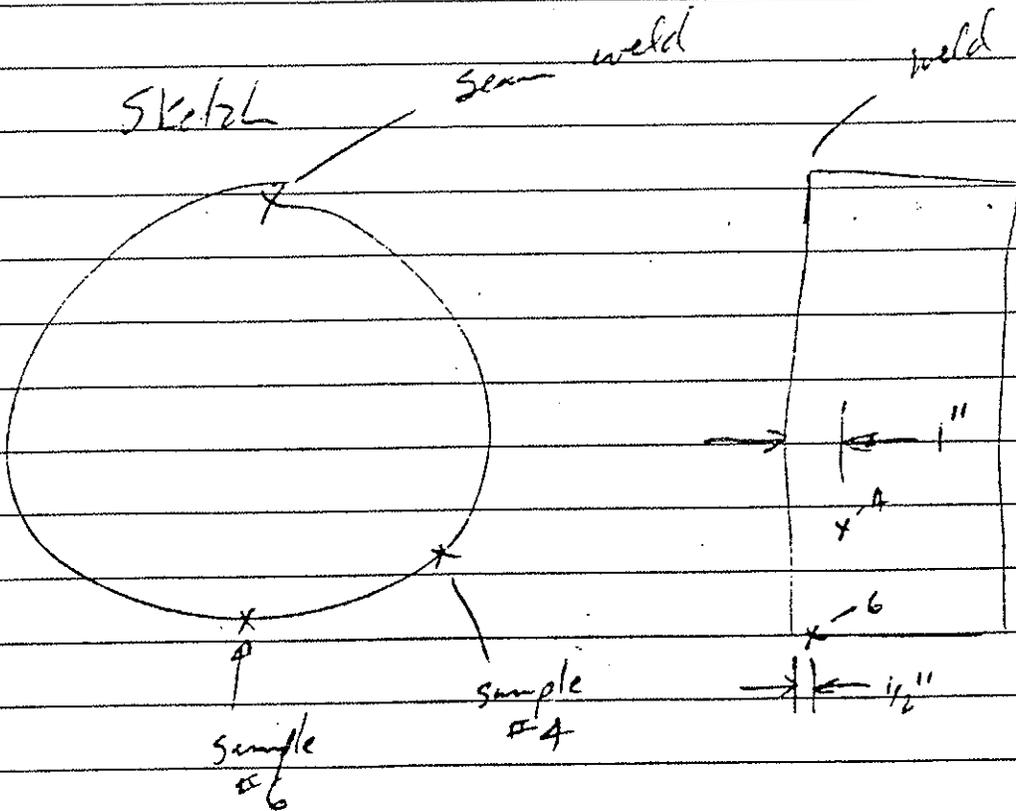
FIG 1

First failure (15" spool between flanges) is shown as rec'd in FIG 1. We made 2 metallographic sections (micros) at locations #1 & 2

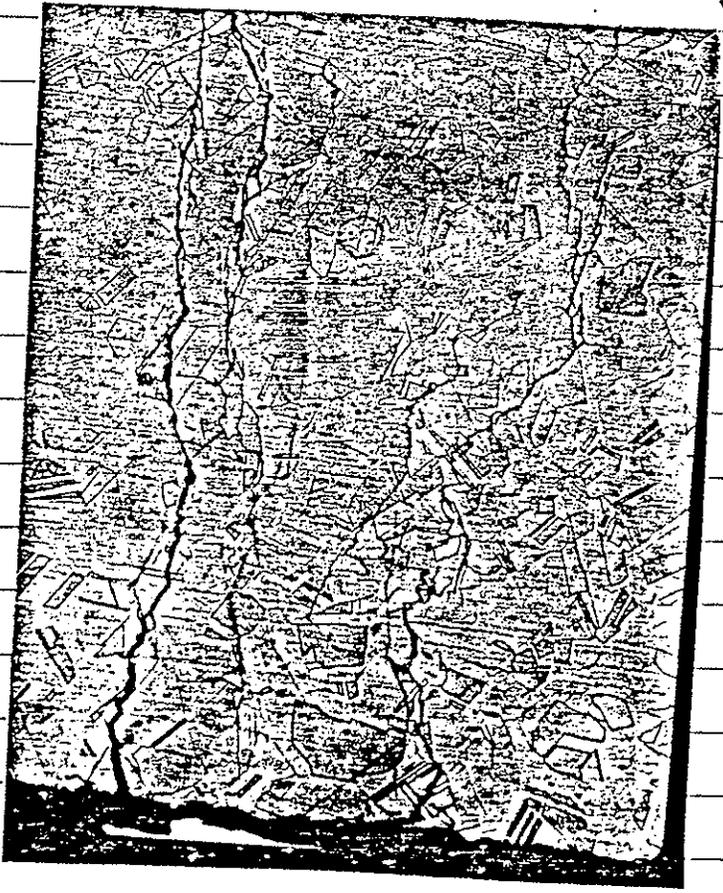
Sample # 4
Mag 50X

Sample # 4 was at 4 o'clock - the crack was about 1" from the weld - at the leak site.

Again, typical
transgranular Cl^- SCC
from the TD.
