**V.W. HOUSEN**  
& ASSOCIATES

This report summarizes approximately nine months of data review, field investigations, meetings, and hydraulic modeling activities that were conducted in 2017 for the Lift Station Master Plan project (“Project”). The objective of the Project was to consolidate and confirm available information, gather new field condition data, and identify system upgrades that are needed to improve overall reliability and wet weather capacity. Necessary improvements were identified and prioritized to address safety, reliability, capacity, and general maintenance. Conceptual costs were then developed for each of the recommended projects. The Project concluded with development of a 10-year Capital Improvement Program (“CIP”) that distributes costs across the planning horizon.

## ES.4 Lift Station Condition Assessment

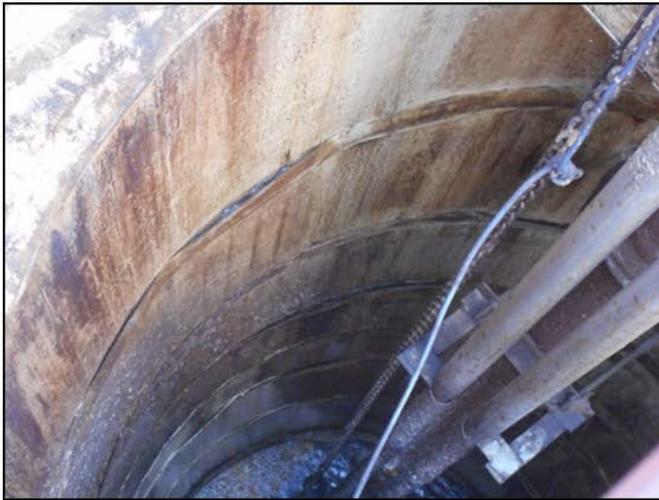
Figure 4-2. Sample of Brickyard Booster Lift Station Observations

Deteriorating T-Lock Lining in Wet Well

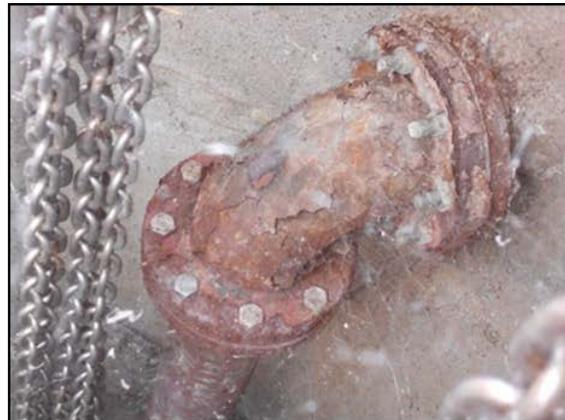
Constrained Site

Corroding Wet Well Piping

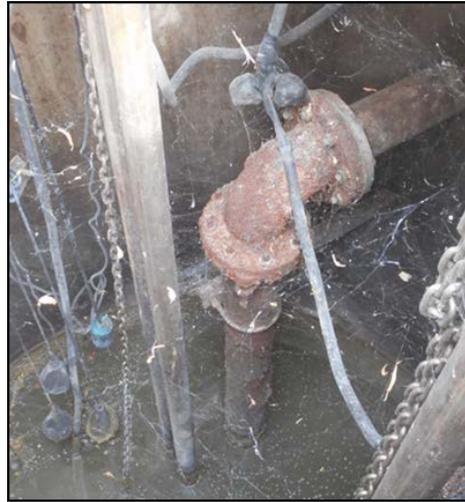
Figure 4-11. Sample of I.C.I. Lift Station Observations

Pipe Corrosion in Wet Well

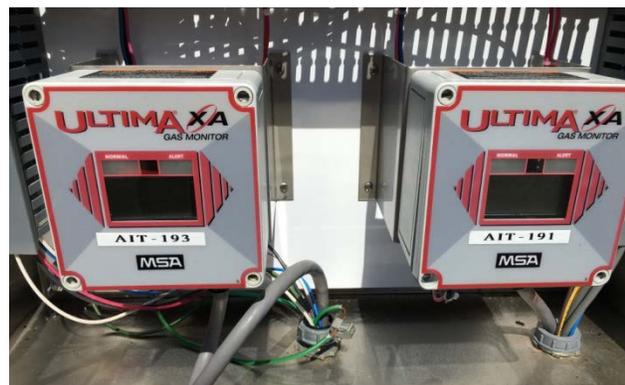
Figure 4-20. Existing Gas Monitors

frequent alarms due to malfunctioning of these monitors. Recommend replacing the monitoring system with a vacuum type system or other solution to be developed by Veolia.

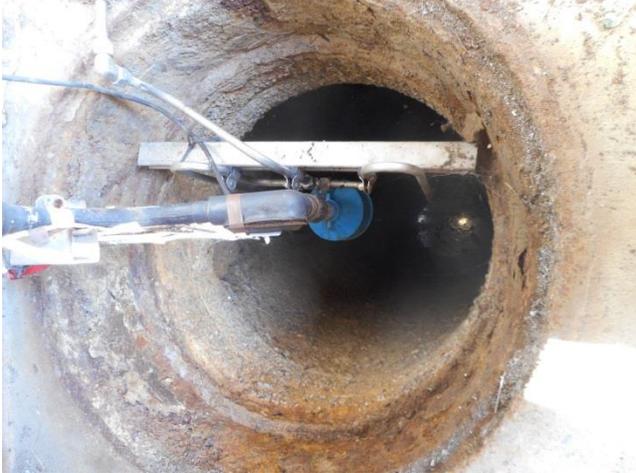
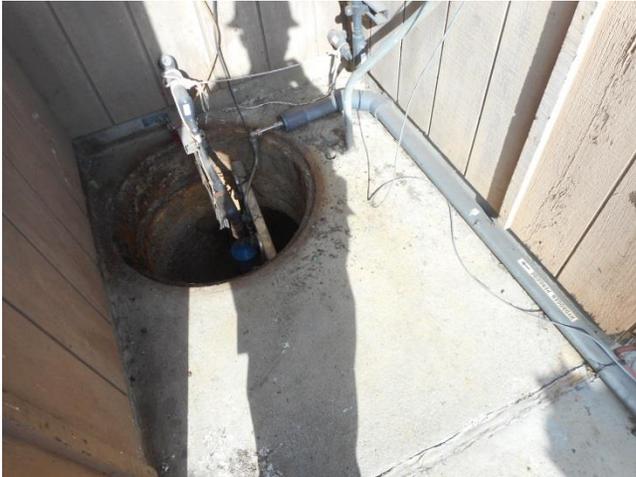
<b>Wet Well</b>	Size: 4 ft. dia. x 14 ft. deep  Material: Concrete  Coating: Unknown  Operating Volume: ___cf  Personnel Accessibility N/A  Equipment Ingress/Egress Difficult – via 16" dia. manhole (did not field measure, approx. measurement from drawing)  Grease/Cleanliness Could not see far enough into wet well to assess condition	Year Constructed 1962/55	Condition: Exterior: <input type="checkbox"/> Good <input type="checkbox"/> Fair <input type="checkbox"/> Poor <input checked="" type="checkbox"/> Not visible/below grade Interior: <input type="checkbox"/> Good <input checked="" type="checkbox"/> Fair <input type="checkbox"/> Poor Comments: <ul style="list-style-type: none"> <li>Manway rims and visible concrete is corroded and there is exposed aggregate.</li> <li>Veolia reported that this wet well historically has damage due to high H2S levels.</li> </ul> <div style="text-align: center;">

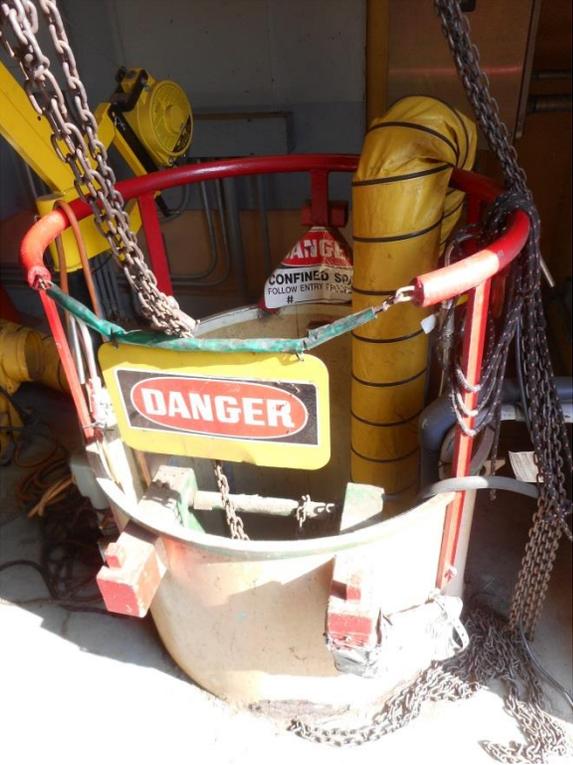
<b>Dry Well</b>	<p>Size: 7 ft. dia. x 7'-2" deep Material: Concrete</p> <p>Coating: None</p> <p>Personnel Accessibility Confined space entry through 3' ø entry tube via ladder.</p> <p>Equipment Ingress/Egress There are two ceiling mounted 1000 lb capacity chain hoists and also a floor mounted jib crane (310 lb rating)</p> <p>Housekeeping Not available - did not enter the dry well</p>	<p>Year Constructed 1962/55</p>	<p>Condition: Exterior: <input type="checkbox"/> Good <input type="checkbox"/> Fair <input type="checkbox"/> Poor <input checked="" type="checkbox"/> Not visible/below grade Interior: <input type="checkbox"/> Good <input type="checkbox"/> Fair <input type="checkbox"/> Poor</p> <p>Comments:  <ul style="list-style-type: none"> <li>Not inspected – confined space entry.</li> <li>Need to measure steel cam thickness.</li> </ul> </p> <div style="text-align: center;">

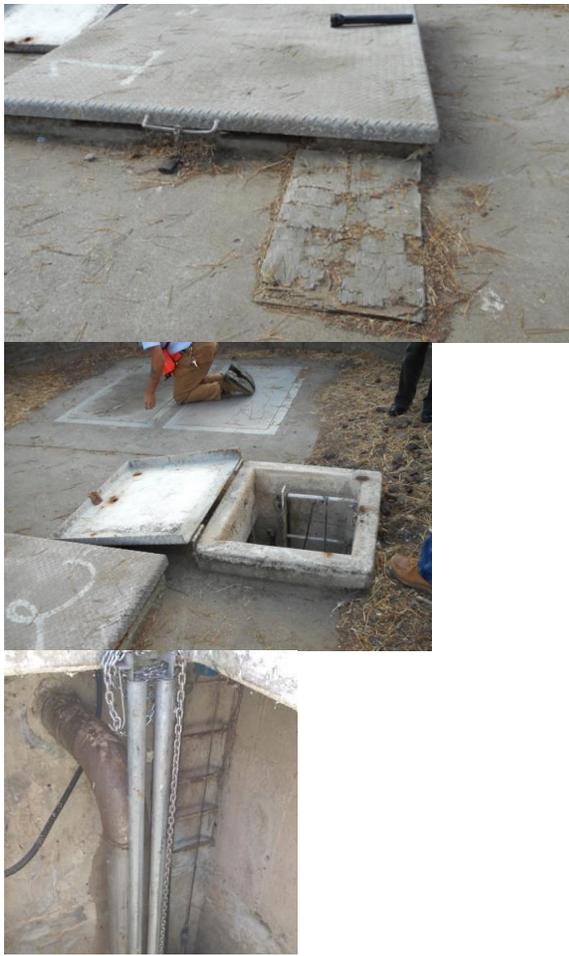
<p><b>Wet Well</b></p>	<p>Size: 10.5 ft x 10.5 ft x 18.71ft</p> <p>Material: Concrete</p> <p>Coating: None</p> <p>Operating Volume: ____cf</p> <p>Personnel Accessibility: Via ladder through 2'x2' hatch in the NW corner of wet well, ladder is corroded and only extends a few feet into the wet well; may not be structurally sound</p> <p>Equipment Ingress/Egress There is a main wet well hatch approximately 4' x 4' which must be lifted by boom truck.</p> <p>Grease/Cleanliness Good</p>	<p>Year Constructed</p>	<p>Condition: Exterior: <input type="checkbox"/> Good <input type="checkbox"/> Fair <input type="checkbox"/> Poor <input checked="" type="checkbox"/> Not visible/below grade Interior: <input type="checkbox"/> Good <input checked="" type="checkbox"/> Fair <input type="checkbox"/> Poor</p> <p>Comments:</p> <ul style="list-style-type: none"> <li>• Invert elevation is -10.94 based on 1996 mechanical drawings. (Note that 1996 drawings show a discrepancy in the elevations between the electrical and mechanical drawings. However, the overall depth is the same)</li> <li>• Ejector pumps were replaced in 1996 with submersible pumps and wet well was modified with the addition of a partition wall and concrete fillets.</li> <li>• Concrete is visually good, surface not friable to touch.</li> <li>• Concrete curb is compromised – must be repaired/replaced.</li> <li>• There is a deteriorating plywood cover adjacent to the main wet well over an abandoned opening in the concrete. This is a safety hazard.</li> <li>• No cable management hardware.</li> <li>• Pump cables don't fit in conduit provided.</li> <li>• Location of the EYS fittings for pump and level sensors is not clear. Abandoned termination boxes in valve vault. Potential safety issue and code violation.</li> </ul>

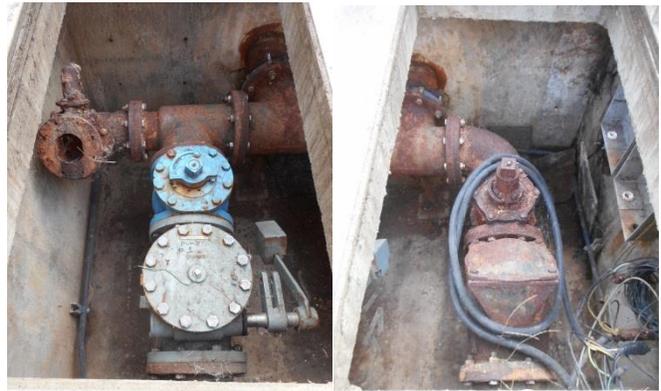
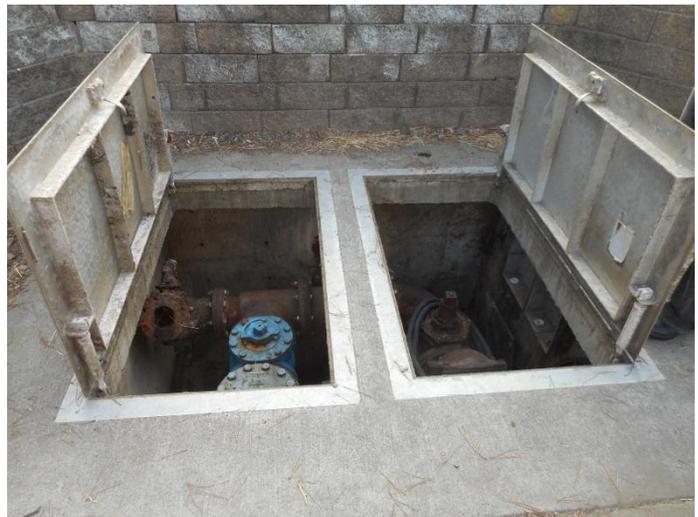
- Pipes and conduits are corroded.
- Conduit in valve vault in worse than poor condition – failed.
- Pump cables are terminated with a tape splice in valve vault, not waterproof/tight (other cables are using wire nuts). If the valve vault is a C1, D2 area, it is a code issue. The splices don't meet industry standards.
- Adjacent keystone retaining wall in good/fair condition.

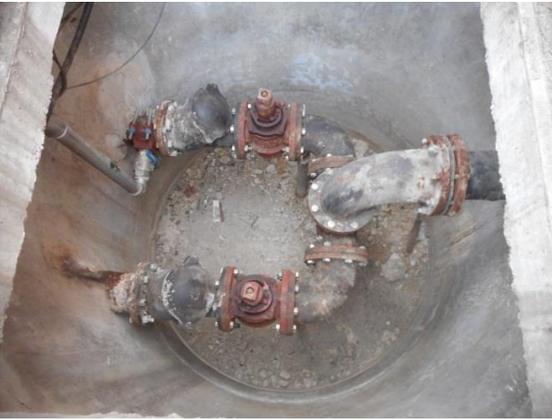
<b>Valve Vault</b>	Size: 5.5' I.D. x 6.6'  Material: Concrete  Coating: None  Personnel Accessibility Single leaf hatch approx. 48" x 30"  Equipment Ingress/Egress Truck mounted crane  Housekeeping Fair	Year Constructed 1996	Condition: Exterior: <input type="checkbox"/> Good <input type="checkbox"/> Fair <input type="checkbox"/> Poor <input checked="" type="checkbox"/> Not visible/below grade Interior: <input checked="" type="checkbox"/> Good <input type="checkbox"/> Fair <input type="checkbox"/> Poor Comments: <ul style="list-style-type: none"> <li>2" tee and SST pipe downstream of isolation valve</li> <li>Hatch needs safety grate.</li> <li>Needs cable management hardware.</li> <li>Evidence that concrete has been patched at pipe penetration in the past - possibly to fix leak at pipe penetration</li> </ul>
