On Tuesday, January 3, 2023, at 8:18 PM, the City of Richmond Fire and Police departments responded to the 300 block of Seaview Drive for a possible landslide. Residents reported a break line in the hillside that could potentially become a landslide due to the expected weather event. Due to the recent storm surges, the hillside above Seacliff Drive and Seaview Drive in the Brickyard Cove area became unstable.

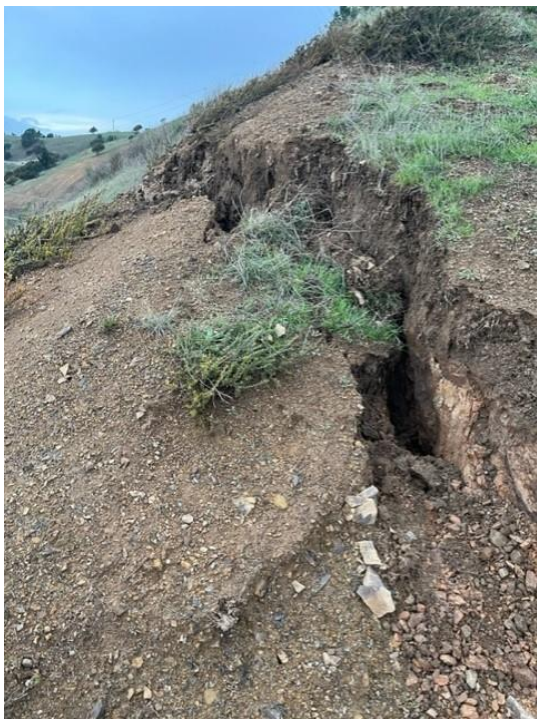
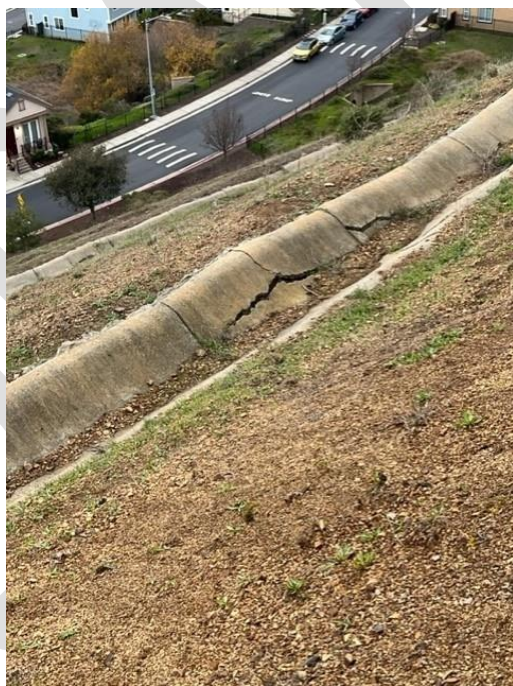
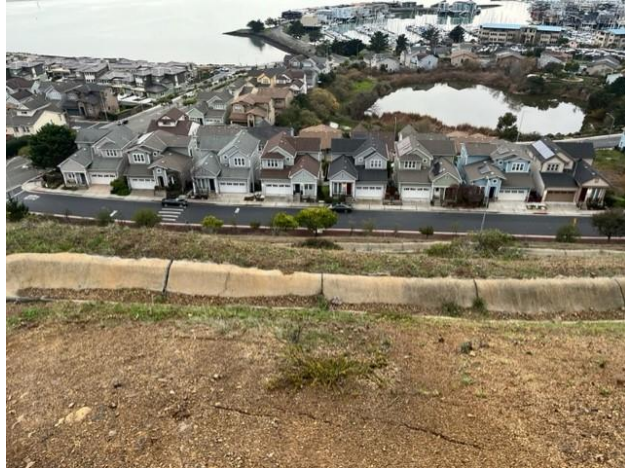
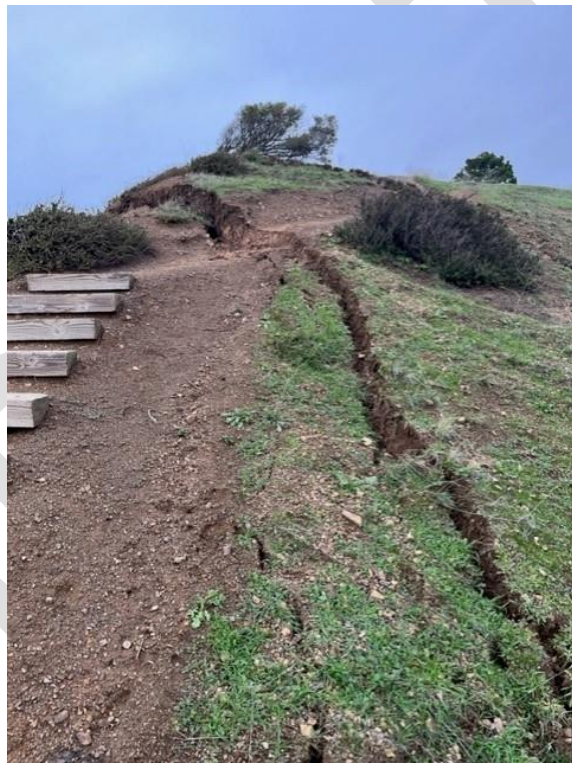
Near the top of slope, there is a large crack that is a maximum of 12 inches wide with evidence of soil movement downhill. The crack spans approximately 100

feet parallel to the slope. Looking into the crevasse, the soil included shattered shale and a clay-silt material. There was no evidence of weathered bedrock at the surface.

Walking north there is evidence of cracking and slope movement. Higher up on the slope and to the north of the largest cracks, it appears there is a scarp from an earth movement that occurred many years ago. It appears that this material has re-mobilized.

Walking along the uppermost concrete ditch, it has significant cracking and movement on each side of the drain inlet. There is a large hole in the earth near the outside of the drain inlet. It appears that stormwater is entering the hole and potentially "piping" in the fill materials along the storm drainage pipe. On the next tier downslope, it appears that the concrete ditch has also shifted.

Based upon field observation, it appears that there is a shallow sloughing of soils near the top of the slope that has impacted the top two concrete ditches. This movement will prevent the proper conveyance of runoff to the underground system and potentially allow runoff to flow directly downslope.

Mr. Stevens is concerned that heavy rainfall as predicted in the coming days could cause additional slope movement. Due to damage of the concrete ditches, storm water is not effectively being conveyed, which could cause additional damage. A significant concern is that if the slope activates, a large rock common in the Point Potrero formation could mobilize and fall down the hill and into the adjacent homes.

Based on this interpretation, Cal Engineering & Geology Inc. strongly recommended that the eight (8) homes on Seaview Drive and seven (7) homes on Seacliff Way that are immediately west of and closest to Seacliff Drive be evacuated until the landslide can be more thoroughly evaluated. They stated that this should be done immediately to reduce the potential for life safety issues that could result for movement of the landslide, particularly considering the forecast amount of rain that is to fall tonight and over the next few days.

Richmond Police will staff the road closures for the duration of the incident. Residents are advised to avoid the area and to expect traffic delays. The City will have a geologist conduct an additional evaluation and it is anticipated that a contractor will implement measures to assist in stabilizing the slope.
