REVITALIZATION OF HISTORIC RICHMOND MAIN LIBRARY

EXECUTIVE SUMMARY

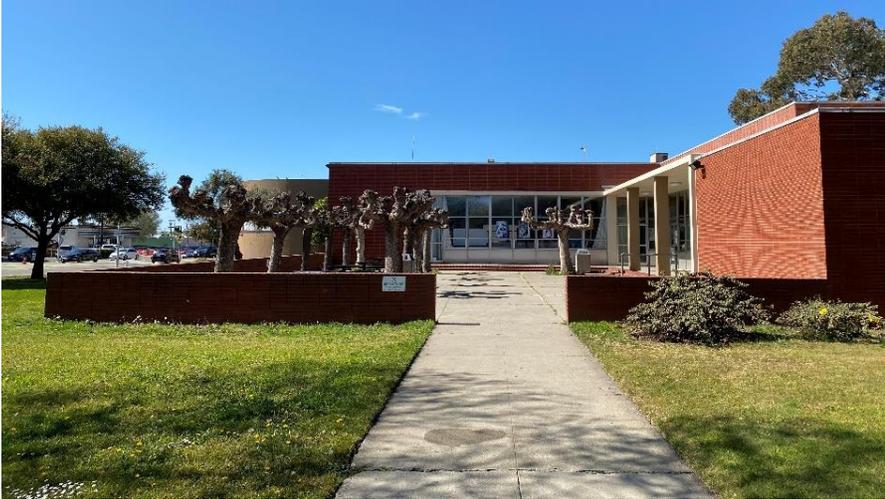
1.1 COURTYARD

Challenge: The local unhoused population congregates in the Courtyard outside the sole entry to the Community Room and the primary entry to the Children’s Room making patrons feel unsafe. Prior to opening each day, staff must clear the area and the refuse left behind. There are no security cameras and minimal lighting to discourage this use of space. In addition, the existing ramp to the entries is not code compliant limiting accessible public access.

Solution: Create a safe outdoor entry by adding metal security fencing on top of the existing low brick wall and full height security gates at the courtyard entry. Provide an accessible ramp, new seating, new lighting, and a shade structure to utilize this area as an extension of both the Community Room and Children’s Room.

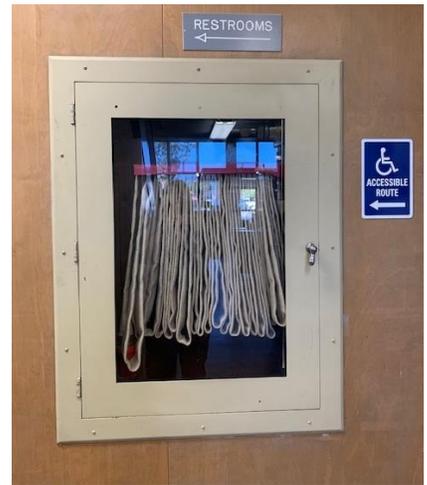
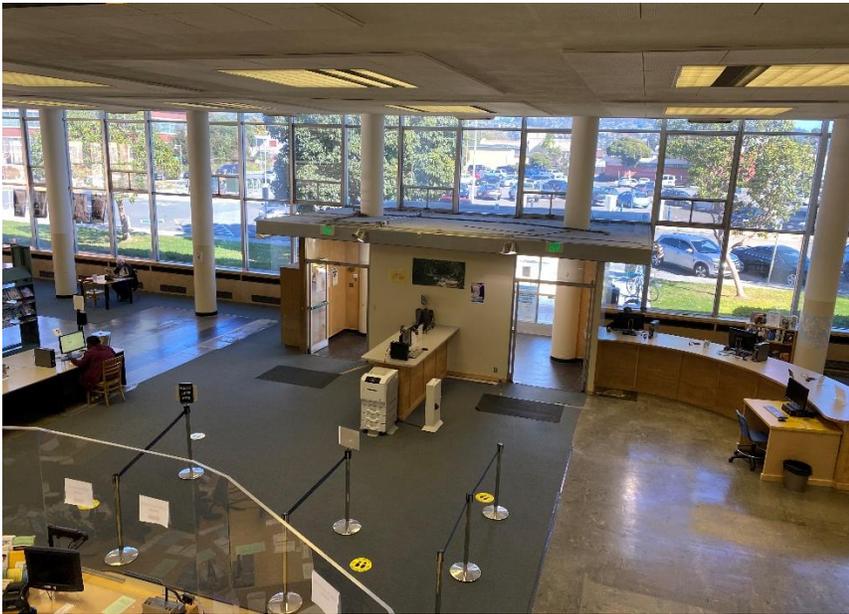
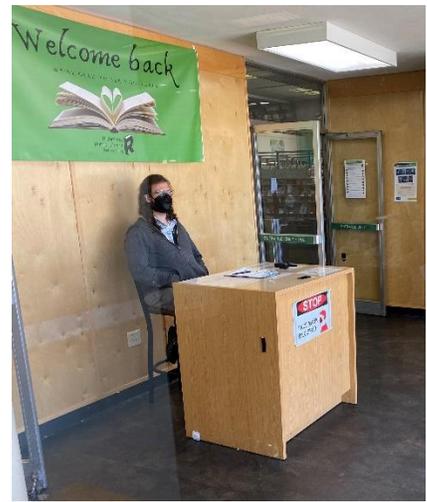
1.4 BUILDING ENTRANCE

Challenge: The circulation desk staff cannot see the main entry to the building due to structure. This creates the need for a separate security guard station.

Solution: Modify the Main Library entrance to replace the existing solid wall with glass to improve visibility for staff to monitor who is entering the building.

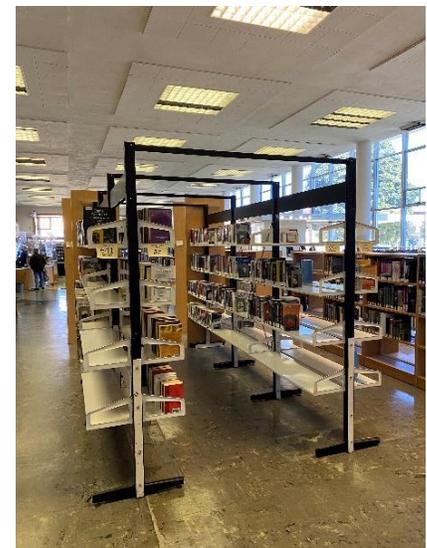
1.5 NEW SEISMICALLY BRACED SHELVING

Challenge: Existing shelving is very old and is not laterally braced creating a life safety hazard in a seismic event.

Solution: Replace old shelving with modern seismically braced shelving.

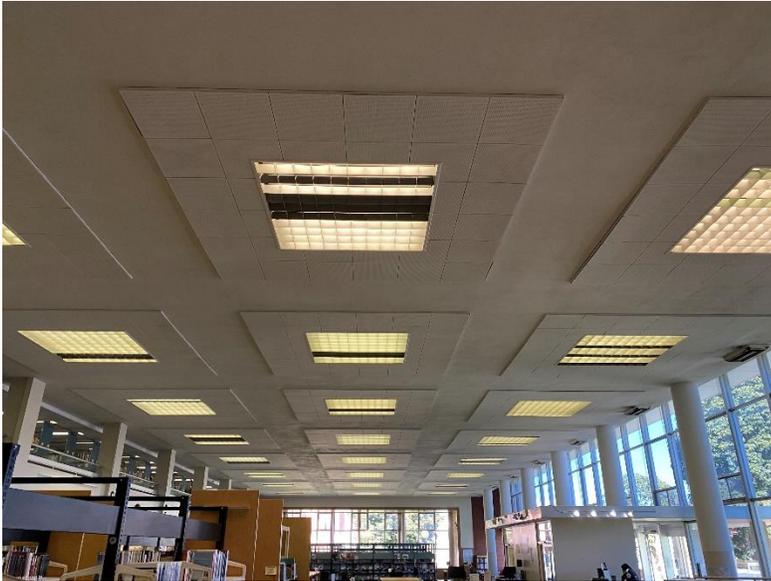
2.1 LIGHTING & CONTROLS

Challenge: Low levels of lighting are inadequate for library needs and existing fixtures are not energy efficient. There are no centralized switches. Library staff must turn off lighting at an electric breaker panel.

Solution: Replace existing fixtures with modern lighting systems appropriate to the Main Library's historic nature and add a code compliant lighting control system for functionality and energy-efficiency.

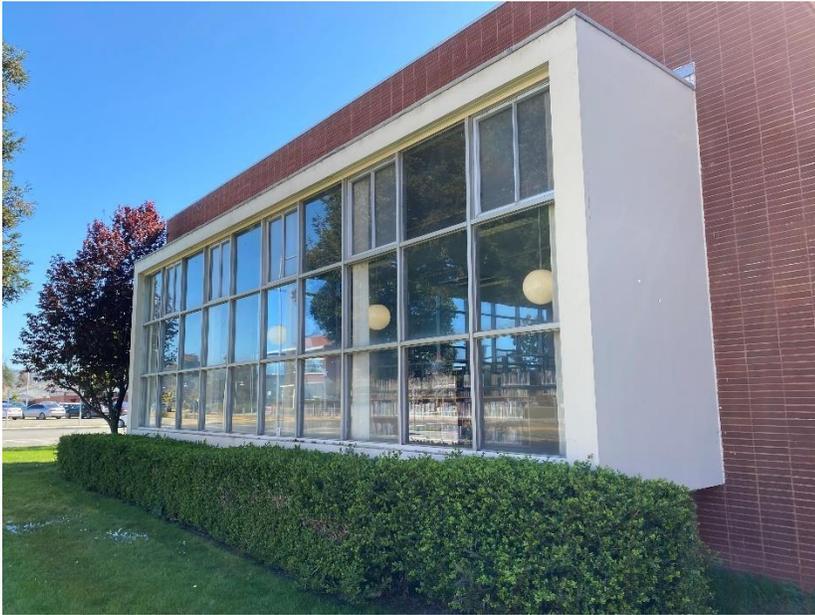
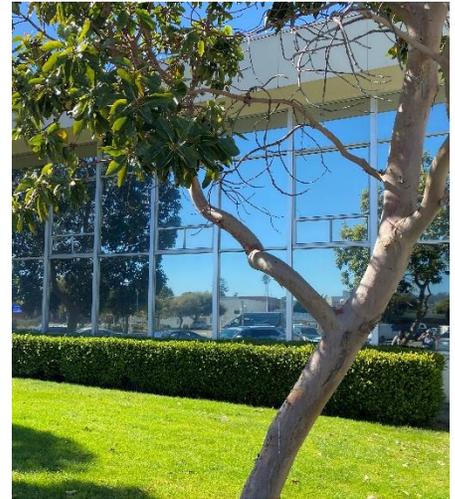
2.4 WINDOW REPLACEMENT

Challenge: Existing window systems are the original single glazed panes and are in disrepair. Additionally, many of the operable windows no longer fully close constituting a security issue.

Solution: Replace the entire window system with modern, high performance glazing complying with modern safety standards.

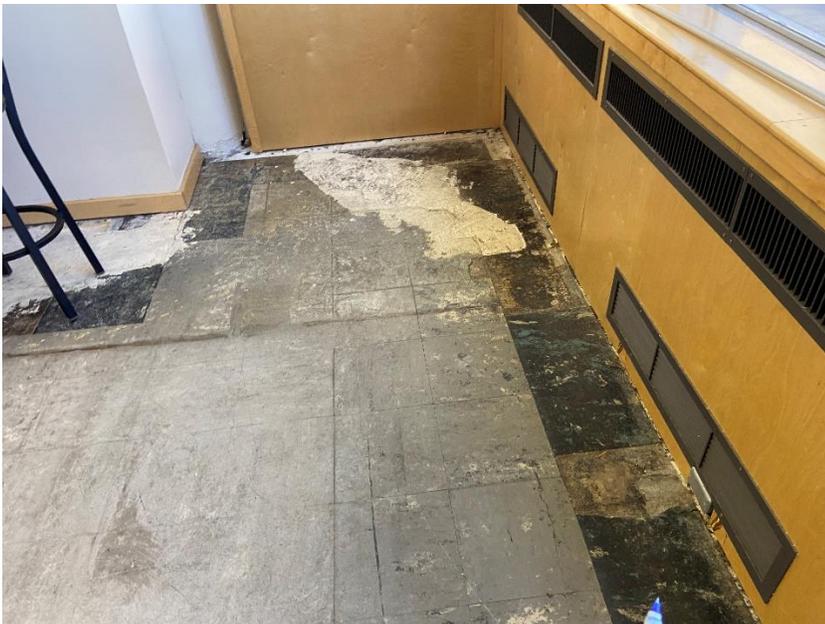
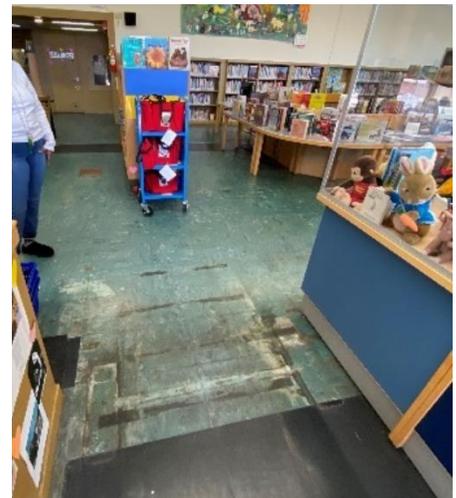
2.5 FLOOR FINISHES REPLACEMENT

Challenge: Existing VCT flooring is peeling and missing entirely in some areas. It was applied with asbestos adhesive which constitutes a safety hazard. The existing carpet is a tripping hazard with a recent staff workers compensation claim.

Solution: Remediate asbestos during replacement of existing flooring including leveling the subfloor. Provide all new flooring.

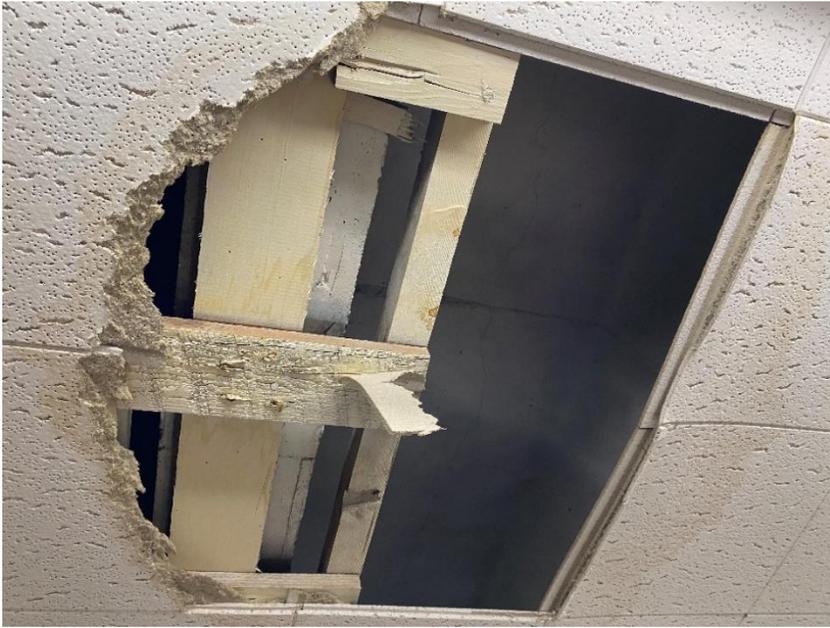
2.6 ACOUSTICAL CEILINGS REPLACEMENT

Challenge: Existing acoustic ceilings have been painted over multiple times and lost their absorptive properties. Extensive Water damage has also occurred throughout the building.

Solution: Replace with new ceilings appropriate to building's historic nature.

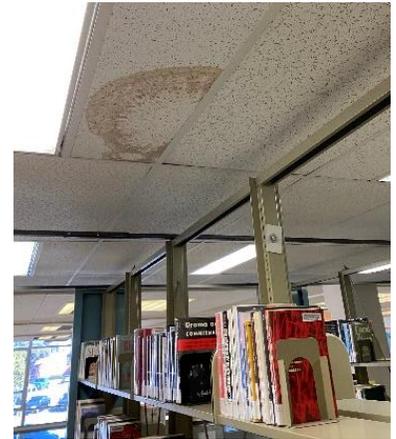
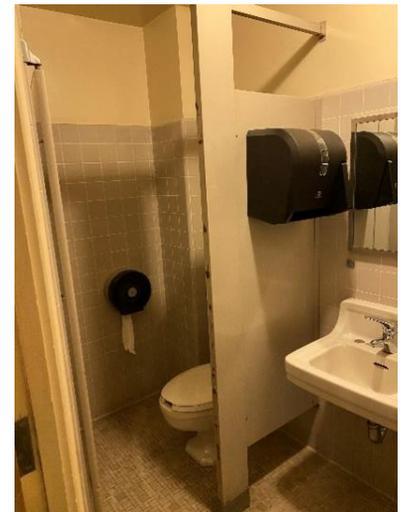
3.1 RESTROOM UPGRADES

Challenge: Existing restrooms have poor lighting and ventilation and are old and decrepit. The incremental accessibility fixes in the main public restrooms have created an inadequate fixture count.

Solution: Fully renovate all restrooms.

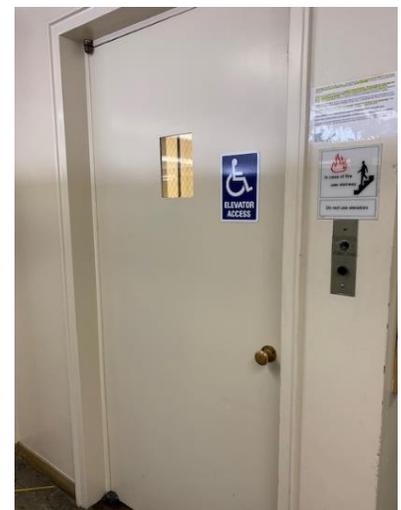
3.2 ELEVATOR REPLACEMENT

Challenge: Existing elevator is original to the building. It is not accessible and not possible to retrofit.

Solution: Replace existing elevator with a modern, code-compliant elevator.
