CITY OF RICHMOND, CA. FORCE MAIN SYSTEM CONDITION ASSESSMENT REPORT

Prepared for: Veolia Water North America
601 Canal Blvd
Richmond, CA 94804

Date: January 2016

V&A Project No. 14-0338

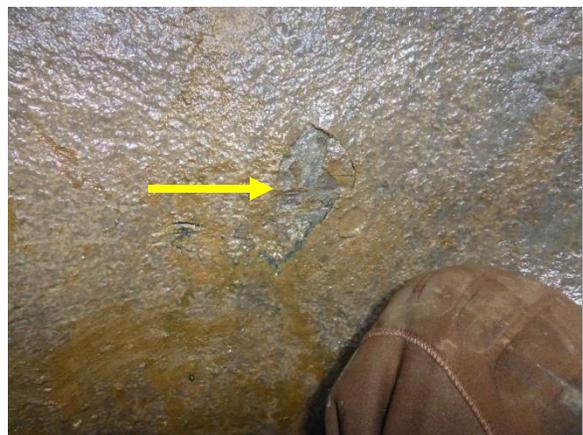
The discharge manhole in the Marina Bay Parkway force main system was generally in good condition and was sealed well to the pipe connections. The pipe connections included the force main and a gravity outlet. The force main was black plastic (possibly HDPE) and was approximately 9.375 inches in diameter in the vertical direction and 9.5 inches in diameter in the horizontal direction. The gravity outlet was white plastic (also possibly HDPE) measuring approximately 14.25 inches in diameter, and oriented 90 degrees to the influent pipe. During the pump cycle, the discharged water became quite turbulent (Photo 3-1). The pipes are clear of debris and buildups except for minor thin apparent grease coatings on the wall surfaces (Photo 3-2 and Photo 3-3). A thin mortar layer on the manhole concrete surface is chipping off in places (Photo 3-4).

Photo 3-4. Thin Surface Mortar Detachment on Discharge Manhole Wall

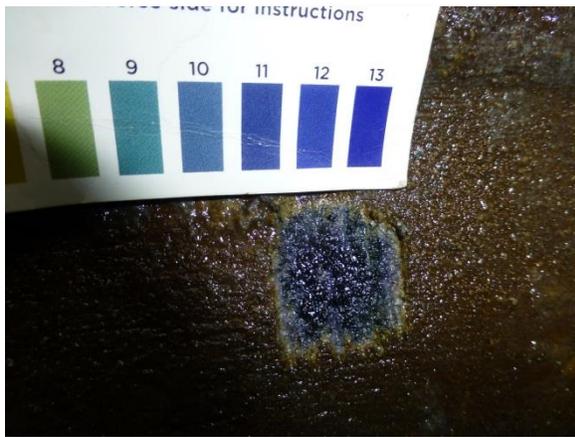
The concrete under the thin mortar layer is fresh and solid as evidenced by an in situ pH reading of 12 (Photo 3-5), and concrete sounding/penetration test results. Both the cone and barrel/bench sections of the manhole are in good condition. The chimney is constructed of three stacked rings 3 inches (two rings) and 5 inches thick. The joints are not sealed (Photo 3-6). An open 3/4 to 1-inch wide gap separates the bottom ring from the cone section (Photo 3-7). A 4-inch wide by 3-inch high triangular piece of concrete is missing from the middle ring (Photo 3-8). The manhole chimney is structurally sound but the open joints and the triangular spall cavity should be sealed with a repair mortar. The right angle turn between the influent and effluent pipes generates turbulent flow during discharge cycles that will release corrosive hydrogen sulfide gas into the manhole headspace. The new manhole concrete condition is rated a VANDA Level 1 according to Table 2-1 guidelines.

Photo 3-5. Concrete Under Thin Mortar Coating is pH 12

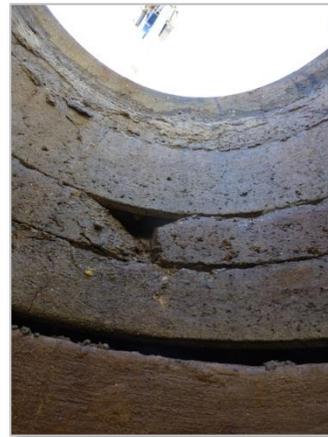
Photo 3-6. Open Joints Between Manhole Rings and the Manhole Cone; A Concrete Fragment is Missing from the Middle Ring

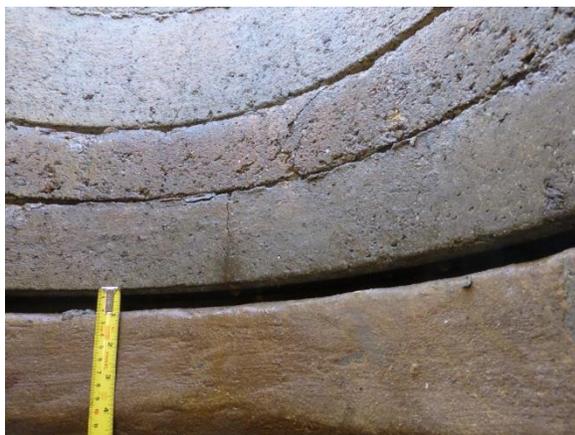
Photo 3-7. A 3/4-inch Wide Gap Separates the Lower Ring and the Cone Section

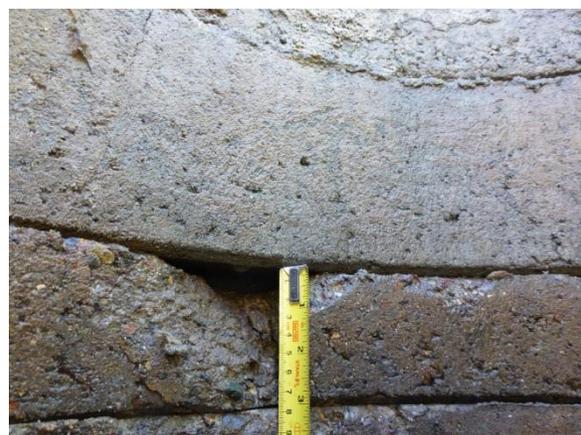
Photo 3-8. A Triangular Spall Fragment is Missing From the Middle Ring

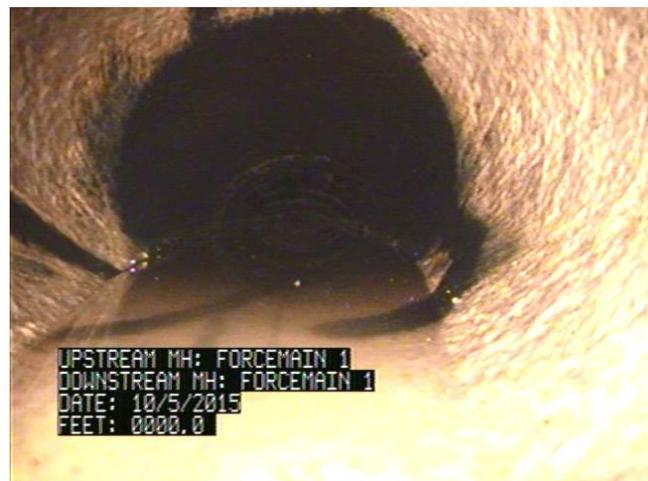
There were multiple trial entries and cleanings required to CCTV the Marina Bay Parkway force main. The camera was under water from 5.5 feet upstream of the discharge manhole up to 340 feet upstream. Note that only 180 feet were recorded. This signifies a continuous sag in the force main and not much more can be evaluated from the CCTV to add to the confined space entry at the discharge manhole. Photo 3-9 shows the condition at the discharge manhole.

Photo 3-9. CCTV of Marina Bay Parkway FM at the Discharge Manhole

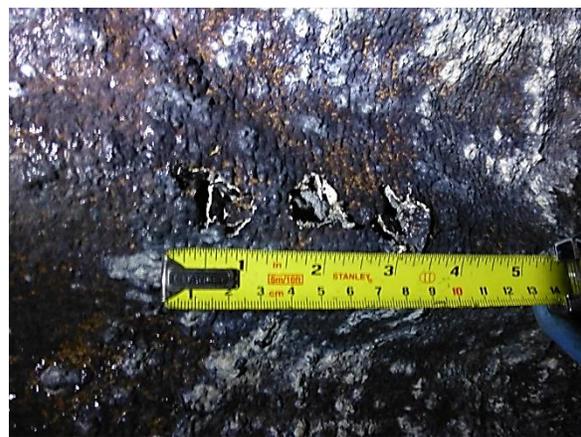
Photo 3-11. Three Holes in the Detached Manhole Liner

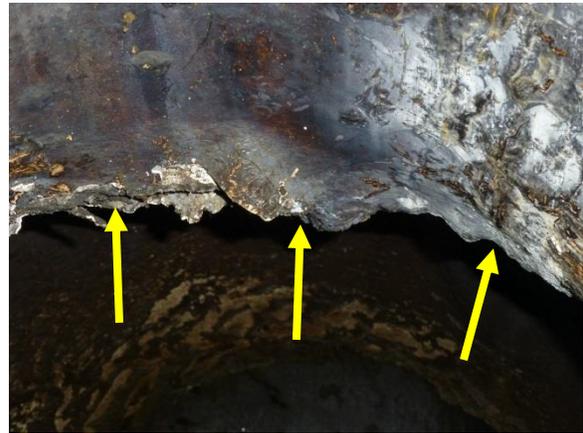
Photo 3-13. Liner Detached from Concrete at the Bottom of Manhole Riser

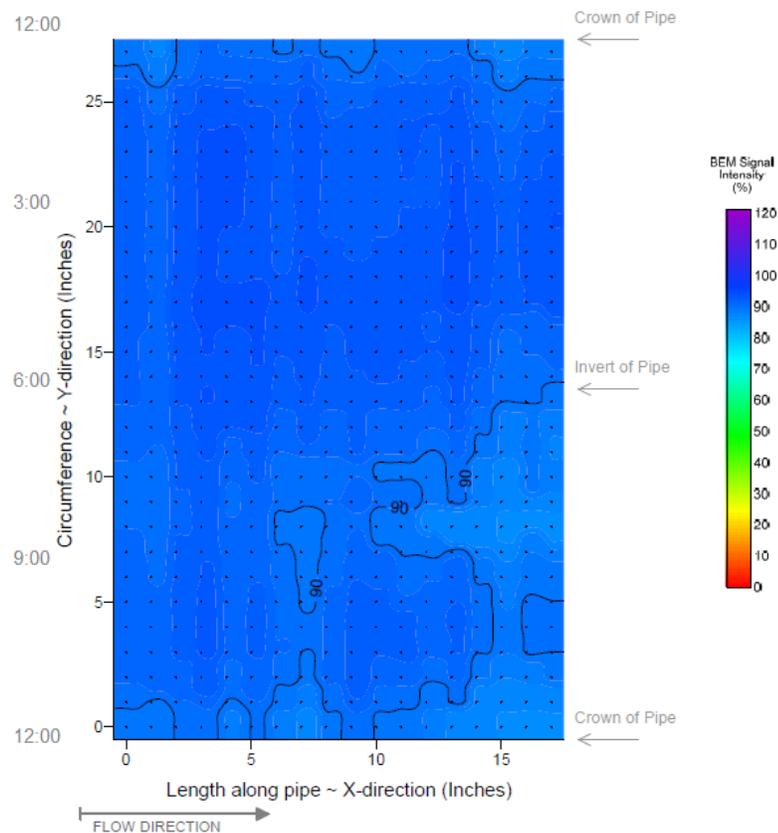
Test	Wall Thickness (in.)				Coefficient of Variation
	Min	Max	Average	Range	
BEM	0.370	0.404	0.390	0.034	1.9%
UT	0.369	0.410	0.390	0.041	5.2%

Figure 3-3. Keller Beach Force Main - BEM Contour Plot

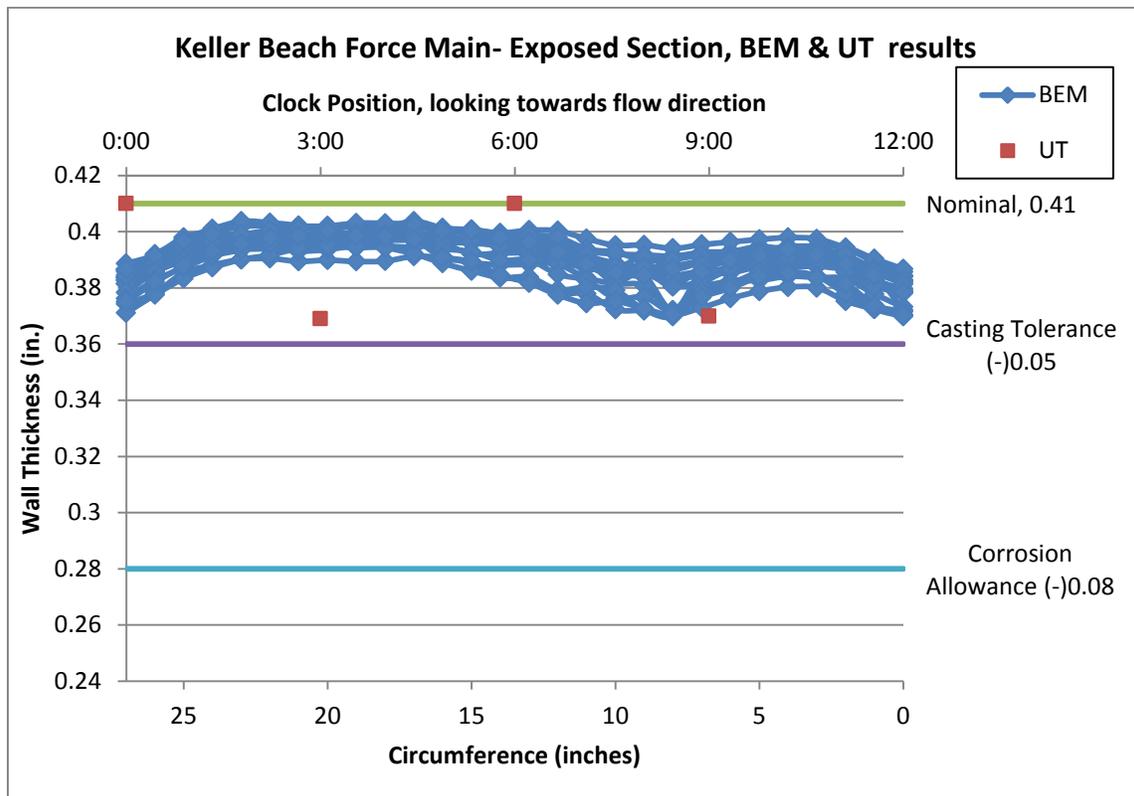
Out of these standard thickness classes, the pipe is most likely thickness Class 22 of nominal thickness 0.41 inches.

Figure 3-4. Keller Beach Force Main - BEM & UT results plotted with Nominal Thickness

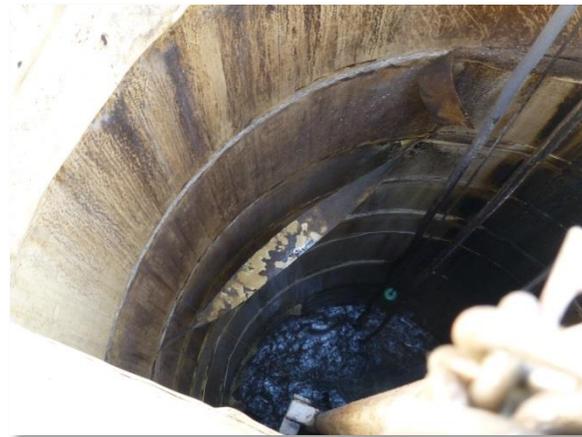
The Brickyard Booster Pump Station Wet Well was assessed as a substitute for a discharge manhole since it was thought that the Brickyard Cove Force Main discharged directly into the Booster Pump Station Wet Well. The wet well is cylindrical in shape and is completely lined with T-Lock (Photo 3-21). The weld strips at the horizontal joints between sheets are failing, and in places, are exposing the underlying concrete (Photo 3-22 and Photo 3-23). Two vertical discharge pipes from the submerged pumps show moderate surface corrosion exfoliation (Photo 3-24). Stainless steel flange bolts and other stainless steel hardware in the wet well are in good condition (Photo 3-25). The concrete exposed where the T-Lock liner strips have failed is hard beneath a thin soft, chalky surface layer. The concrete is rated VANDA Level 2 Condition per Table 2-1. The wet well liner is pliable and intact, but is being undermined in places by moisture penetration behind it.

Photo 3-22. Failed T-Lock Weld Strips at Horizontal Joints

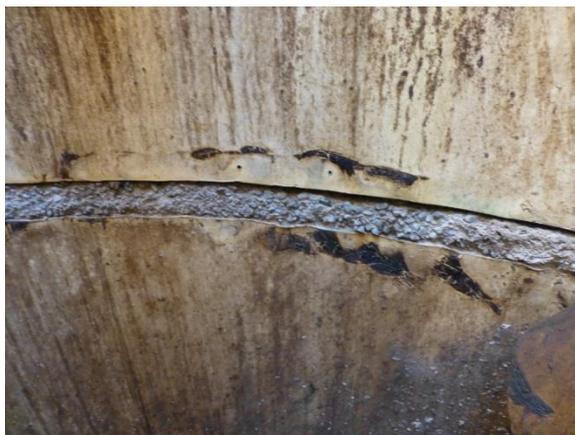
Photo 3-23. Exposed Concrete at Failed Horizontal Joint in T-Lock Liner

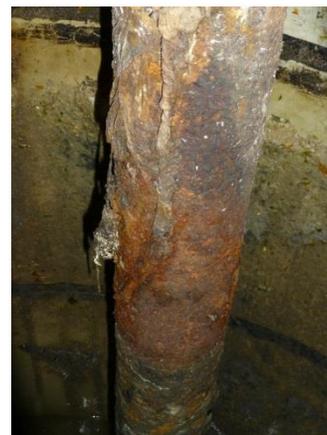
Photo 3-24. Moderate Corrosion Exfoliation on Discharge Pipe Surface

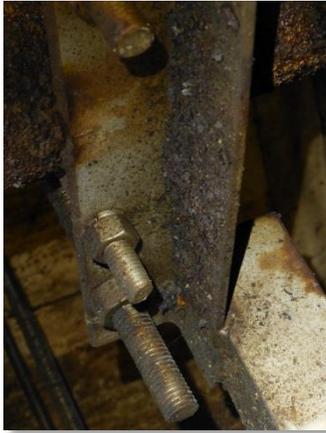
Photo 3-25. Stainless Steel Hardware is in Good Condition

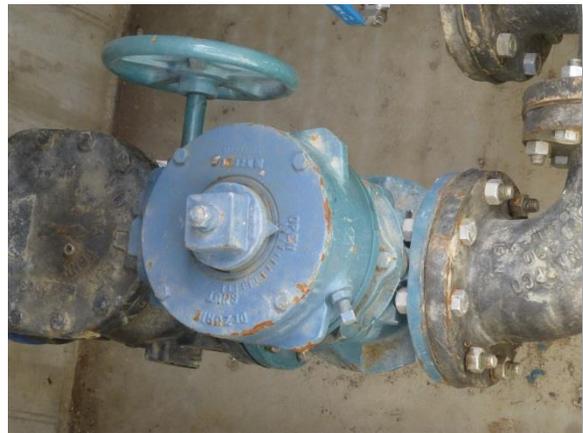
Photo 3-27. Minor Localized Corrosion on Valve Components

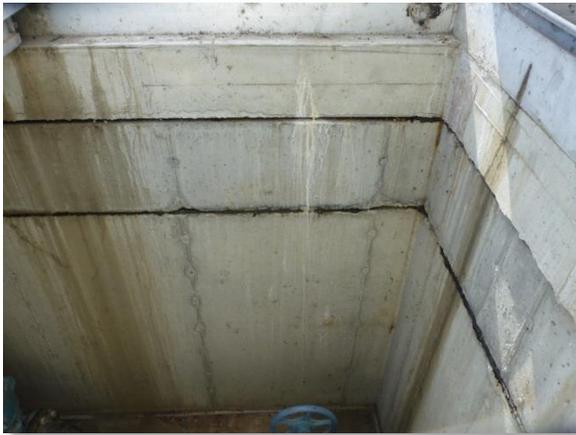
A precast pipe vault is located downstream of the wet well. The two discharge pipes join into a single force main in this structure (Photo 3-26). The concrete and metallic piping and valves are in good condition. Metal corrosion is minor (Photo 3-27). No leakage at joints and sealed wall-to-floor seams was observed (Photo 3-28).

Photo 3-28. Minor Concrete Staining on Valve Vault Walls and Well Sealed Joint Seams

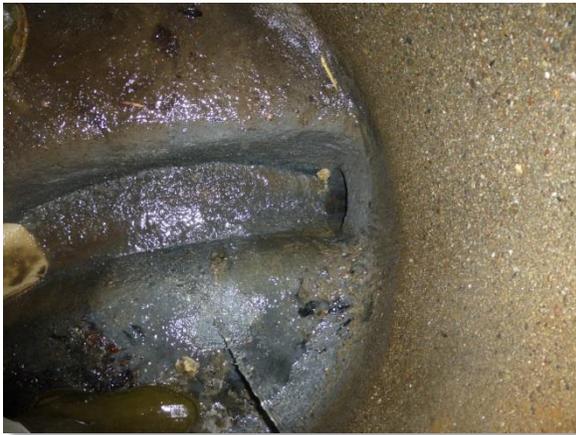
Photo 3-33. Bench and Lower Barrel Concrete in Good Condition. VANDA Level 1 to 2 Condition.

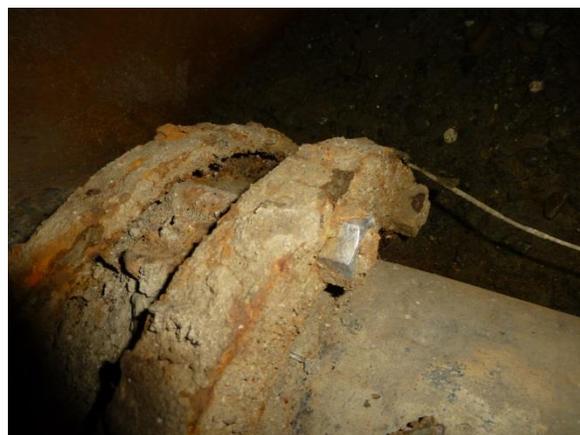
Photo 3-35. Flange Coupling on HDPE Force Main Showing Exposed Stainless Steel Nut.

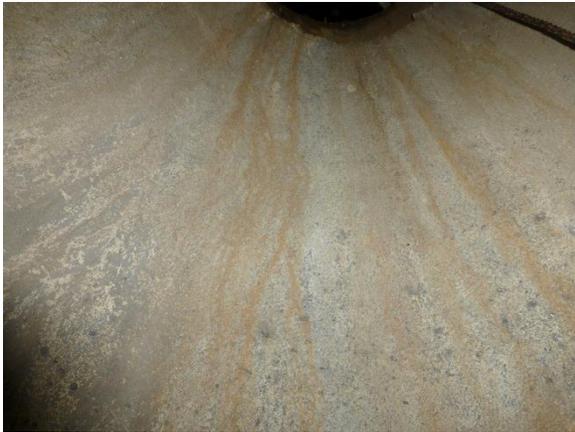
The concrete in the manhole is in good condition. It is hard and mortar-coated with no exposed or protruding aggregate (Photo 3-36). Concrete condition throughout the pressure manhole is rated a VANDA Level 1 per Table 2-1. . A small slit-shaped hole approximately 1-1/2 inches deep was seen in the wall near the bottom of the manhole, apparently an original construction defect (Photo 3-37). It is merely a curiosity and has had no effect on the functionality of the manhole, outside of possible source of infiltration. There was no evidence of active infiltration but the drought conditions may have contributed.

**Photo 3-36. 8-inch Diameter Black HDPE
Brickyard Booster Force Main.**

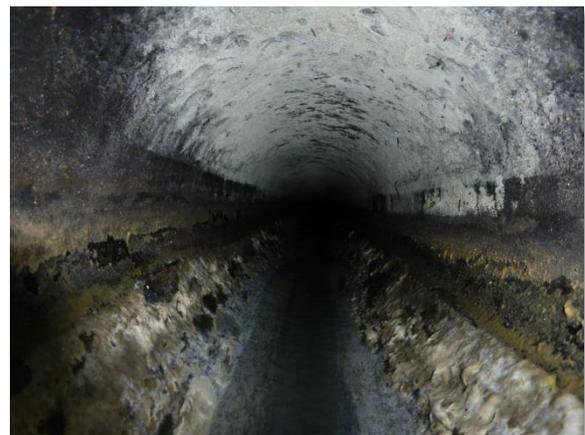
Photo 3-41. Grease Buildup in Invert of the 8-inch Black HDPE Inlet Pipe

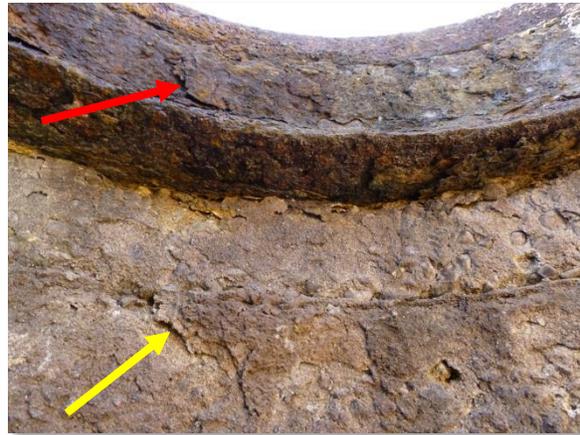
Photo 3-43. Mortar Peeling Off Manhole Riser Surface (yellow arrow), and Metal Exfoliating on Manhole Ring (red arrow)

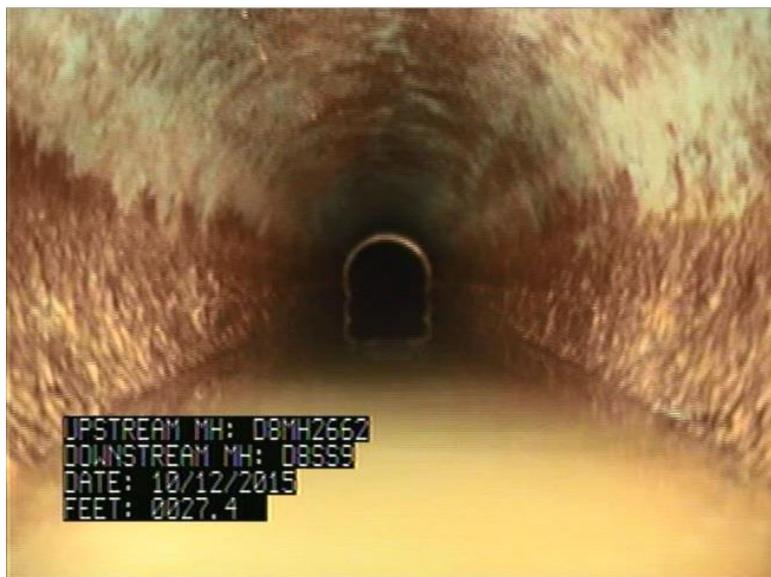
The CCTV that began at the Brickyard Cove discharge manhole was successful. The Brickyard Cove force main was identified as plastic; probably PVC given the blue-green color. The force main looked relatively new and was in good condition. A joint was approximately 27 feet from the manhole and was in good condition (Photo 3-44). At approximately 39 feet, there was a 45 degree bend that prohibited further advancement. This alignment was previously not documented nor understood well, and the Brickyard Cove discharge manhole location was previously unknown.

Photo 3-44. CCTV of Brickyard Cove Force Main Showing Joint at ~27 feet from Discharge Manhole

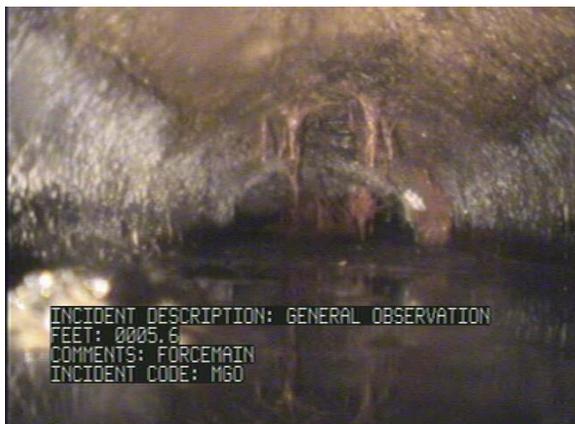
The CCTV that began at the Brickyard Booster discharge manhole had some challenges. Roots, worms and debris were encountered about 7 feet into the pipe as shown in Photo 3-45 and Photo 3-46, which indicates the force main would benefit from more regular cleaning. The pipe was cleaned to allow further progression of the CCTV and better viewing of the pipe surface. Photo 3-47 shows a possible fracture at the pipe-crown. This was a similar location to where roots were observed prior to cleaning. There was a bend about 8 feet upstream of the discharge manhole that inhibited further progress.

Photo 3-45. CCTV of Brickyard Booster Force Main showing Roots before Cleaning

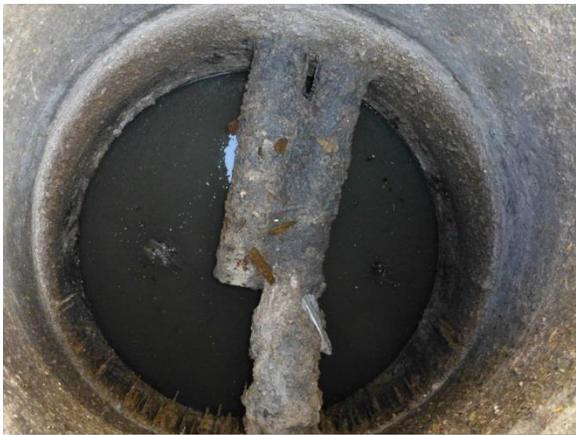
Photo 3-48. Plan View into Port Pressure MH with One Pipe Severed and Abandoned

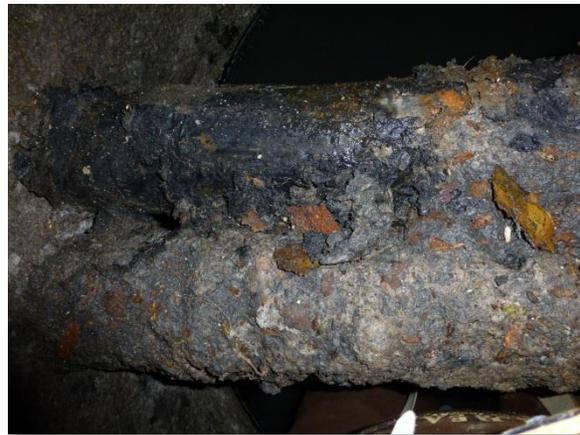
- Poor condition. A severely corroded metallic pipe at the pressure manhole and a reinforced concrete pipe with grease and partial cave-in at the discharge manhole.
- The pressure manhole concrete was in a good to moderate condition. The discharge manhole was in poor condition.
 - ⇒ Replace the severely corroded metallic section.
 - ⇒ Regular/ more frequent cleaning of the Port FM

Photo 3-49. Corroded Surfaces of 4-inch Diameter Metal Force Main Pipes

- 1) Replace the severely corroded metallic section of the Port FM.
- 2) Perform regular/ more frequent cleaning of the Port FM.
- 3) Excavation of Ferry Point FM to gain more condition information.
- 4) Rehabilitate the Ferry Point/ Keller Beach FM discharge manhole.
- 5) Regular/more frequent cleaning of the Brickyard Booster FM.
- 6) Rehabilitate the Brickyard Booster FM/Port FM discharge manhole.
- 7) More condition assessments and a risk assessment for the City force mains not yet assessed.
- 8) Repair the T-Lock joints in the Brickyard Booster PS wet well liner.
- 9) Monitor Marina Bay Parkway discharge manhole location due to turbulent flow.
- 10) Remove and reapply concrete top coat in the Marina Bay Parkway FM discharge manhole.

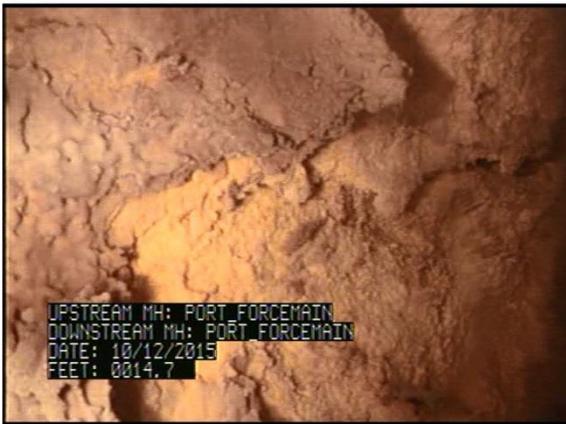
Photo 3-51. Port Force Main- typical thick layer of FOG at pipe crown
