STREETLIGHT MASTER PLAN

January 2011

Republic ITS
Intelligent Transportation Services

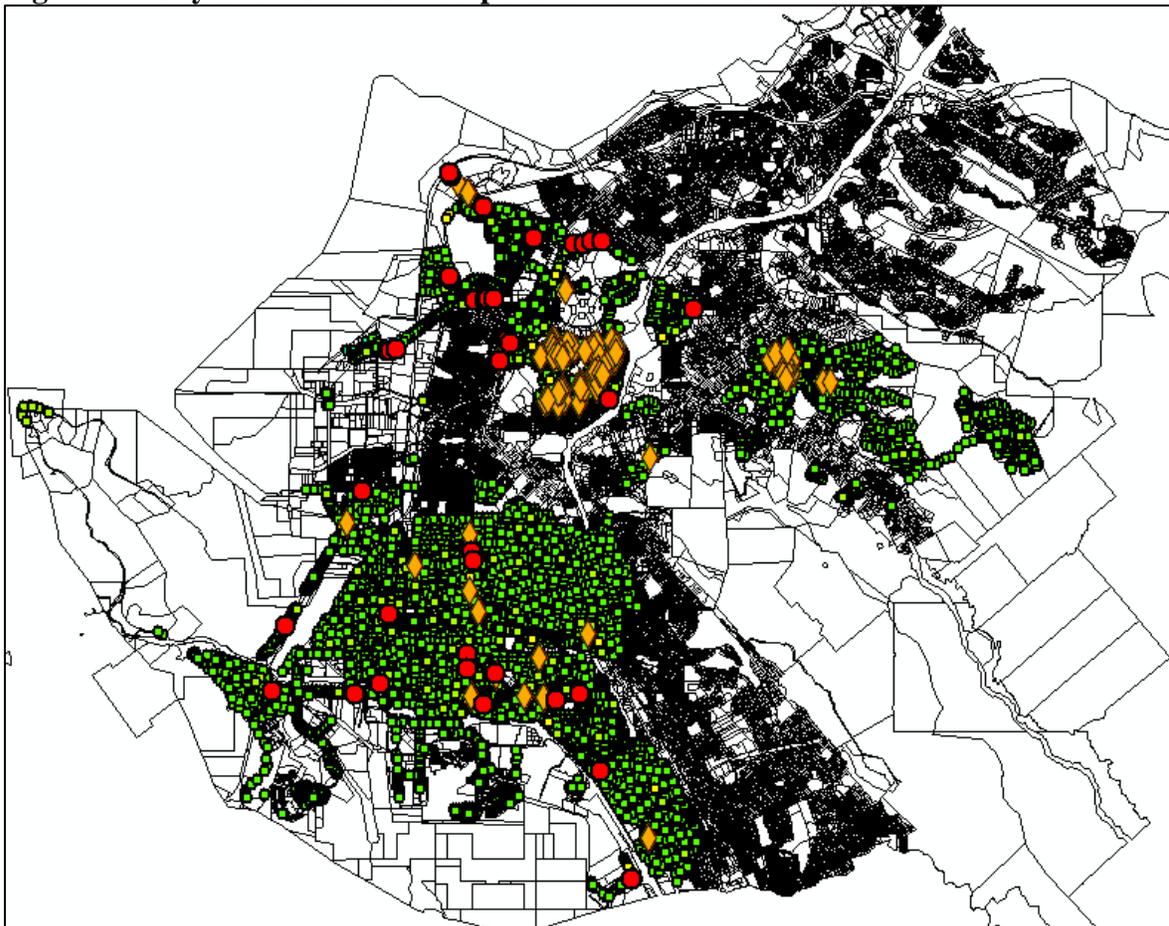
Figure 4 – City and PG&E Owned poles and conditions

The poles with a rating of 5/Very Poor are shown in Figure 4 with red circles. These poles are significantly dented, rusted, or missing. The locations of these poles are shown in the

appendix. City staff have indicated that several fiber glass poles in the Marina area have severely rusted steel bases. These bases are completely covered by the ornamental base cover and were not visible to Republic ITS field staff. The poor condition of these poles is not reflected in the survey results. Poles with 4/Poor ratings are also shown in Figure 4. These poles might have visible dents but are still vertical, or significant rust but still pass the ‘ping’ and penetration tests.

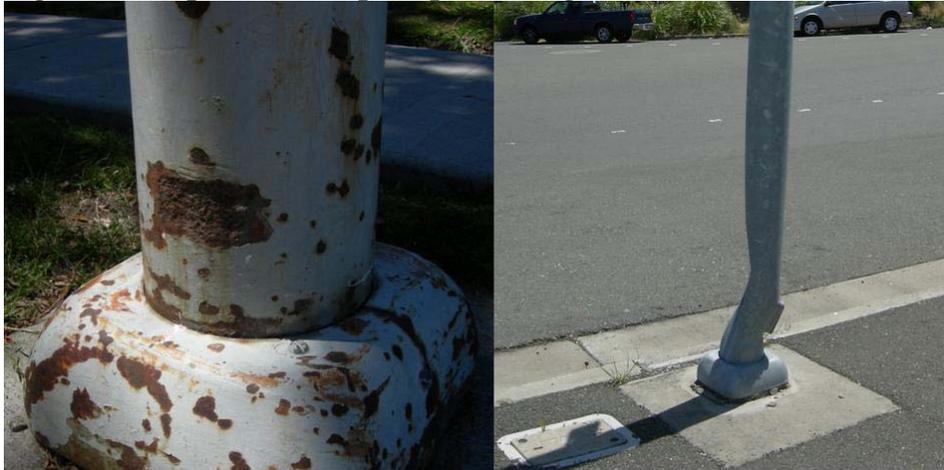
Figure 5 – Explanation of poor pole ratings

Rating 4 – Extensive rust with pitting

Rating 5 – Severely dented and no longer vertical

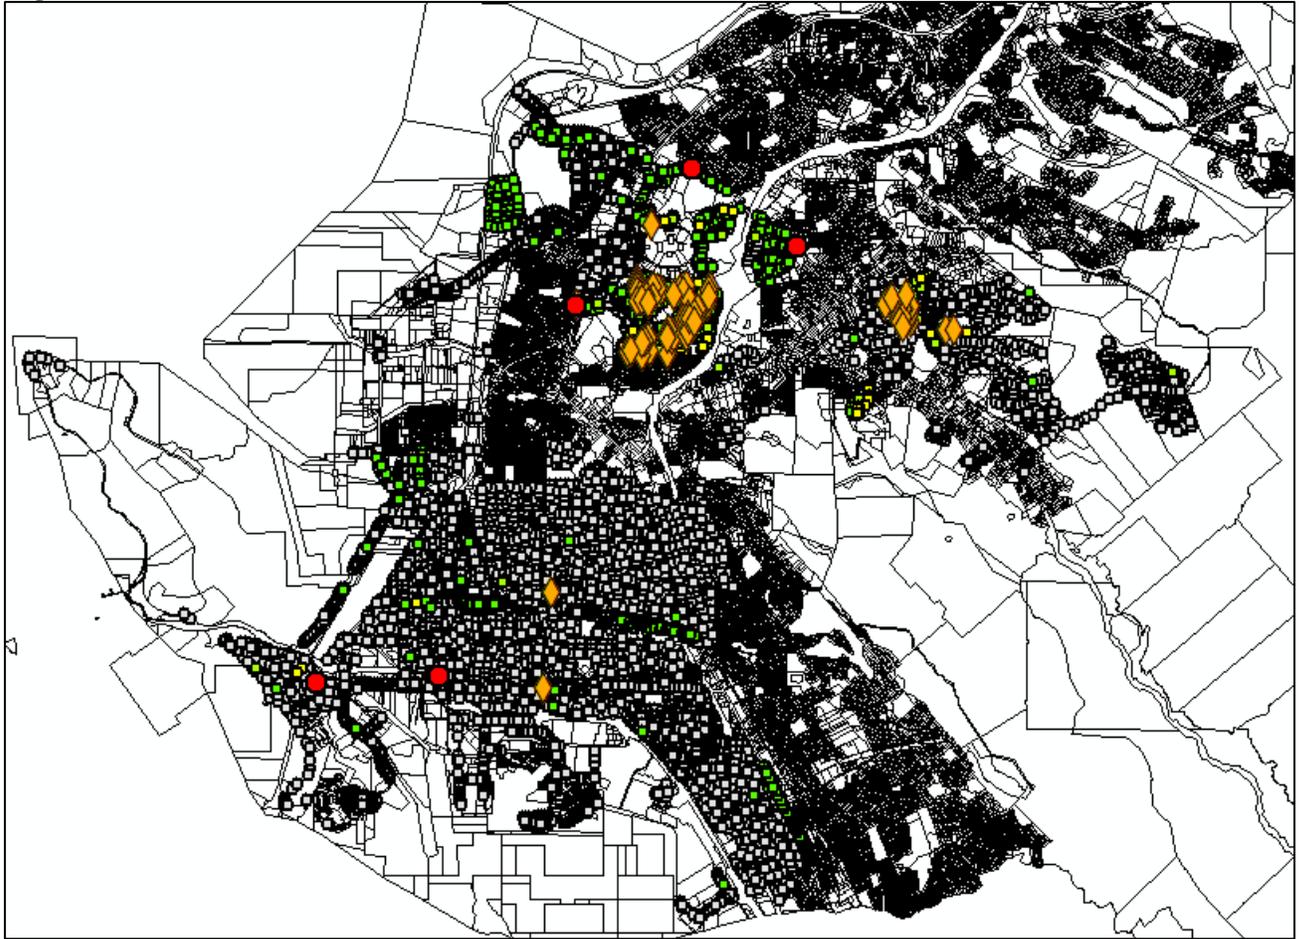
Figure 6 – Painted Poles and Conditions

Only a small percentage of the streetlight poles in Richmond have been painted. Many that have are old steel poles, often with significant rust. They appear to have been painted to cover the rust and marginally extend the pole life. Almost all poles of this type have a Poor rating for paint, since the rust typically bleeds through the paint.

Figure 6 shows the inventory of painted poles, with color coding to note paint condition. Note that several poles in the Fairmede/Hilltop neighborhood appear to have been repainted since the inventory was conducted, and have better appearance than the inventory suggests.

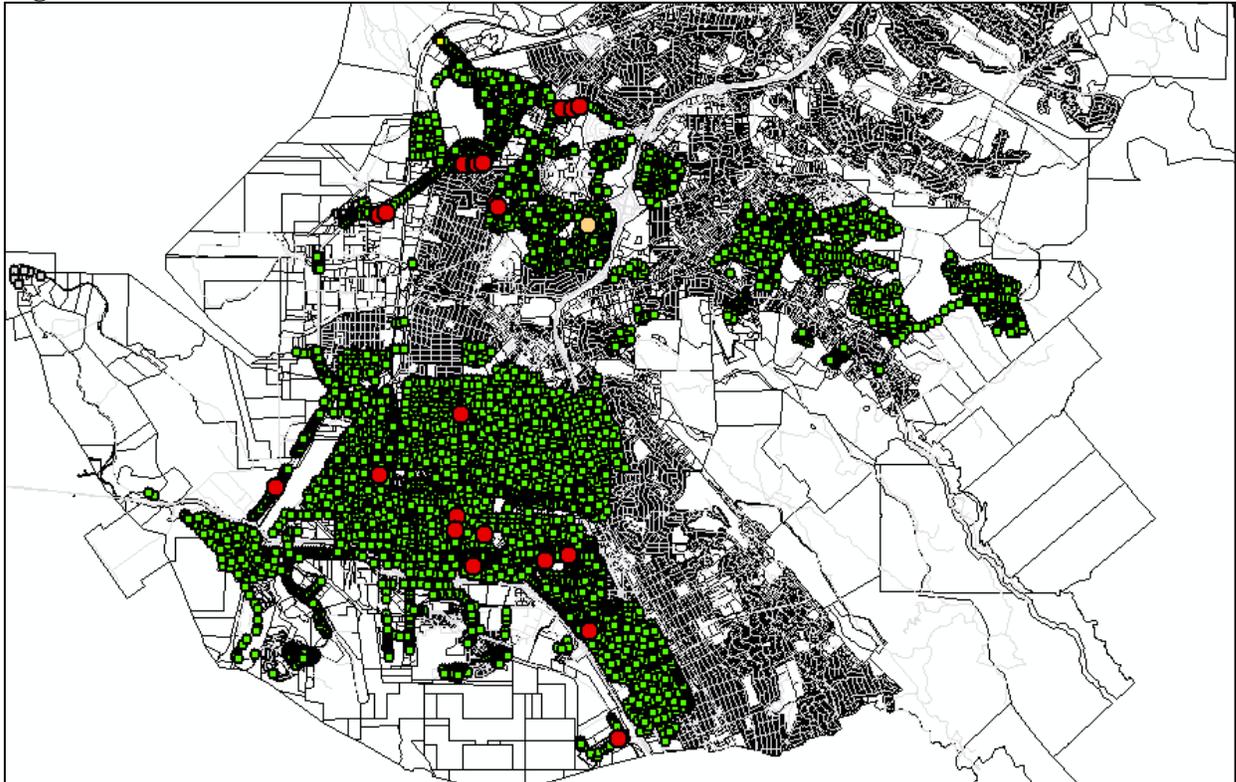
Figure 7 – Locations of Failed Foundations

Poor rated foundations are identical to the locations shown in Table 2 for knocked down poles. It can be stated in general that when a pole is hit hard enough to knock down the pole, the foundation is damaged and must also be replaced. Most foundations were not visible because of a base cover plate or landscaping. These were not rated. See Figure 7.

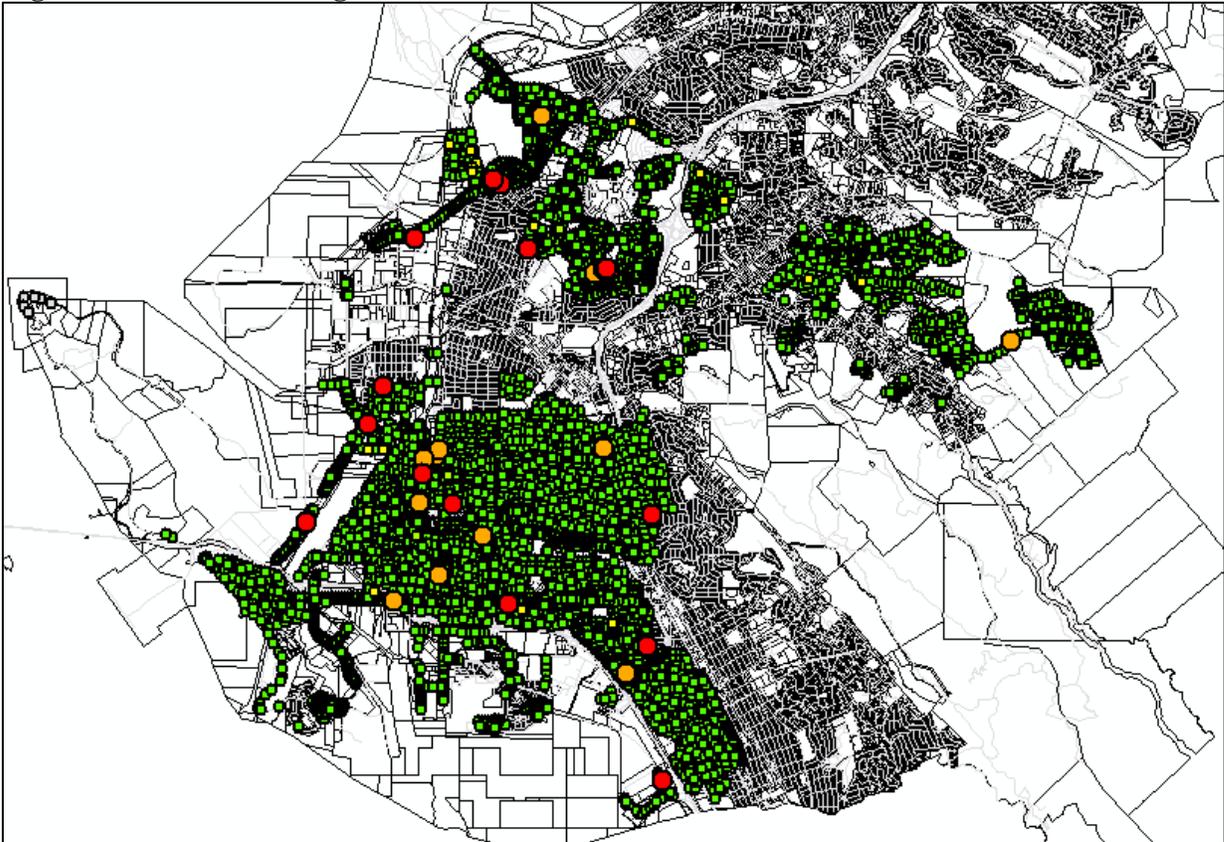
Figure 8 – Fixture Ratings

Fixture ratings are shown in Figure 8. Failed (rating of 5) ratings indicate broken lamp covers or lamps, shown as a large red dot in the figure. Fixtures that are due for replacement (rating of 4), shown as a large yellow dot in the figure, indicate aged and obscured glass covers or other damage.

Since the survey was conducted in daylight hours, the ratings do not show lamps that are burned out, or the large number that are not functioning because of wire theft (discussed later in this SLMP).

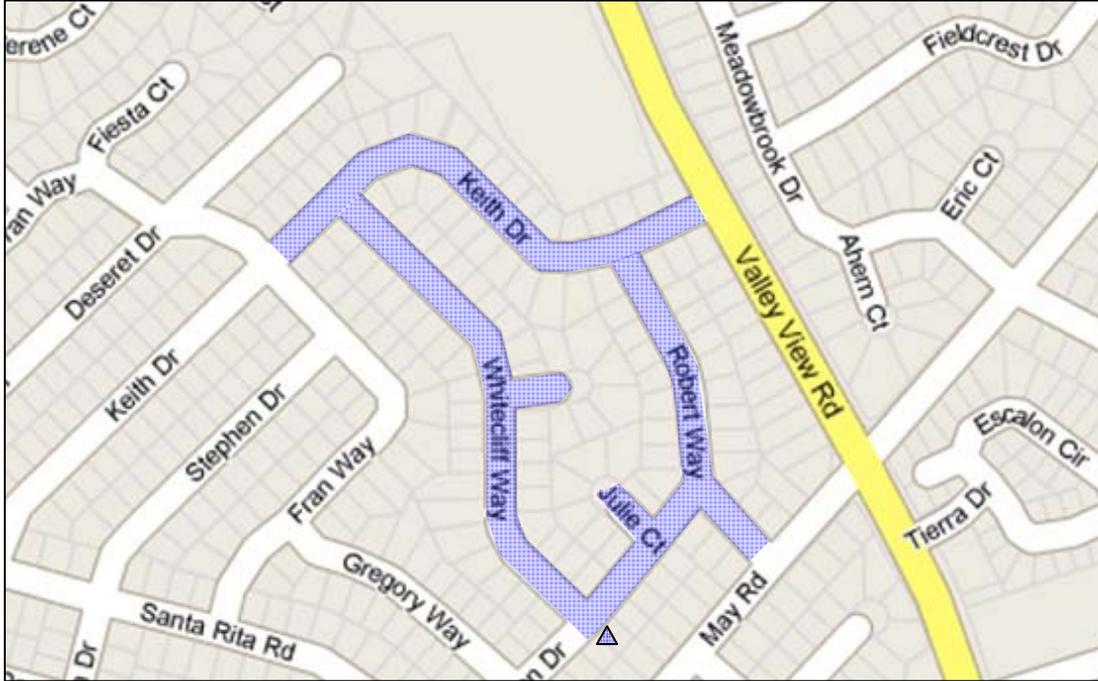
Figure 12 – May Valley Neighborhood Series Circuit

The May Valley neighborhood contains about 28 streetlights and pull boxes and 4,500 feet of conduit. Using the same unit costs as above yields a cost of \$363,000 to upgrade these lights to a state of the art LED lighting system.

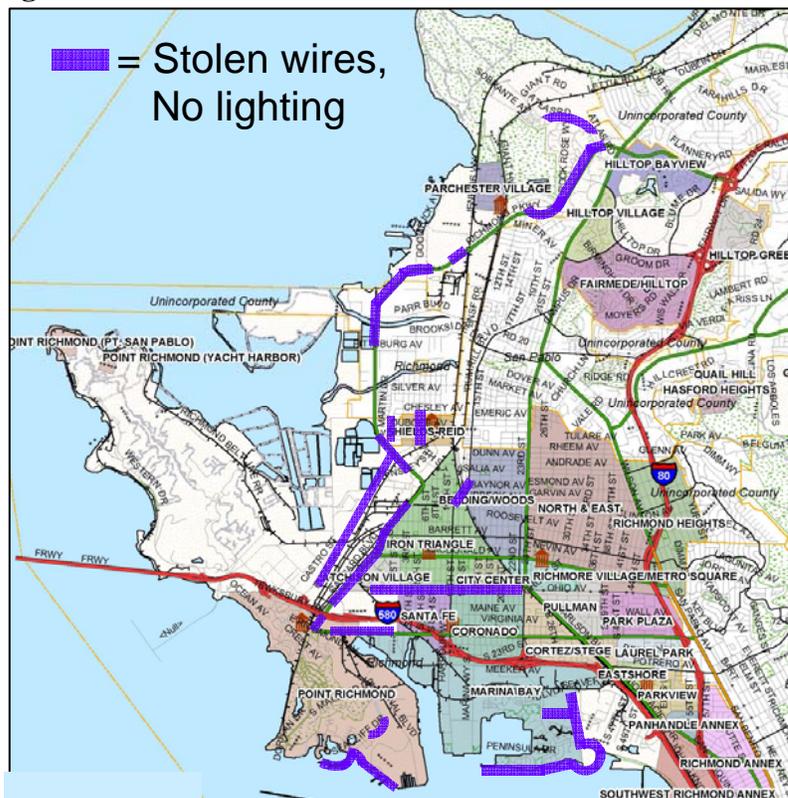
Figure 13 – Wire Theft Locations in Richmond

The primary motivation for wire theft may be the salvage value of copper. As the value of copper increases, wire theft can become more prevalent. Wire theft appears to be a random type of crime: random in the sense that is it not organized, and catching one thief does not necessarily stop the problem. Figure 13 shows the locations within Richmond that have been sites of wire theft over the last year.

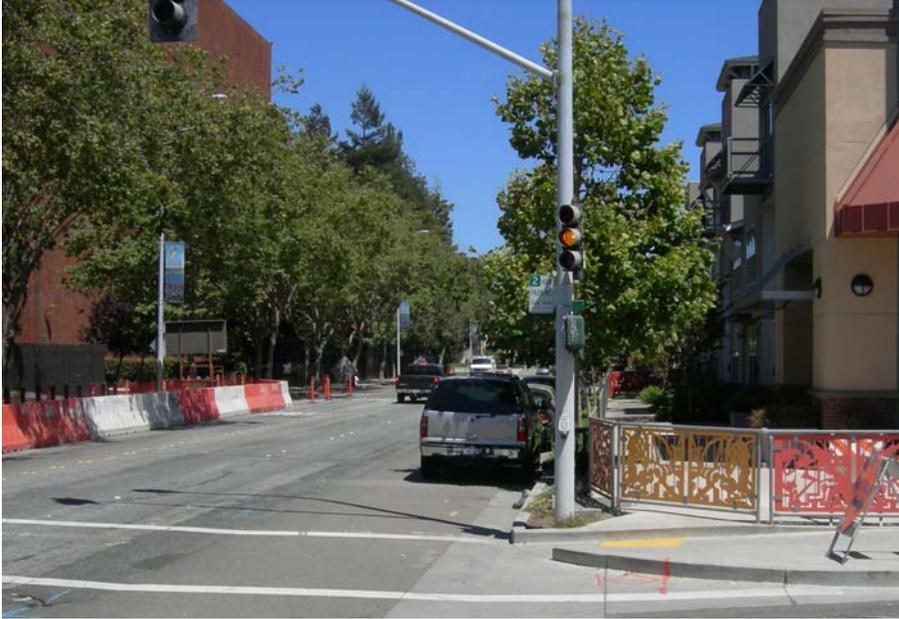
Figure 24 – Marina Way (looking north from Nevin Plaza)

Figure 24 shows Marina Way. In theory, the 400W lighting should be more than adequate. However, the cobra-head lighting (visible on the left side of the photo) is all surrounded by foliage of the large adjacent Sycamore trees. The SLMP recommends installation of pedestrian level lighting on these poles. There are five streetlight poles along the west side of Marina Way. At a cost of about \$3,000 and 50% markup, the total project cost is \$22,500.

enhancements. Instead, we recommend the City contact the homeowners association and defer action to them.

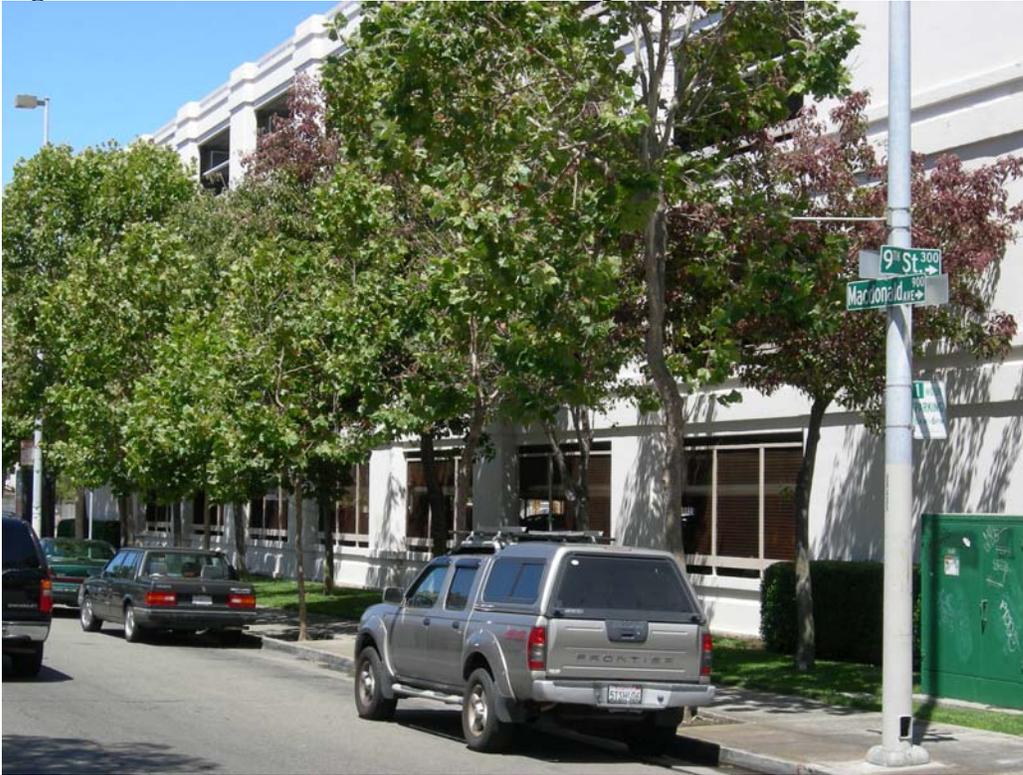
Figure 26 - Macdonald Ave near Kaiser Hospital (looking west)

There is also on-street parking at a few locations nearby, notably along the north side of Macdonald Avenue near 9th Street and on both sides of 9th Street for about half a block on either side of Macdonald Avenue. Figure 26 shows Macdonald Avenue west of 9th Street, which appears to have adequate ‘shoe-box’ lighting, visible on the left edge of the photo. However, the foliage of the street trees is between the streetlight fixture and the sidewalk, meaning the sidewalk is not well illuminated at night. This is an area where pedestrian level lighting is needed to supplement the existing streetlights.

The length of sidewalk involved is about 1,600 feet. With lamps spaced at 60' intervals, this equates to about 24 lights. With a unit price of about \$3,000 and 50% markup, the approximate cost would be \$108,000. The costs of upgrading the shoe-box fixtures is already included in the Iron Triangle Neighborhood discussion.
