**SITE VISIT REPORT  
CONDITION ASSESSMENT OF WHIRLEY CRANE  
AT POINT POTRERO, RICHMOND, CA**

**FOR THE CITY OF RICHMOND  
PRIME CONSULTANT: MOFFATT & NICHOL**

**VISIT DATE: MARCH 27, 2025**

**Prepared by Liftech Consultants Inc.  
June 26, 2025**

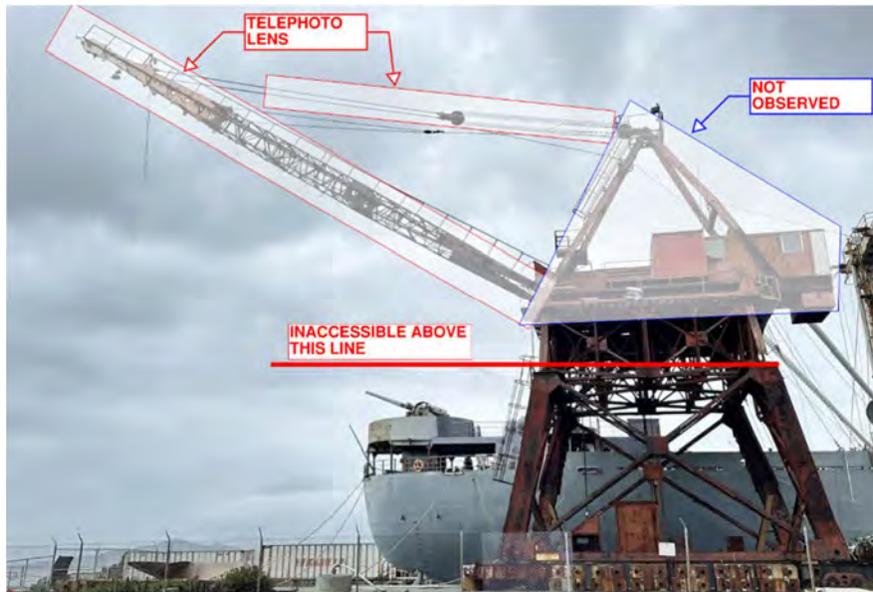
Photograph 1: Crane accessibility overview

Access was limited due to ladder damage. The second ladder to the machinery level was hazardous due to degraded and missing attachment welds. See Photograph 1. Inaccessible areas were photographed using a telephoto lens from different vantages, including the adjacent *Red Oak Victory* ship. No internal areas were observed, e.g., the machinery house.

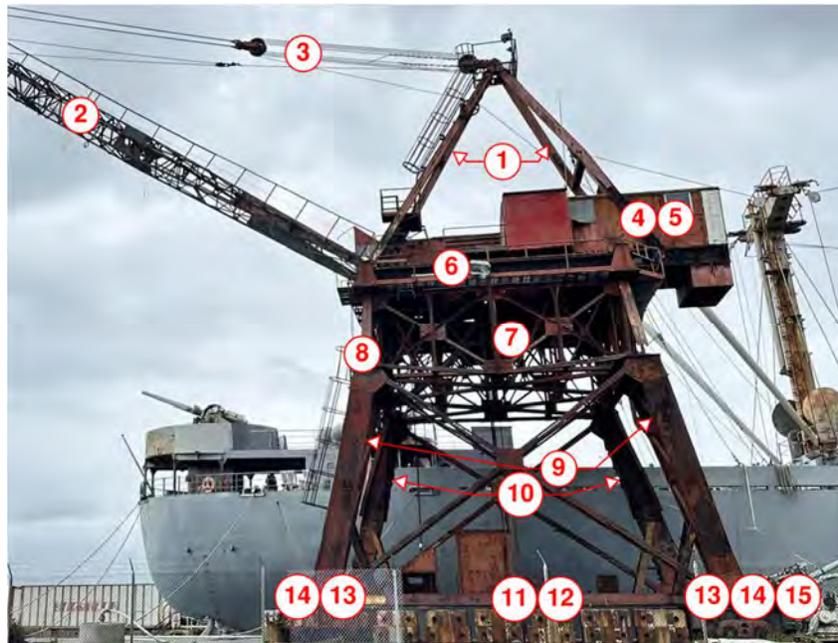
Photograph 2: Indexing of observed areas

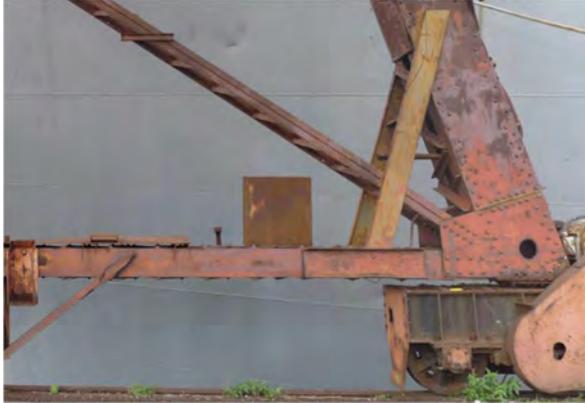
Photograph 3: Leg 4 – typical leg and sill beam.

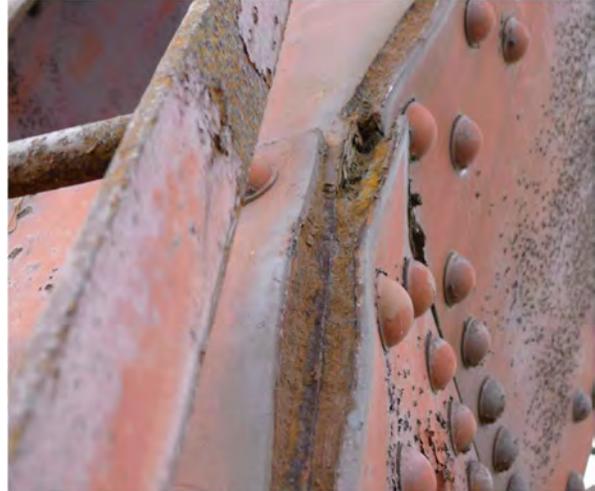
Photograph 4: Corrosion jacking; rivets appear unbroken.

There is significant corrosion jacking at most riveted connection plates. Corrosion jacking is caused by the expansion of rust between plates, resulting in local plastic deformation of the connection plates. No broken rivets were observed. We could not observe the inner surfaces of rivets between the connection plates and members.

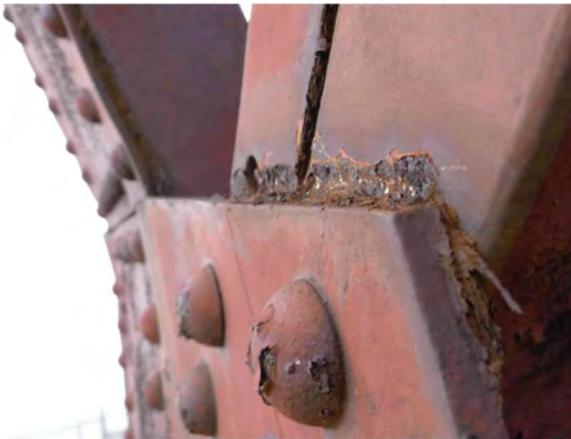
Photograph 5: Example of section loss near connection plate joints.

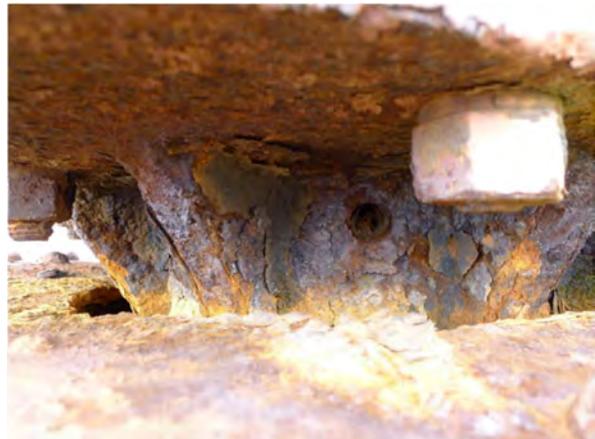
Photograph 6: Kingpin to gantry equalizers; corrosion and section loss.

The kingpin joints of the equalizer assemblies have major corrosion damage and have lost significant material and strength.

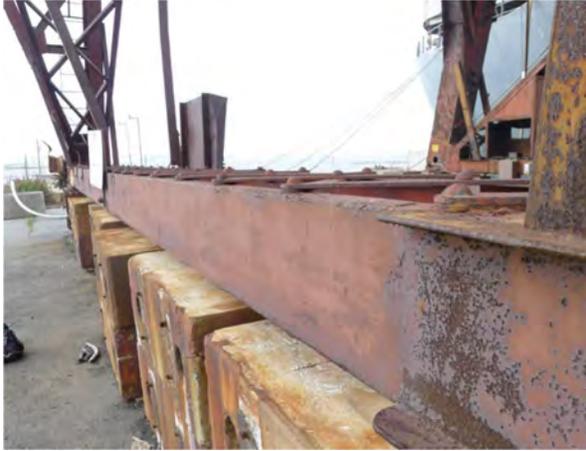
Photograph 7: Longitudinal sill beams with minor corrosion damage.

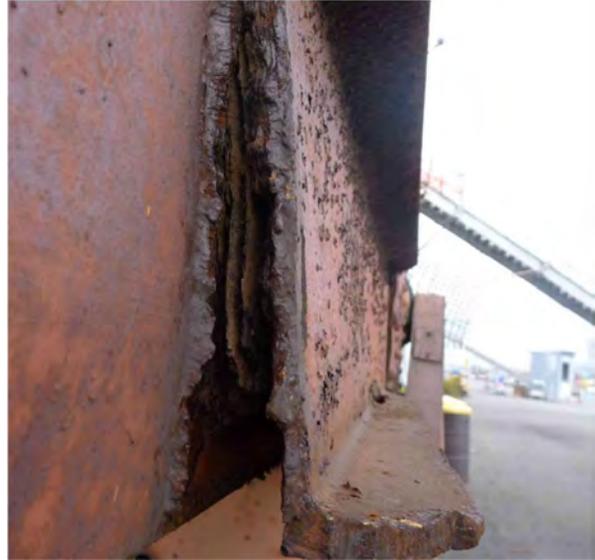
Photograph 8: Sill beam structural reinforcing is detached.

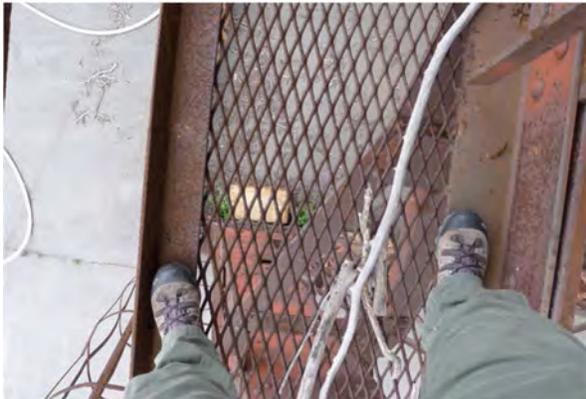
Photograph 9: Walkway grating has significant corrosion and is unreliable.

Many of the thinner secondary structural components, including handrails, walkways, and ladder systems, have major and severe corrosion damage and are not suitable for safe access. Many expanded metal walkways appear unsuitable for supporting people. Several handrails are detached and several failed ladder welds were observed.

1. Access:
  - a. **Do not allow people access on or under any part the crane.**
  - b. Before ladders and walkways are used, repair or replace areas with major corrosion. Some engineering input will be required during the design, and to review the completed repairs.
2. Falling objects: Related to item 1a above, confirm that areas below secondary components with major corrosion damage are blocked off. Repair, or if not needed, remove compromised components with significant corrosion damage that may fall, e.g., compromised ladders, railings, and gratings. Have an engineer design and review completed repairs, determine what to remove, or both.

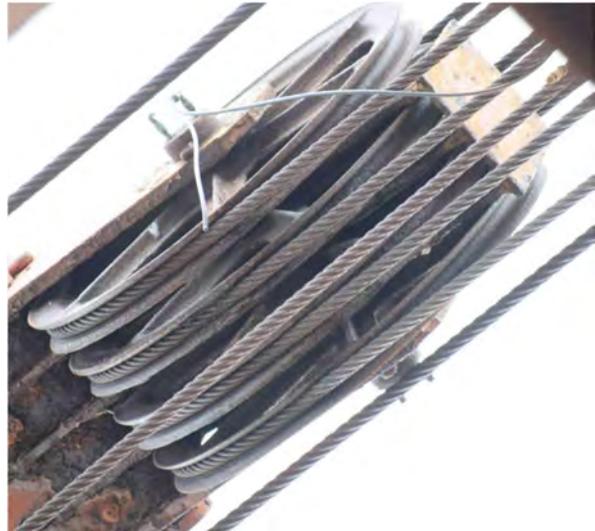
Photograph 10: Wire rope, no signs of broken wires or significant corrosion; condition of core (internal) unknown.

The wire ropes supporting the boom appear to have only minor corrosion with no signs of external wire breaks. Since the boom is at a stowage position with no live load, the rope load is small compared to its design operating load. However, it cannot be assumed the rope is uncompromised. Given the exposure of the ropes to weather and the potential for internal water entrapment, there is a risk of hidden corrosion that cannot be assessed visually. An internally compromised rope can have a significant reduction in strength. In addition, the boom reeving is not redundant, meaning that the boom is supported by only one rope. Any failure along its entire length would release the boom.

1. Boom rope inspection and secondary support: Have a qualified rope inspector inspect the rope, e.g., for internal corrosion, broken wires, and loss of cross-sectional area, and advise if replacement is necessary and feasible. If the ropes are found to be significantly compromised, install a new rope, or install a redundant support in addition to the existing to provide redundant support. Replacing the existing rope may not be feasible if the reeving system is compromised, e.g., seized bearings or excessive corrosion.
2. Crane restraints: Install engineered restraints to prevent movement of the crane and slewing of its upper works. Options may include pinning or welding the wheels to the rails, installing structural stops or brackets, or fabricating custom cradles to secure the crane in place.

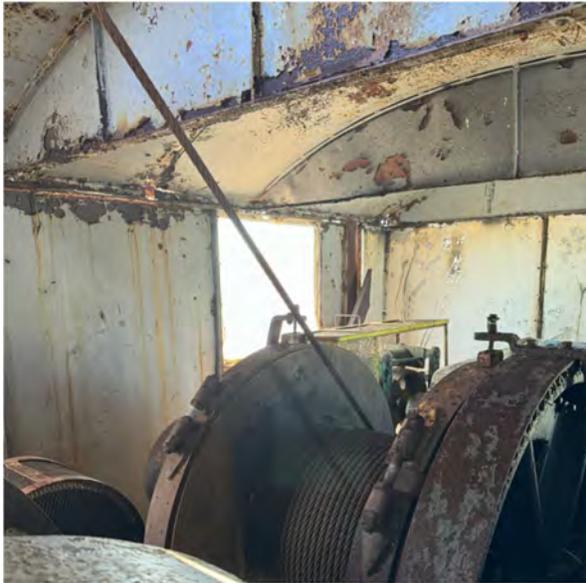
Photograph 11: Boom reeving is not redundant; it is supported by one rope (photograph courtesy of the City's 2024 walkthrough).

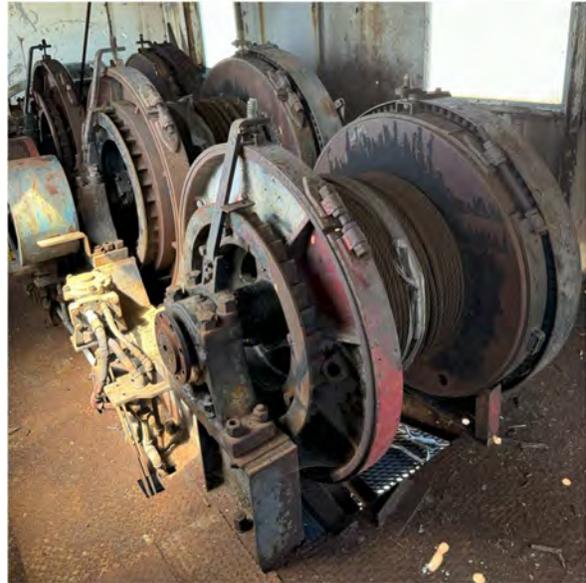
Photograph 12: Hoist and boom machinery in the machinery house (photograph courtesy of City's 2024 walkthrough).

The hoist machinery is unloaded, with ropes spooled onto the drums. Motors are absent; only the drums remain. The design is outdated and lacks functional utility.

As noted in the Boom and Reeving section, the boom drum is currently supporting the boom load. A pawl and band brake system provides redundancy for load holding; however, given the system's age, it should not be considered reliable for long-term load support.

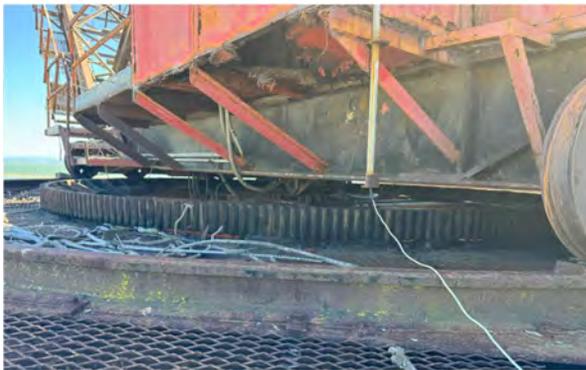
Photograph 13: Slewing arrangement (photograph courtesy of City's 2024 walkthrough).

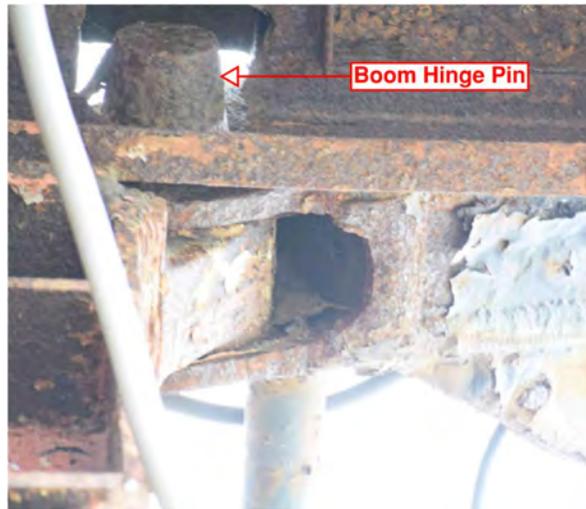
Photograph 14: Boom hinge pin with significant corrosion, but with significant thickness remaining.

The boom structure has minor corrosion damage. The boom hinge has major to severe corrosion but still has substantial diameter remaining.

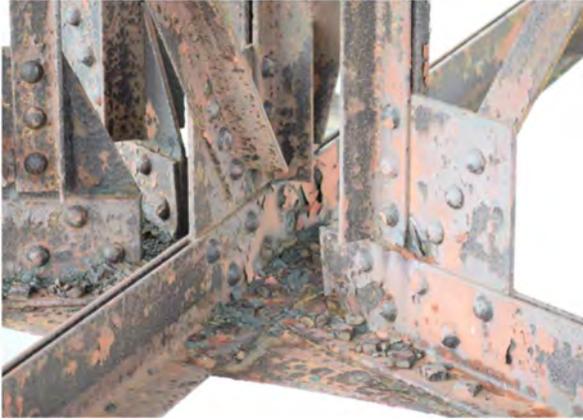
Photograph 15: Typical truss structural joint with limited corrosion damage to members. Rivets appear unbroken.

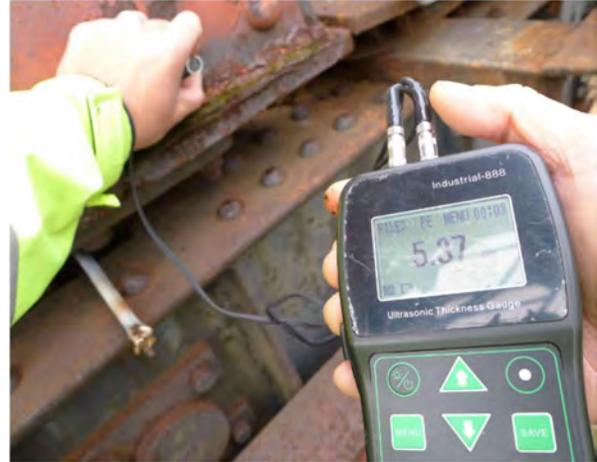
Photograph 16: Thickness measurement of structural lap plate. Fifty percent thickness loss measured near the corroded drain hole.

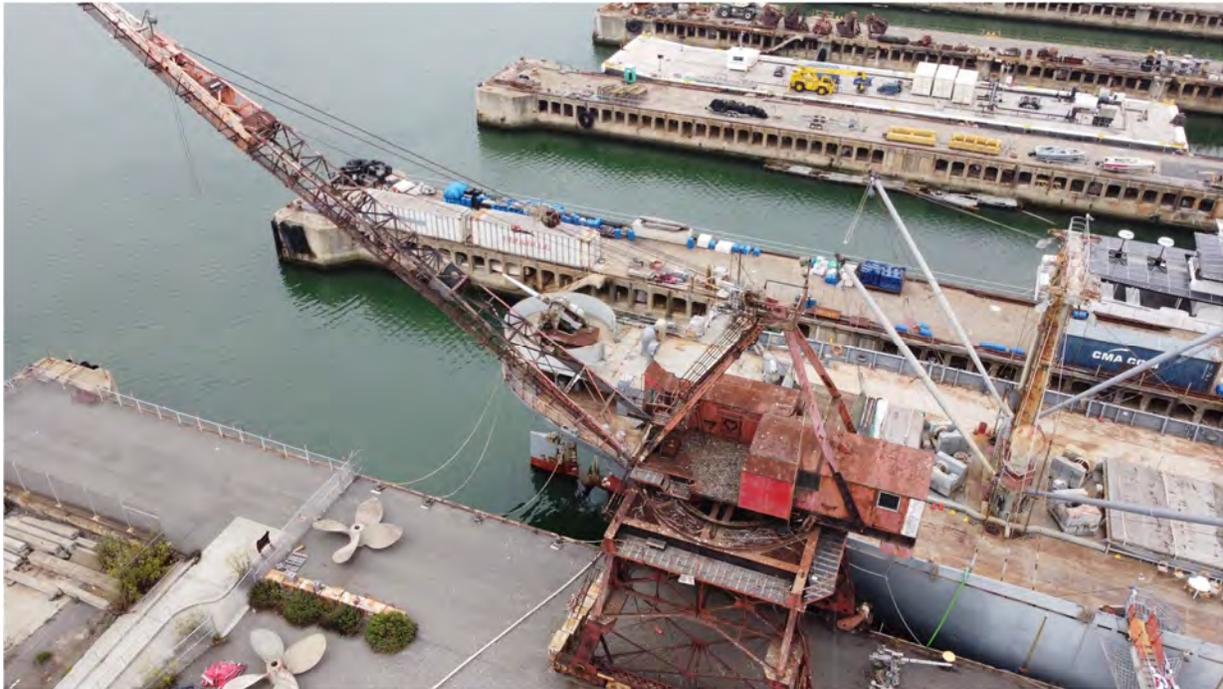
Photograph 17: Whirley crane position near the edge of the wharf.

Demolition will require significantly less cost than preservation. Similar to preservation, demolition will probably require lead paint abatement. To limit costs, it may be favorable to dismantle the crane into large sections and truck them to a recycler, such as SIMS or Snitzer Steel, who can handle most of the paint abatement at their facility. Although less probable, if the crane can be moved close to the south edge of the wharf, it may be practical for a marine contractor, such as Manson Construction Company or Power Engineering Construction Company, to lift the entire crane with one of their floating cranes, set it on their barge deck, and then offload the entire crane at a local metal recycler such as SIMS or Schnitzer. See photograph 17.
