8.3 Graving Basin and Finger Piers Inspection Report

Point Potrero Marine Terminal Inspection Report

Produced for the Port of Richmond
August 19, 2025

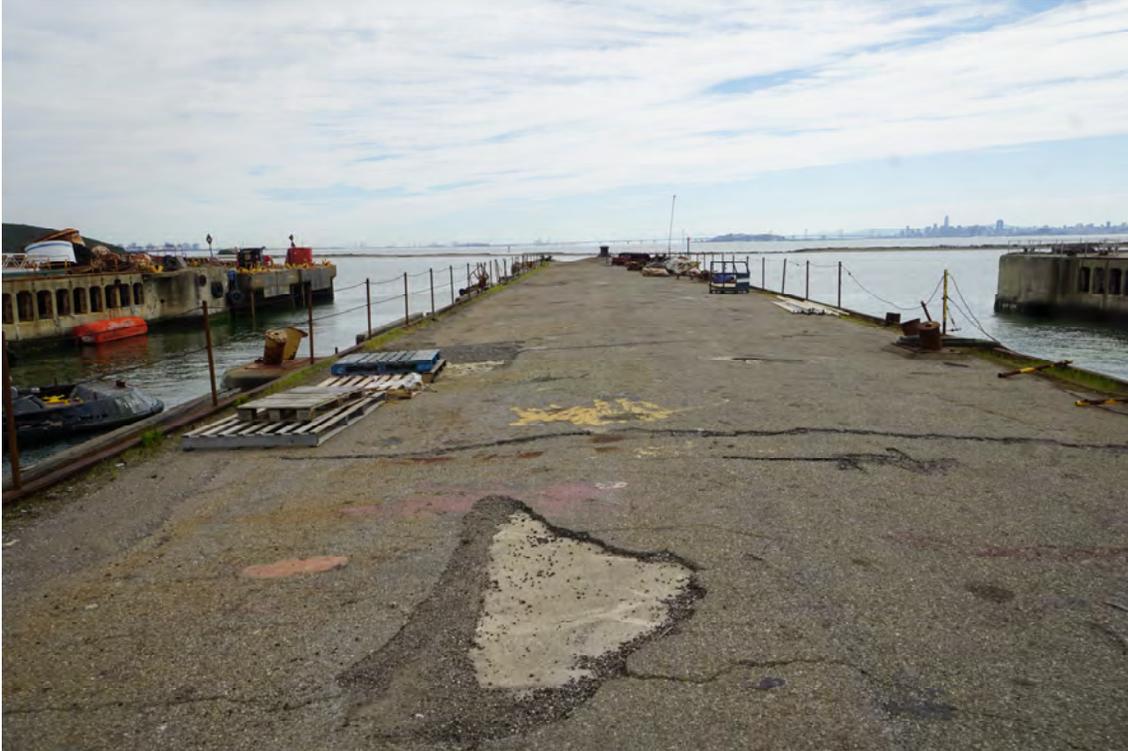
The gallery roof deck of the graving basin fingers has asphalt overlay measured at ±2 inches atop of a concrete deck surface. Mild to moderate damage was observed on the topside of the deck of the graving basin fingers. There were areas of localized depressions in the asphalt surface, delaminations, cracks, and exposed reinforcing. At several locations, installations made after initial construction, such as bollards, have led to underside deck damage, as depicted in Photo 6 and Photo 7.

Photo 3 Typical Gallery Roof Deck Damage to Deck Asphalt at Graving Basin Fingers

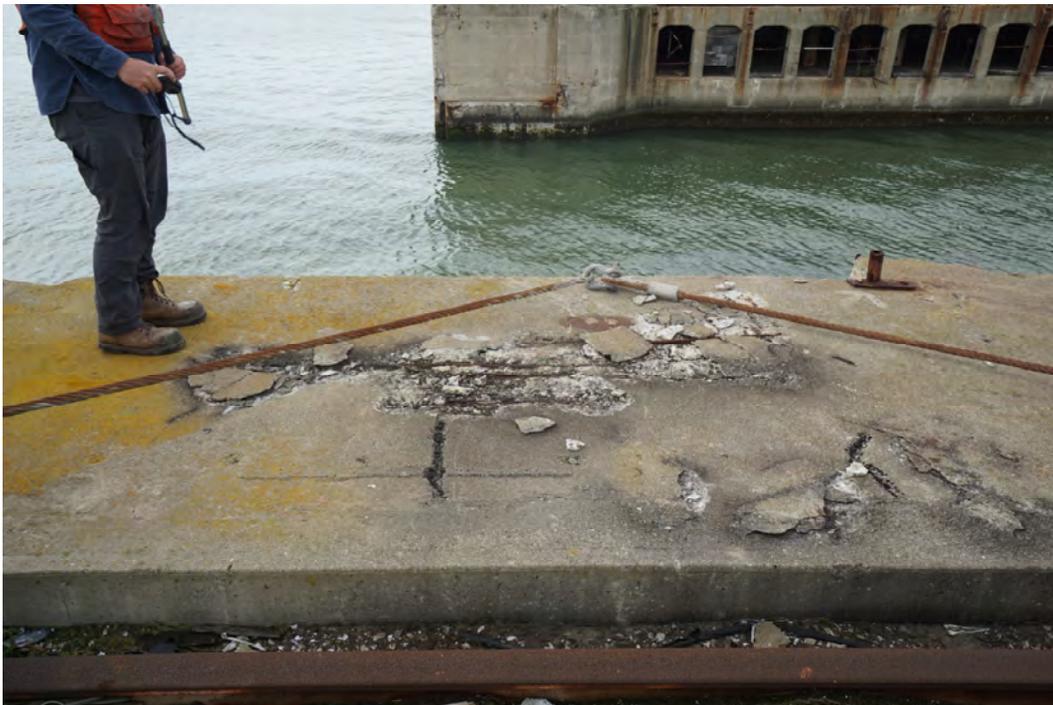
Photo 4 Deck Damage with Exposed Reinforcing

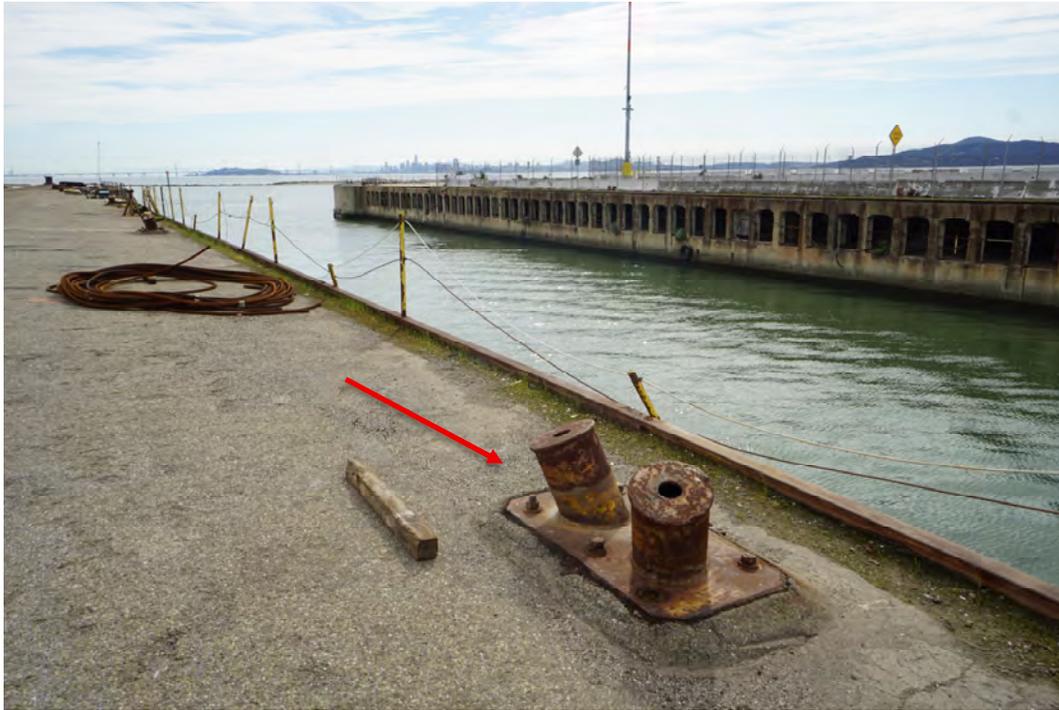
Photo 5 Typical Post Construction installed Bollard

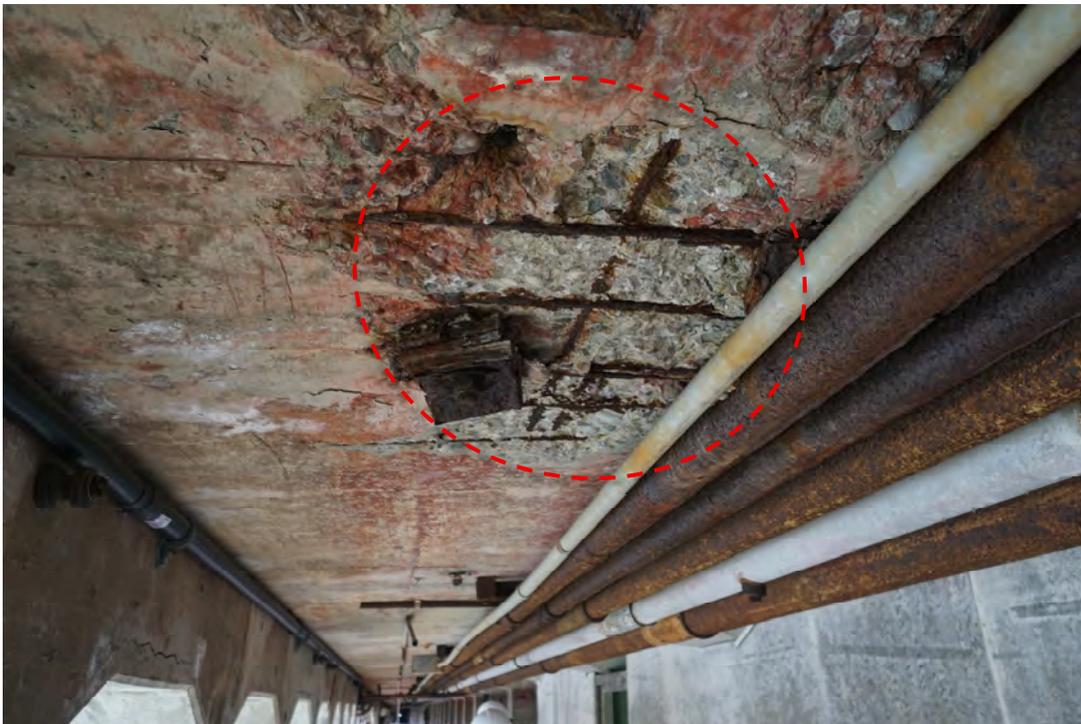
Photo 6 Underside of Gallery Roof Deck at Post Construction Bollard Location

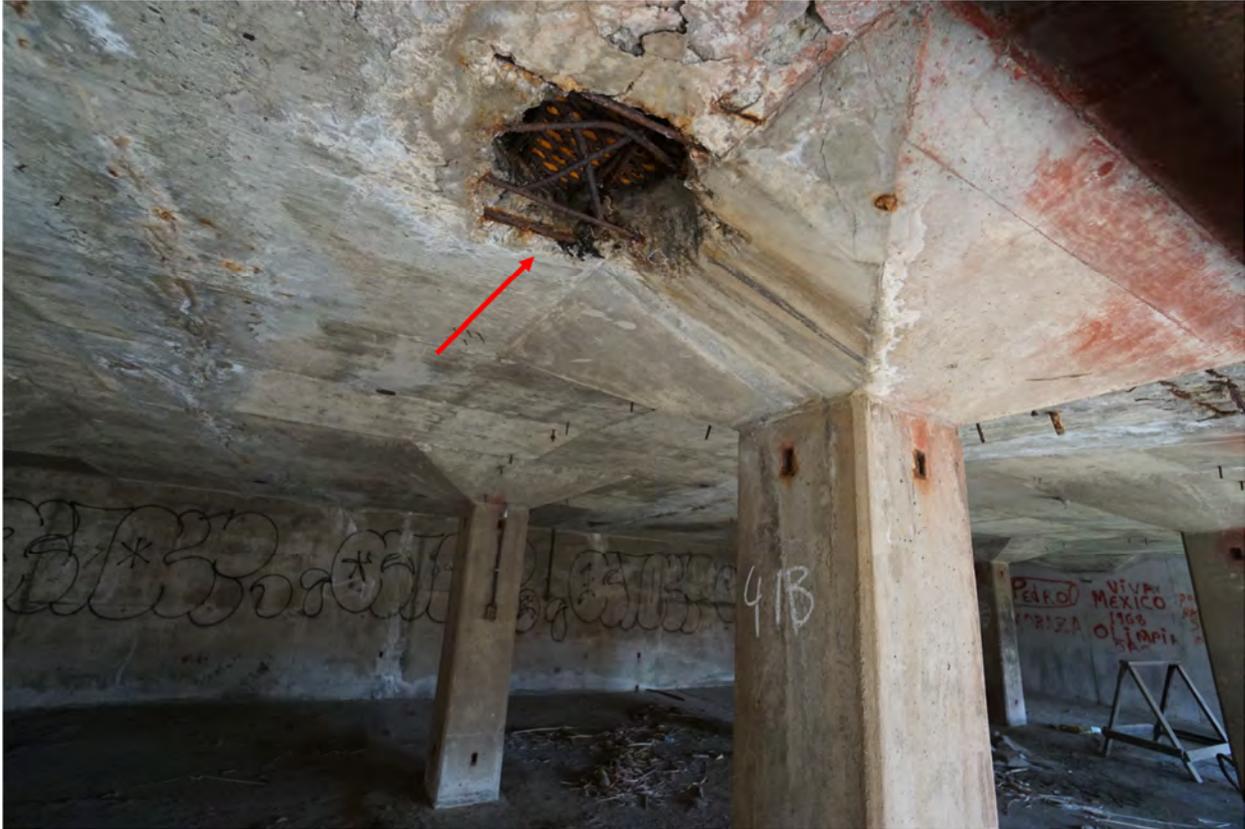
Photo 7 Gallery Roof Deck Damage due to Installation Post-Construction

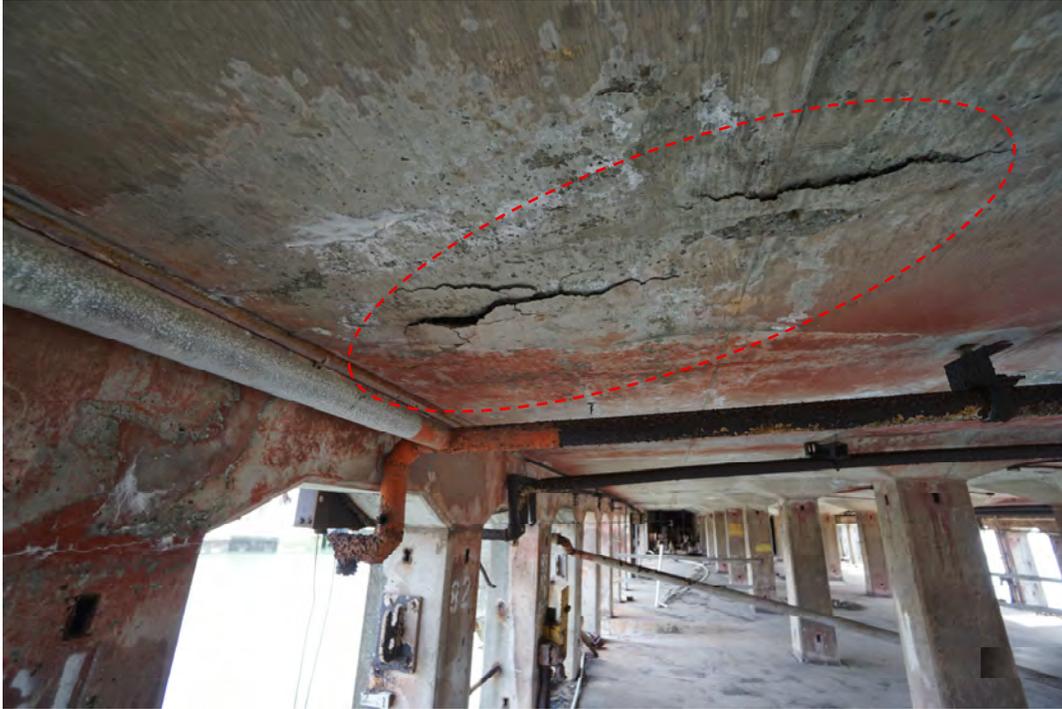
There were delaminations and spalling observed at various locations throughout the soffit and slab. Delamination occurs when the outer layer of a concrete slab separates from the rest of the slab body, most commonly caused by expansive corrosion of reinforcing steel that exerts pressure on concrete, causing it to crack and flake off. Delamination is indicated when tapping the concrete surface produces a dull or hollow sound. For slabs on grade at the gallery deck level, delaminations pose a safety risk in some areas, as they can potentially cause slips, trips, and/or falls, they likely will not significantly alter the strength of the structure. This is because the concrete slab rests directly on the rock layer below; as a result, the capacity of the structure is dependent on the bearing capacity of the rock beneath the graving basins. Additionally, the exposed reinforcing at areas on the soffit were likely caused by lack of adequate concrete cover.

Photo 8 Typical Soffit Delamination

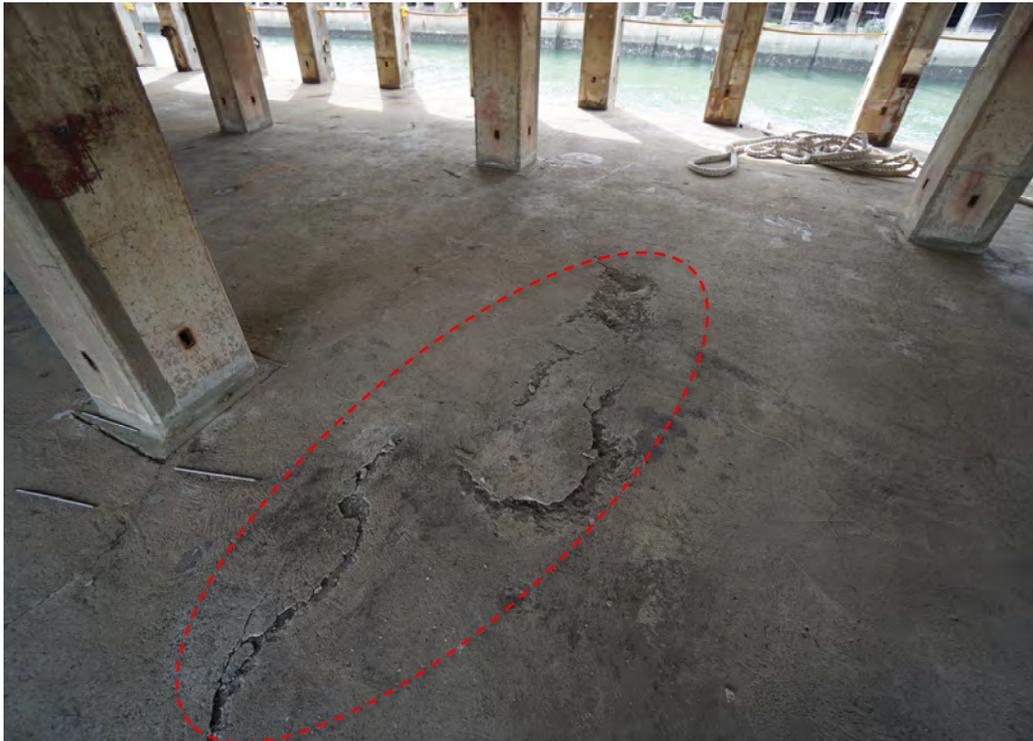
Photo 9 Gallery Slab Delamination

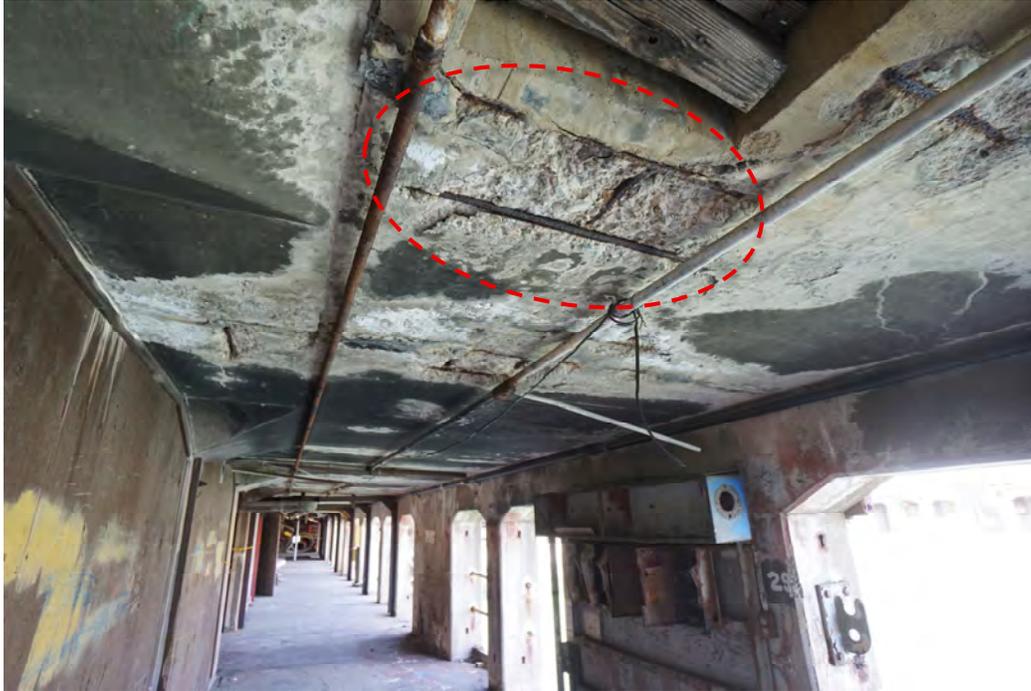
Photo 10 Spalled Soffit with Exposed Reinforcing

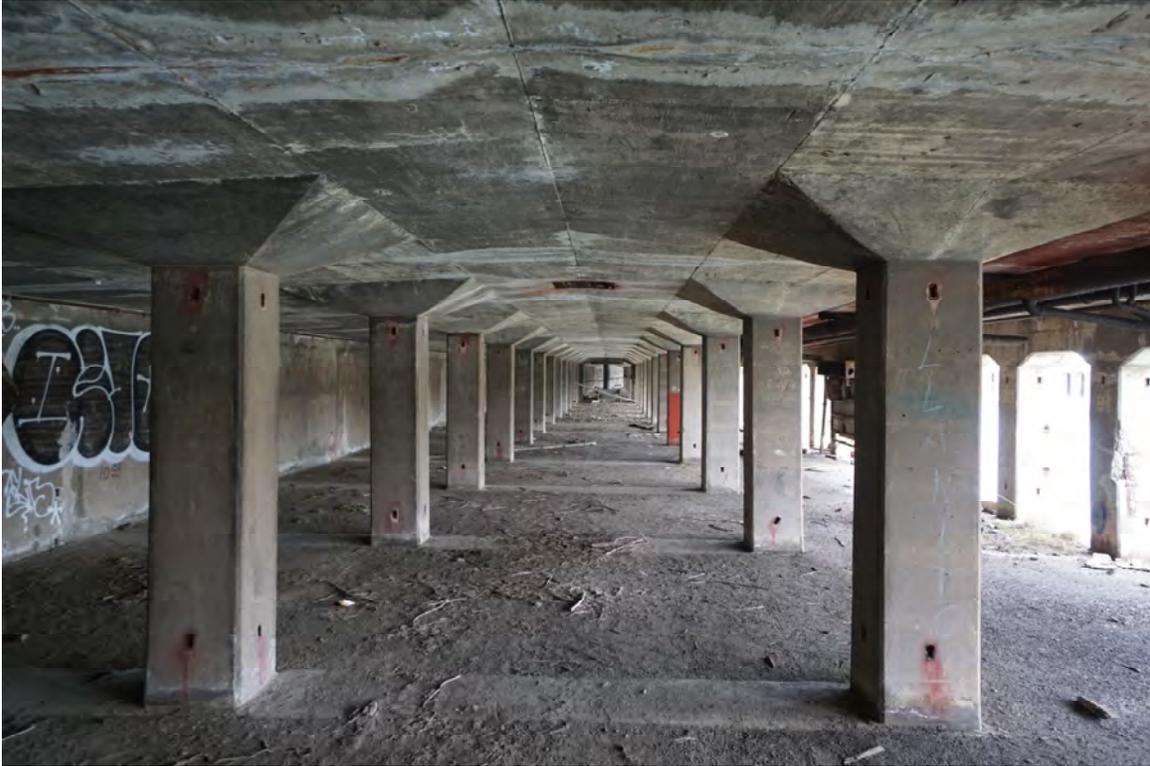
*Photo 11 Interior Columns at Finger 1, Typically No Damage Noted.
Note, dirt floor between grade beams at Finger 1 only.*

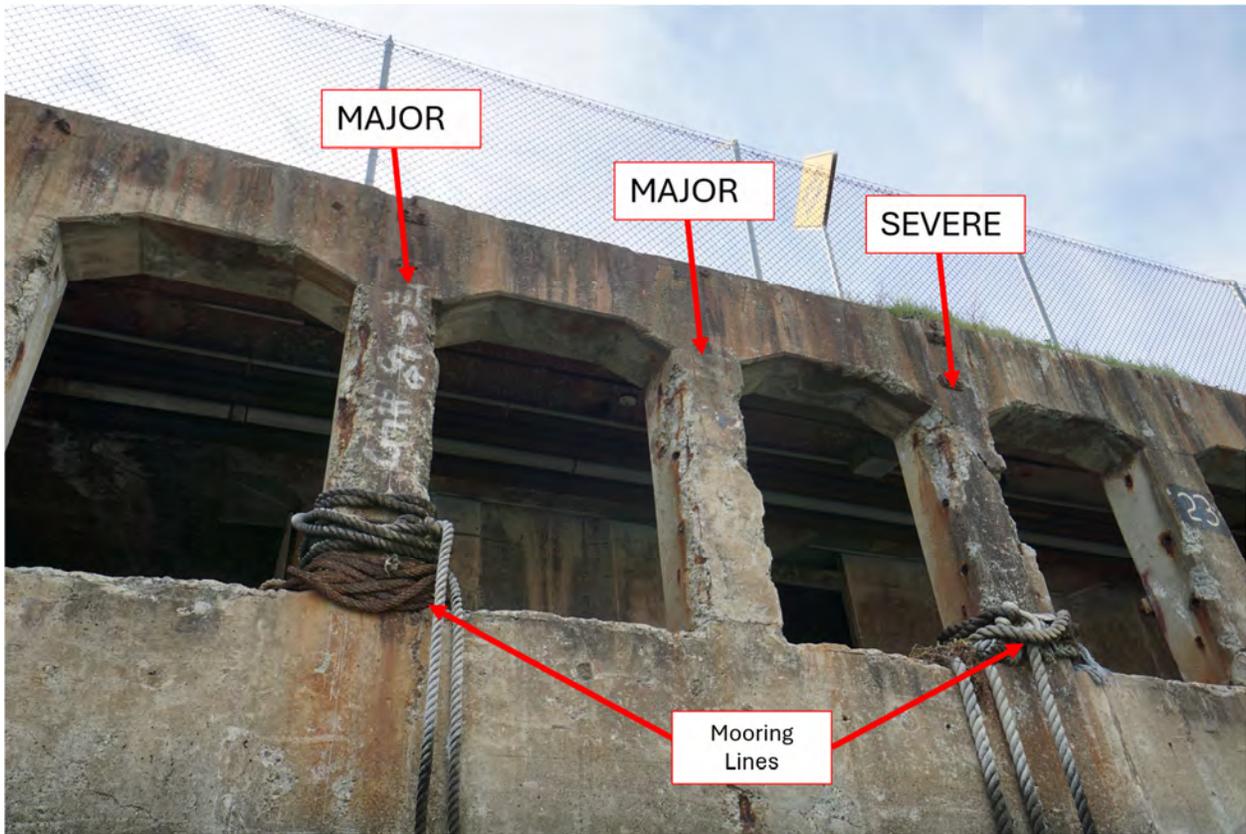
*Photo 12 Exterior Columns Used for Mooring, Major to Severe Damage
Location: Graving Basin Finger 1, Columns 33A-35A*

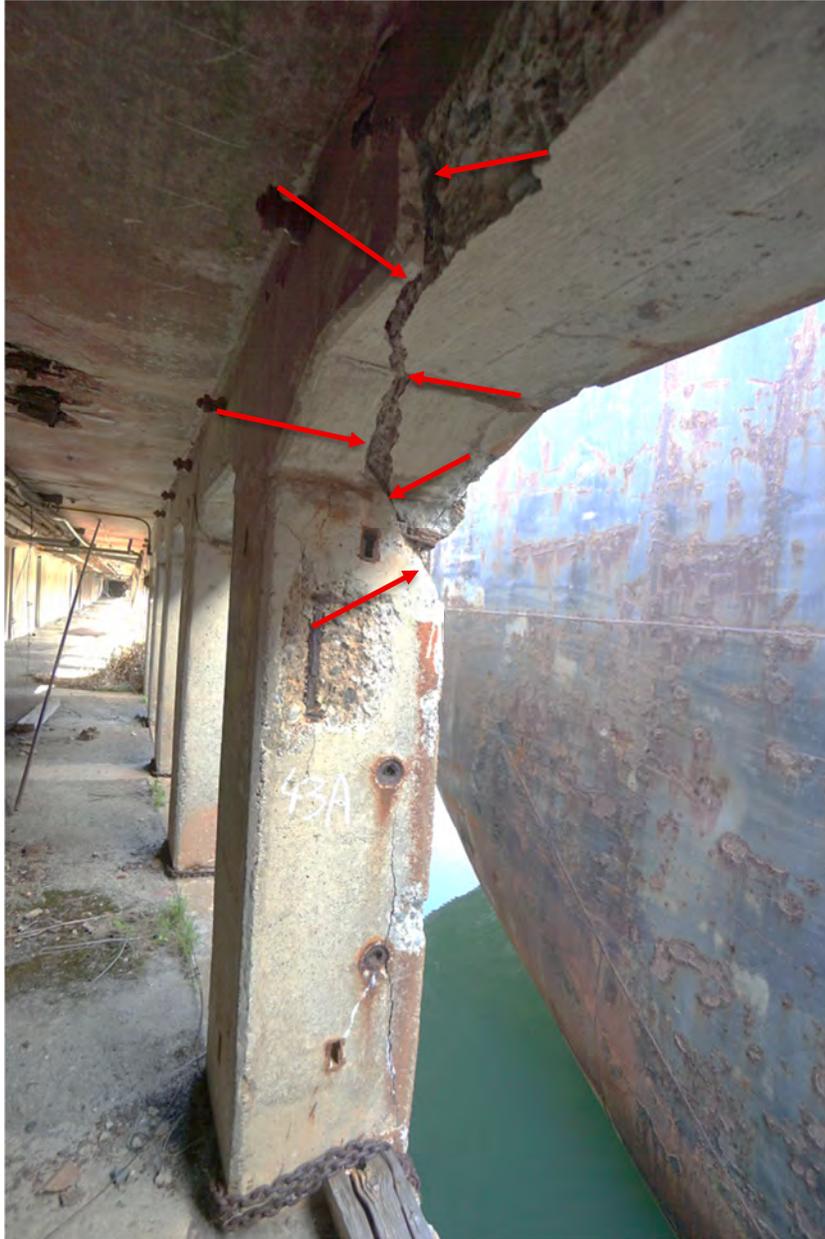
The columns were rated from minor to severe based on damage as described in ASCE MOP 130, shown in Figure 3. The interior columns are in good condition, as they generally exhibit no to minor damage. The exterior columns generally exhibited more moderate damage with some showing major damage, likely due to their exposure, usage for mooring and fendering systems, and inadequate cover. Some columns observed displayed severe damage, likely due to impact loads from vessels. Examples of columns rated as severely damaged are depicted in Photo 13 and Photo 14.

*Photo 13 Exterior Column with Severe Damage
Location: Graving Basin Finger 1, Column 43A*

The inspection figures summarizing the damage observed for each graving basin finger is shown in Appendix B. The inspection figures depict the column damage observed and hatching where significant soffit damage was observed. Interior columns are not rated as they generally showed primarily minor damage. A summary of the exterior column damage for each graving basin finger is in Table 3. As depicted, the majority of the damage observed to the exterior columns is minor or moderate. Where there are severely damaged columns, Moffatt & Nichol recommends posting loads restrictions to the supported areas.

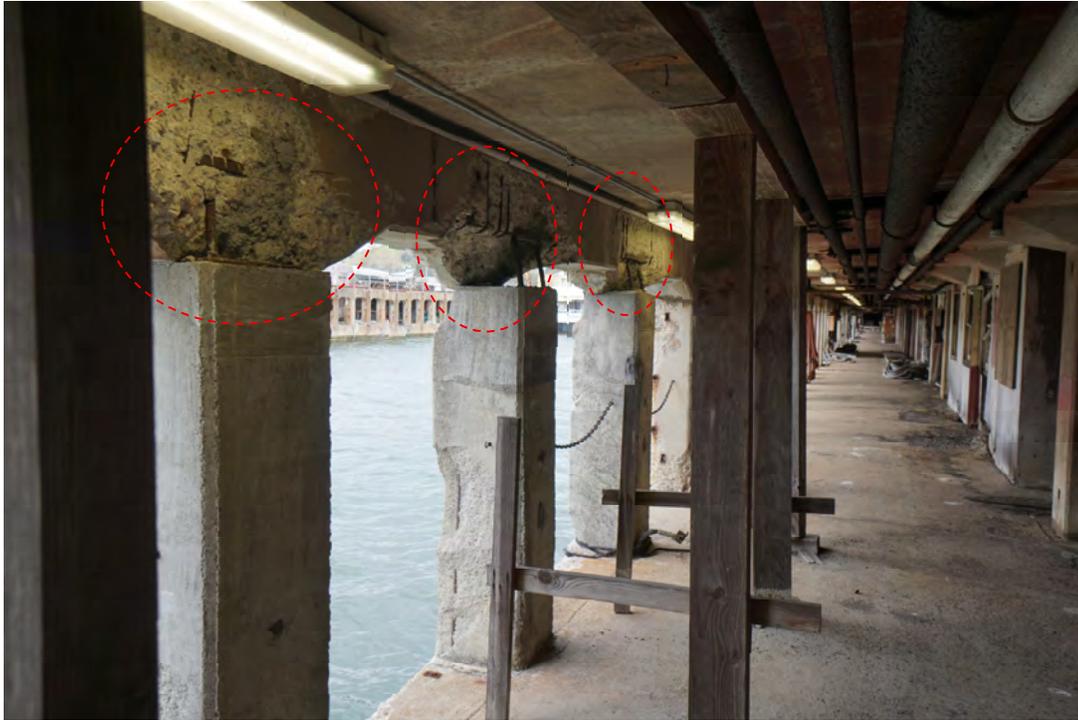
*Photo 14 Exterior Columns with Severe Damage
Note: Temporary Timber Supports
Location: Graving Basin Finger 5, Columns 68D-70D*

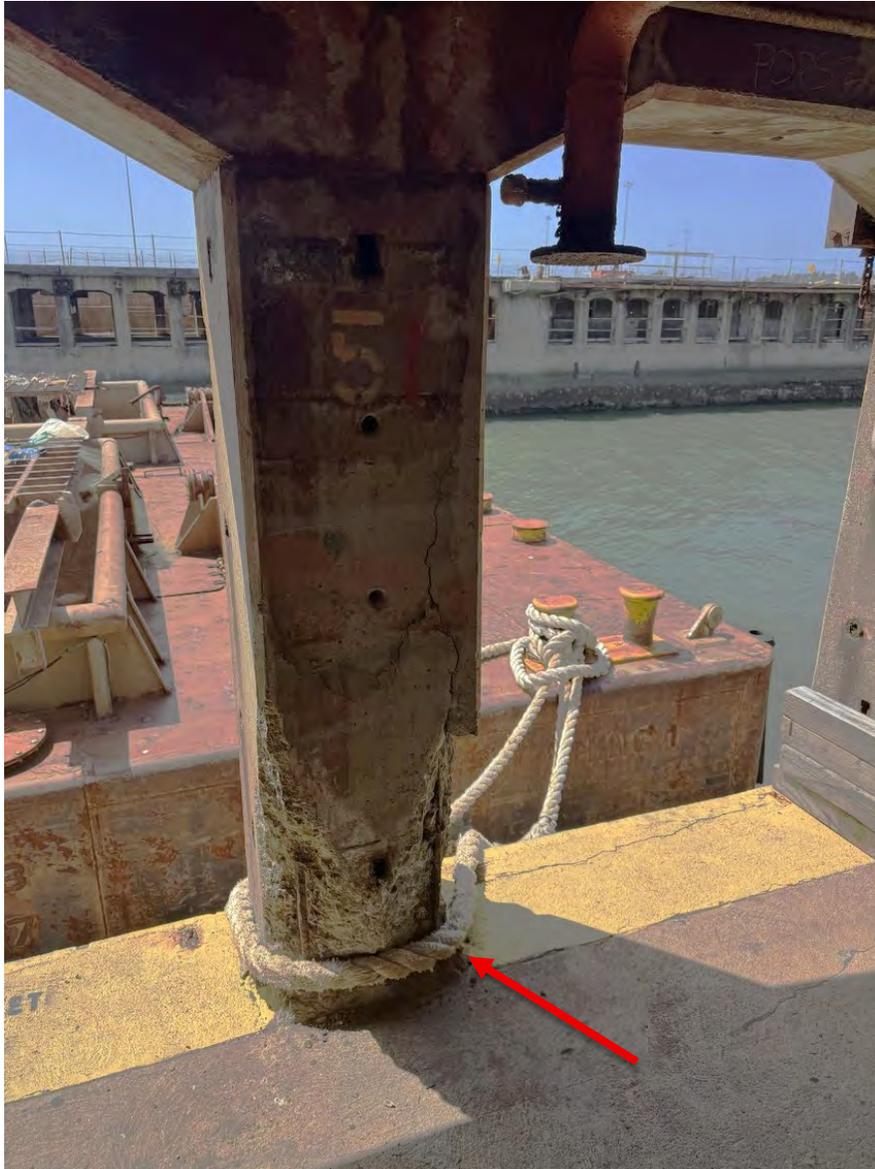
*Photo 15 Typical Exterior Column with Major Damage Caused by Mooring Lines
Location: Graving Basin Finger 3, Column 51D*

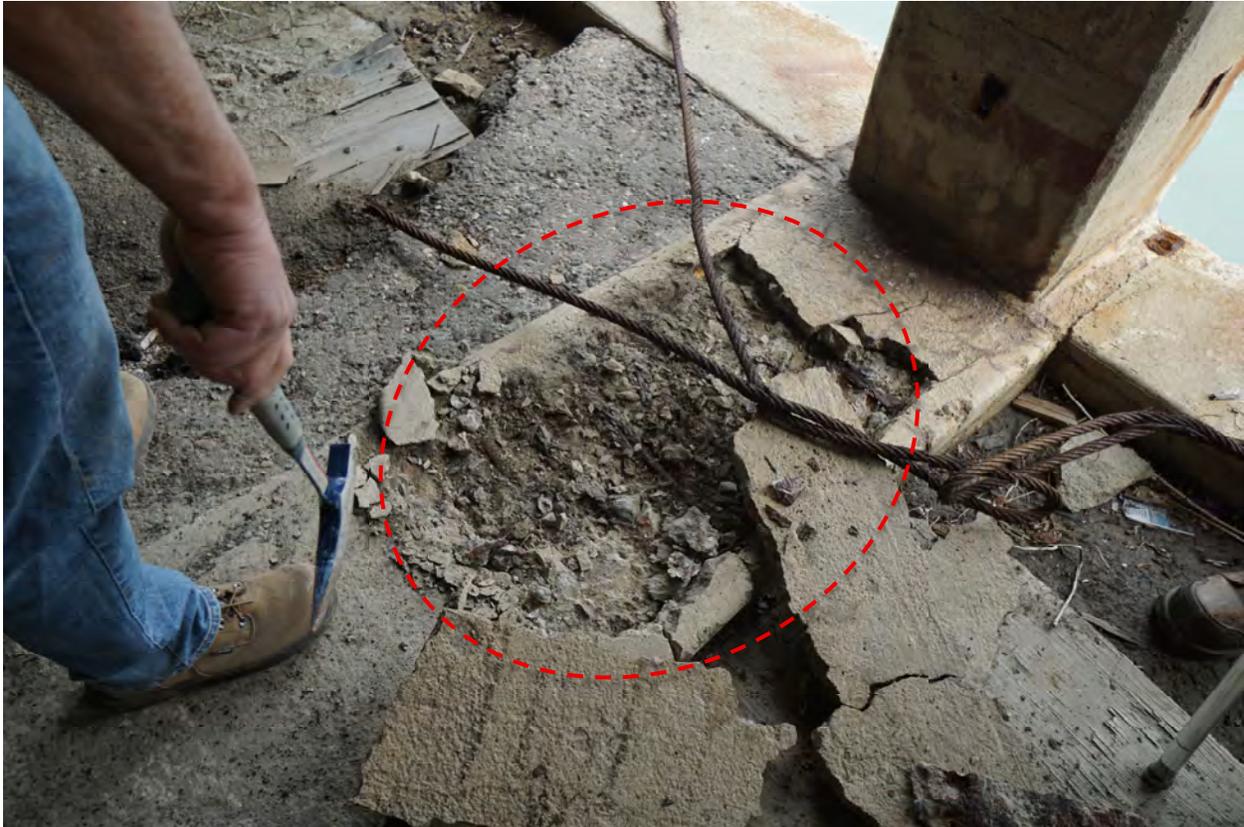
Photo 16 Damaged Grade Beam with Exposed Reinforcing

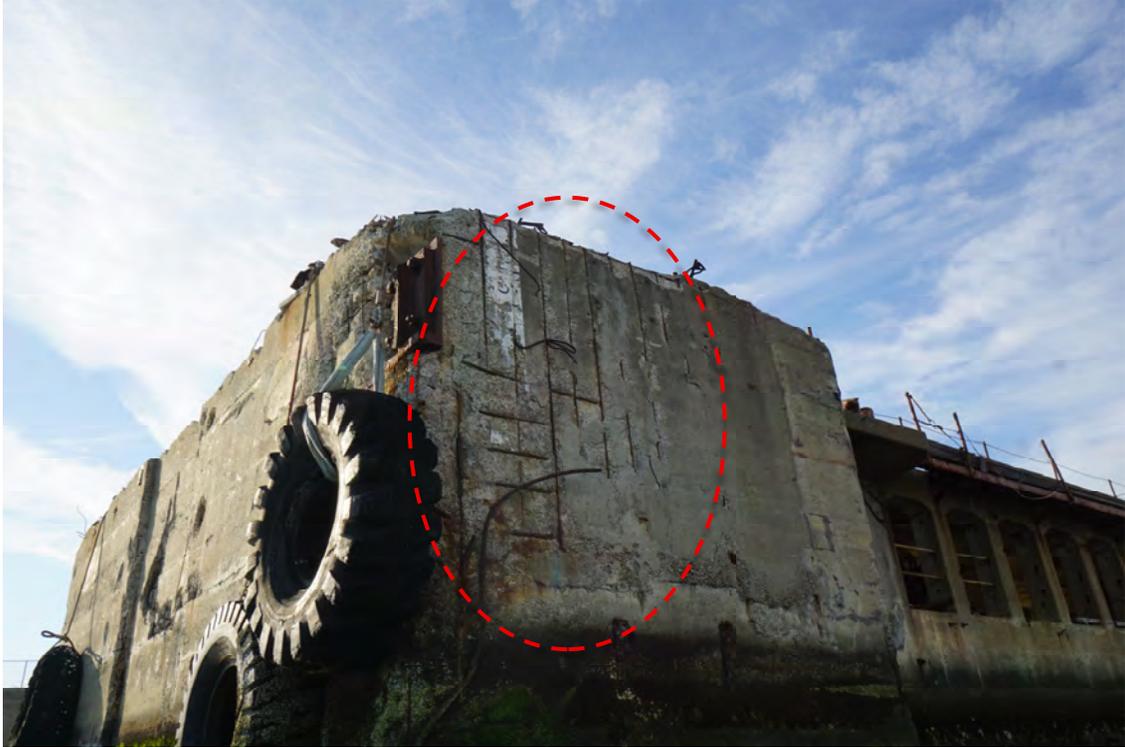
Typical damage observed to the graving basin walls included cracks, exposed reinforcing steel, and delaminations, shown in Photo 17 and Photo 18. This damage was likely caused by exposure to salt water, lack of adequate cover, and vessel impacts, but does not significantly reduce the capacity of the structure.

Photo 17 Exposed Reinforcing on Outside of Graving Basin

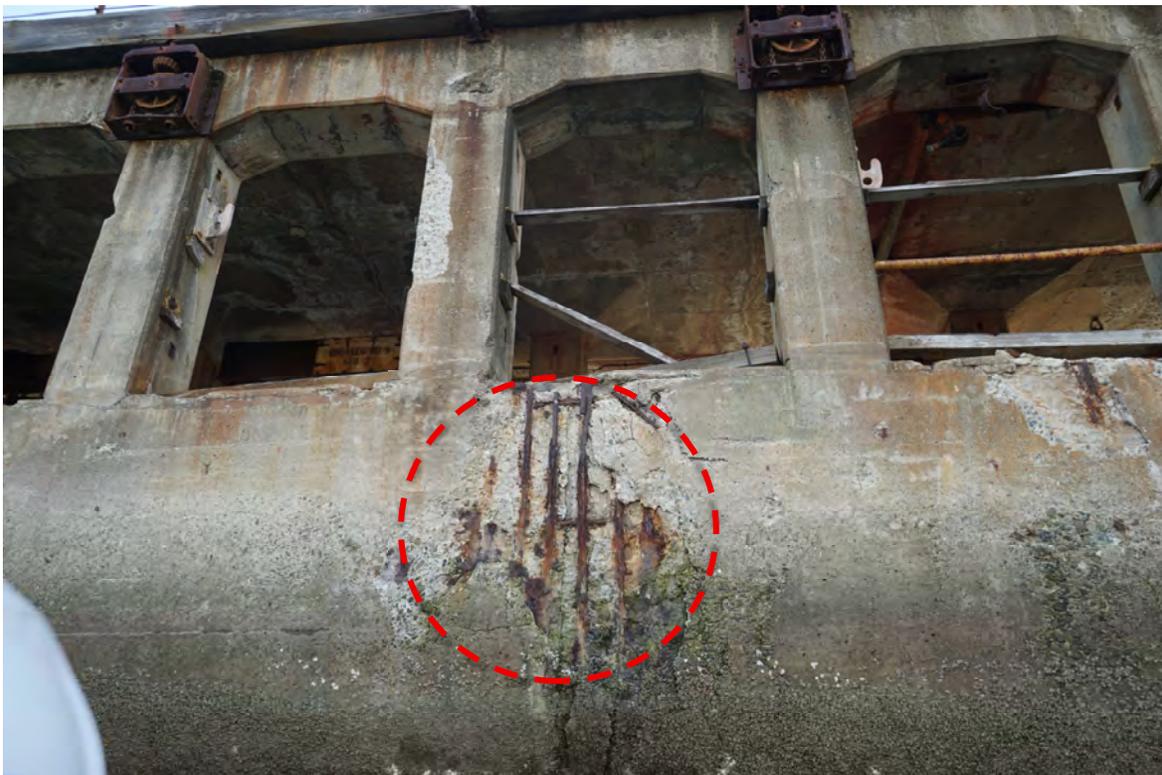
Photo 18 Exposed Reinforcing on Outside of Graving Basin

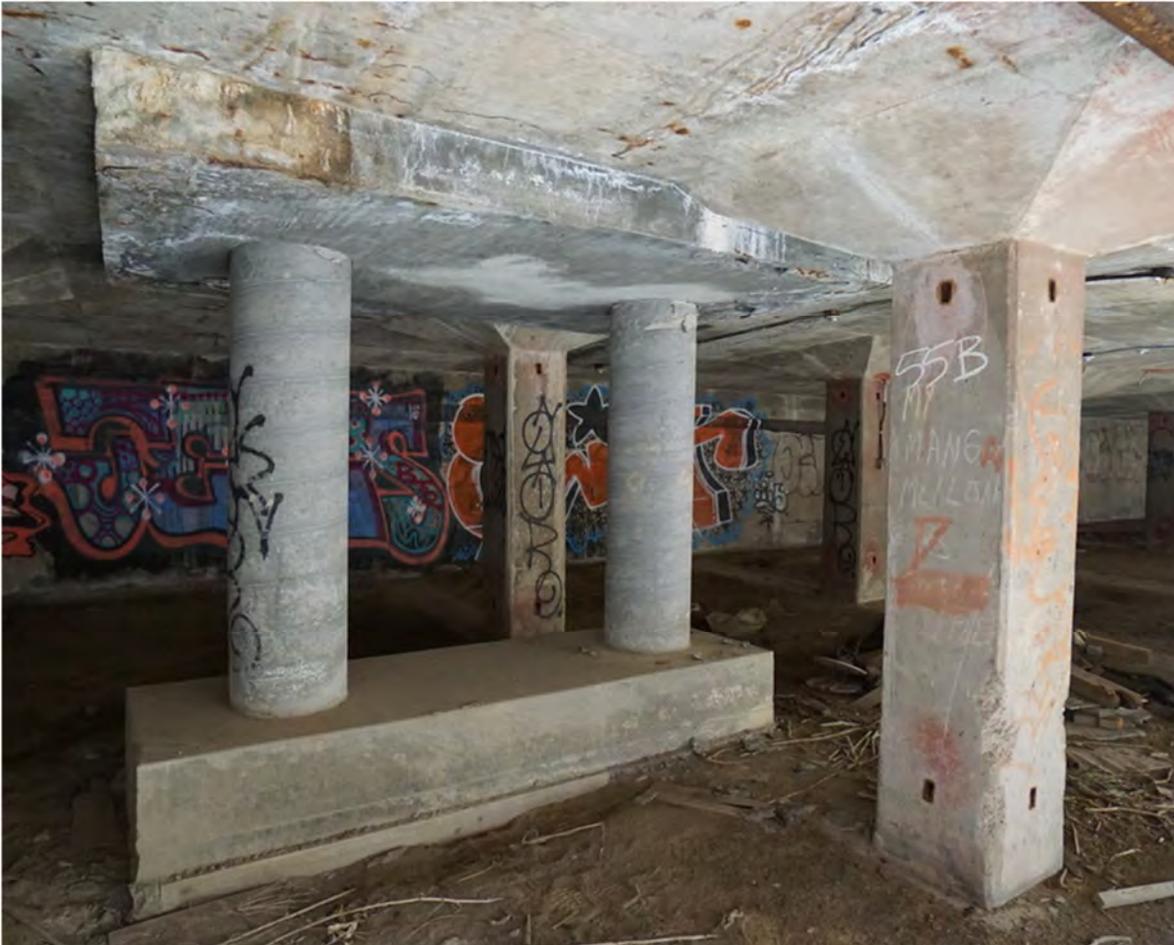
In Graving Finger 1, there are round columns added between Rows 55 and 57, likely for additional support. The columns were measured at ± 16 inches, and the foundation was measured at ± 114 inches by ± 36 inches. It should be noted that a portion of the publicly accessible Canal Blvd is supported by the Finger 1 (as shown in Figure 4) and is therefore subject to unrestricted vehicle loading (see Photo 20).

Photo 19 Round Columns at Graving Finger 1

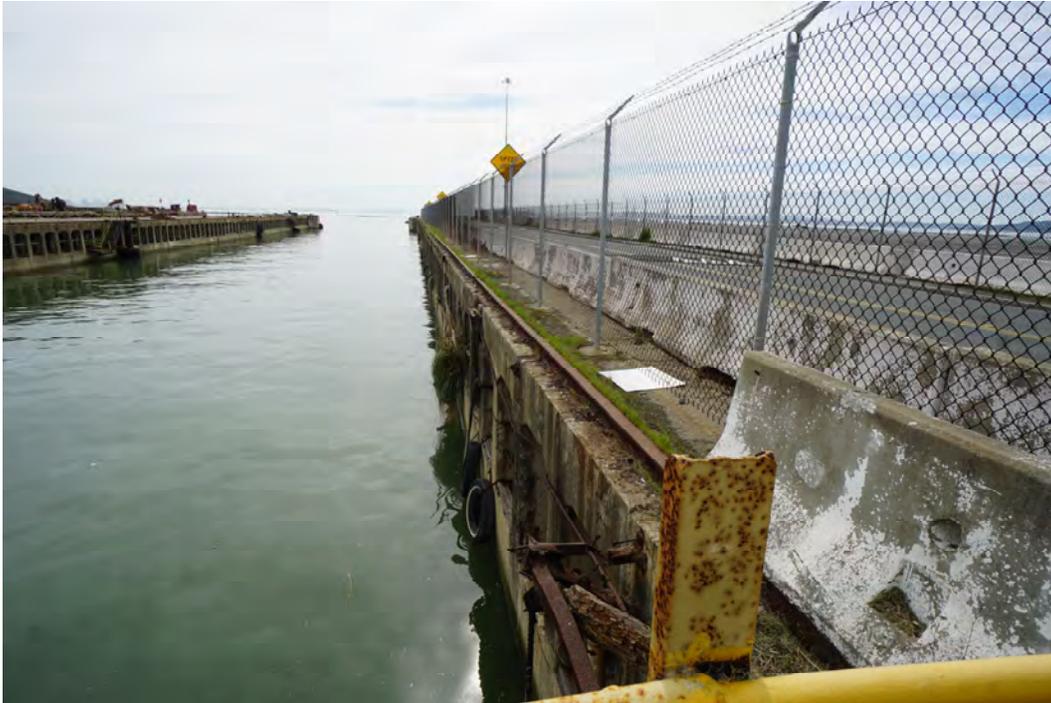
Photo 20 Portion of Canal Blvd Supported by Finger 1

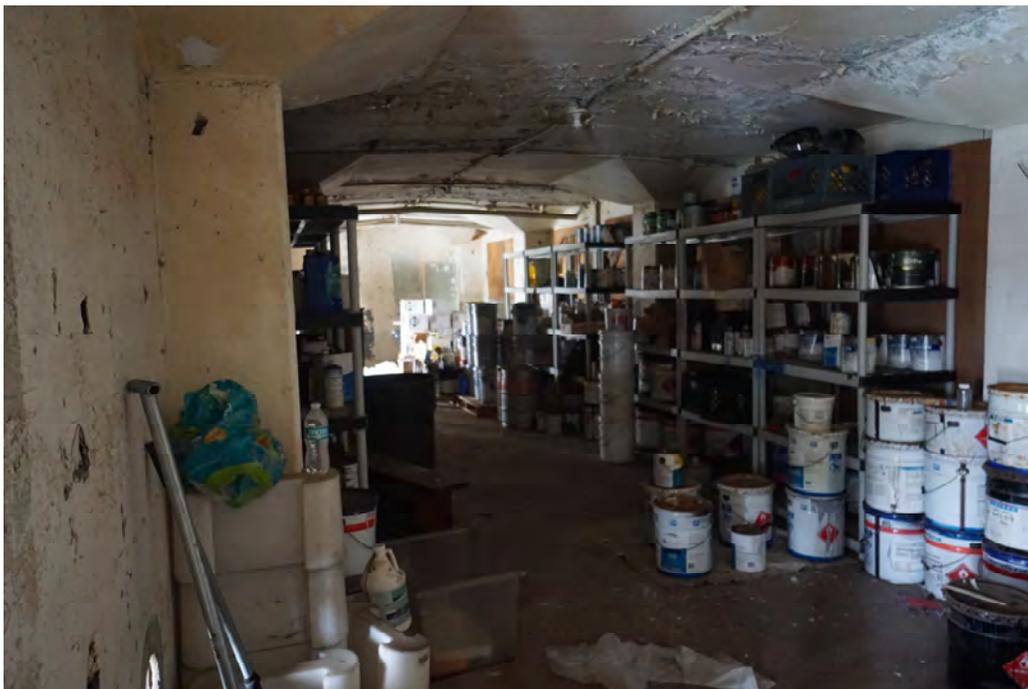
Potential hazards were observed at a few locations of the graving basins. This includes large quantities of paints, solvents, and environmentally hazardous chemicals being stored with no visible methods of containment. Additionally, there are large penetrations in the gallery roof deck and gallery floor slab, generally located at the ends of the basin fingers, which are not properly covered. In places where the holes were covered, the material used did not provide adequate cover and support.

Photo 21 Potential Hazards, Uncontained Environmentally Hazardous Chemicals

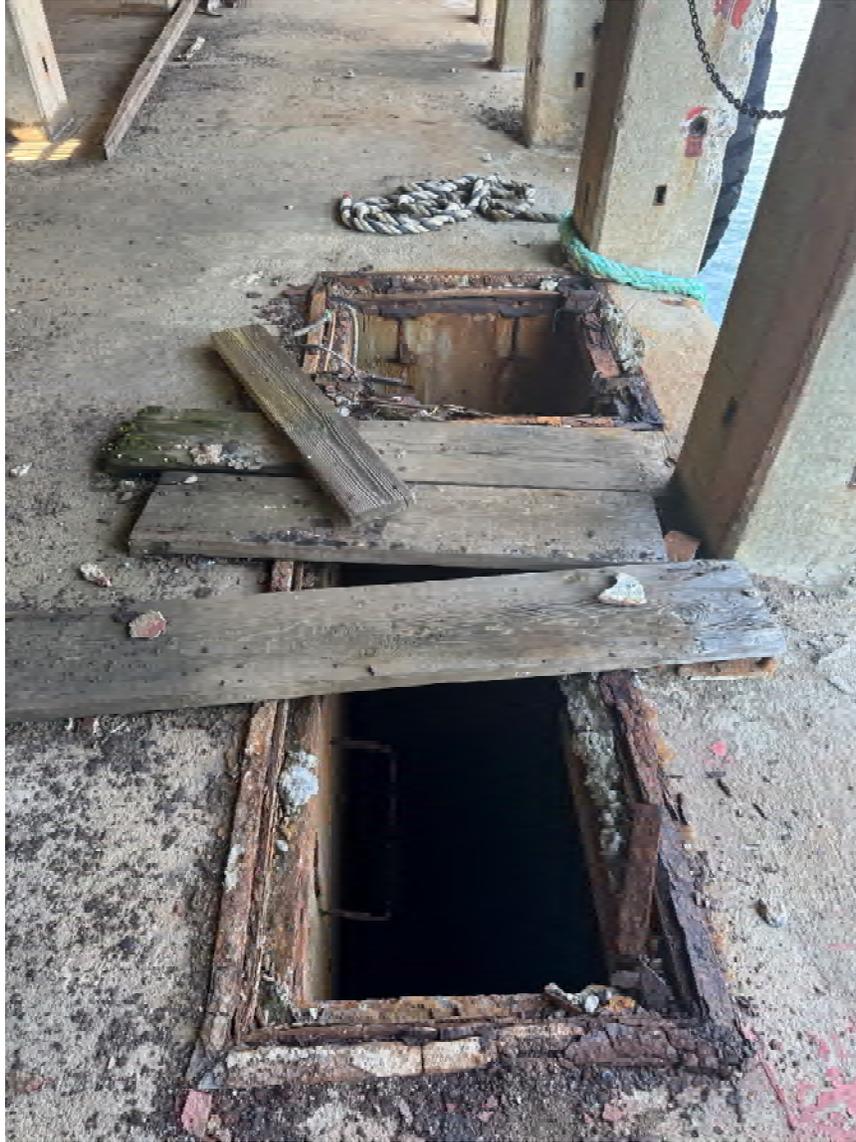
Photo 22 Penetrations in Gallery Floor Slab, not Adequately Covered

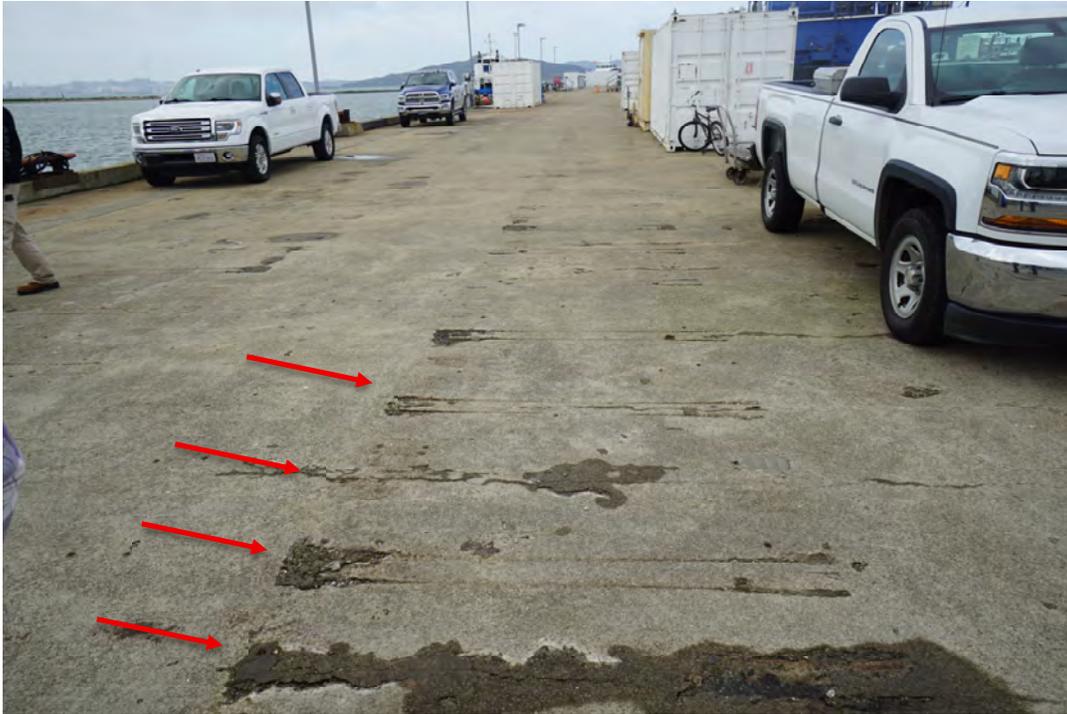
There was some minor damage observed on the deck of the finger piers, most noticeably at Finger Pier 1 where there were deck abrasions caused by crawler crane loading, shown in Photo 23.

Photo 23 Deck Abrasion Damage Caused by Crawler Crane at Finger Pier 1

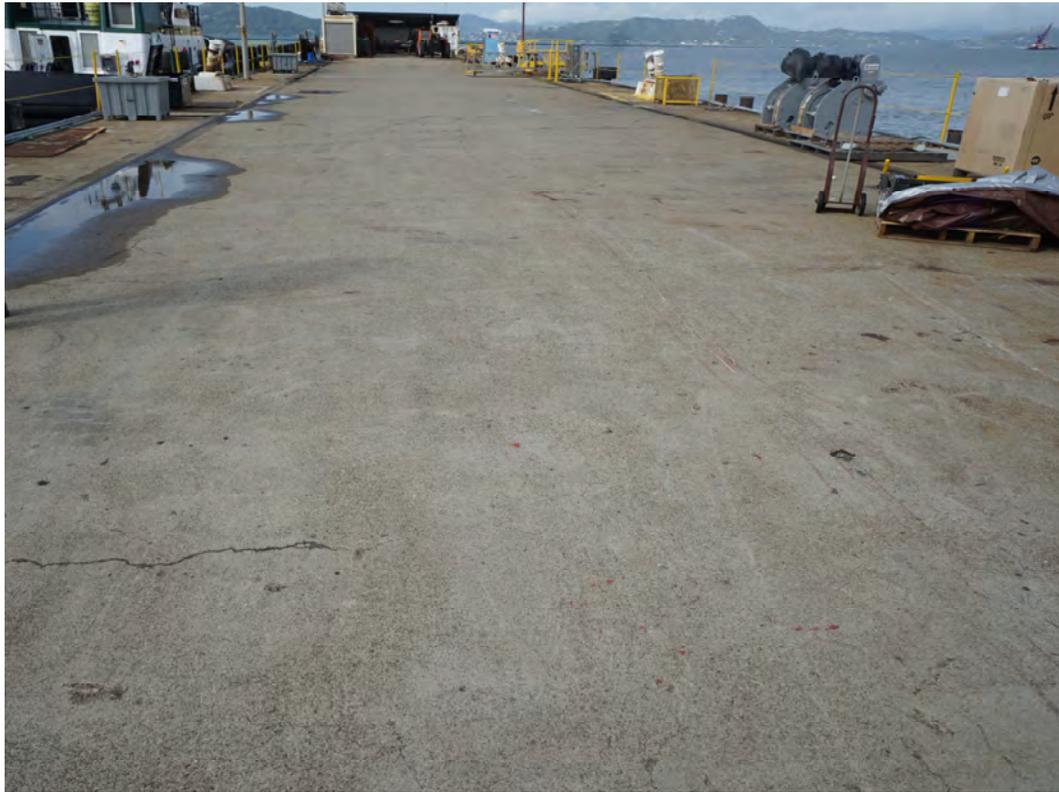
Photo 24 Minimal Deck Damage at Finger Pier 2

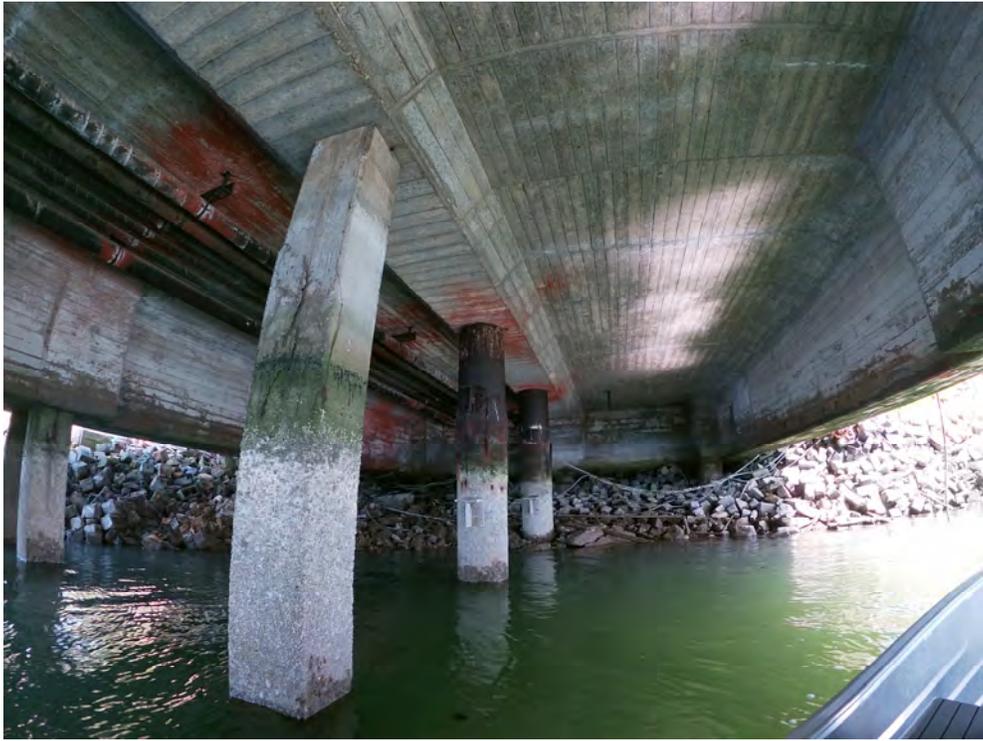
The soffit of the finger piers exhibited no or very minimal damage. The deep longitudinal and transverse beams were typically delaminated or spalled from the soffit up to approximately halfway of the exterior face. There was also exposed reinforcing at the bottom of the transverse beams. It is likely that the deep beams are deteriorated due to continual exposure during high tide levels.

Photo 25 No / Very Minimal Damage on Slab Soffit

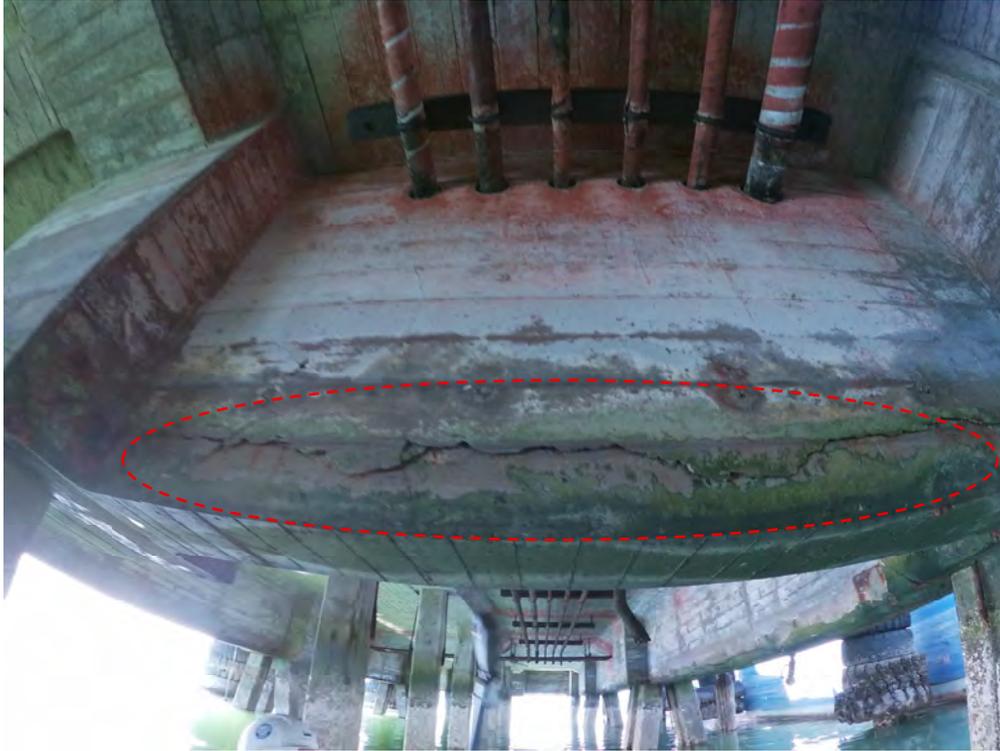
Photo 26 Typical Delamination of Beam Soffit of Transverse Beam

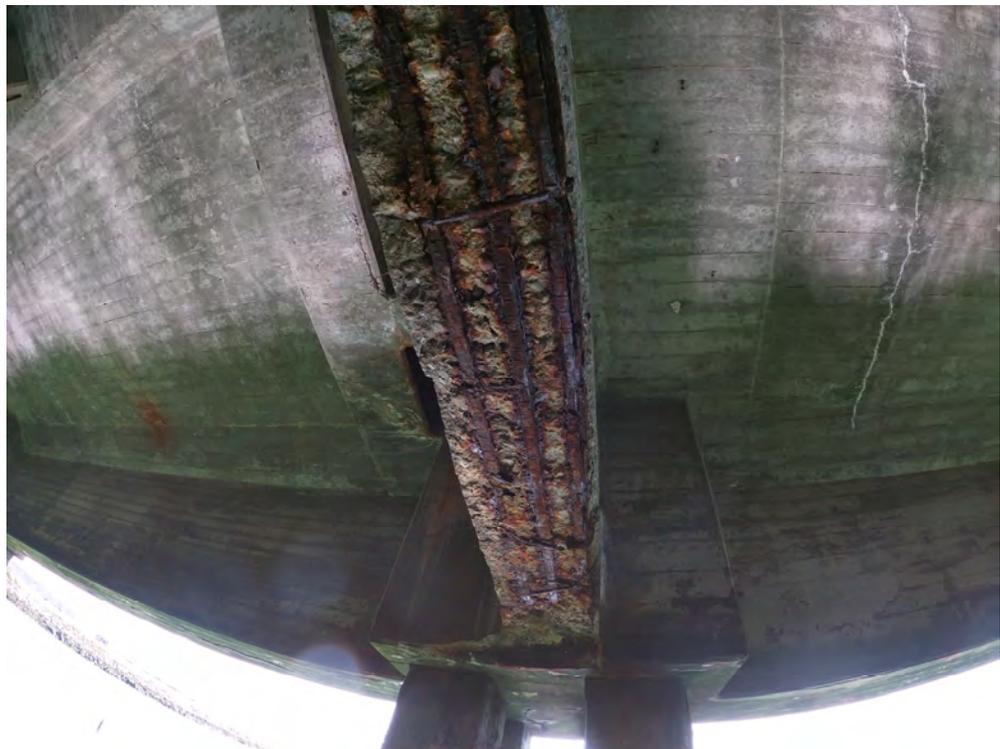
Photo 27 Exposed Transverse Beam Bottom Layer of Reinforcing Steel
