8.3 Graving Basin and Finger Piers Inspection Report

Point Potrero Marine Terminal Inspection Report

Produced for the Port of Richmond
August 19, 2025

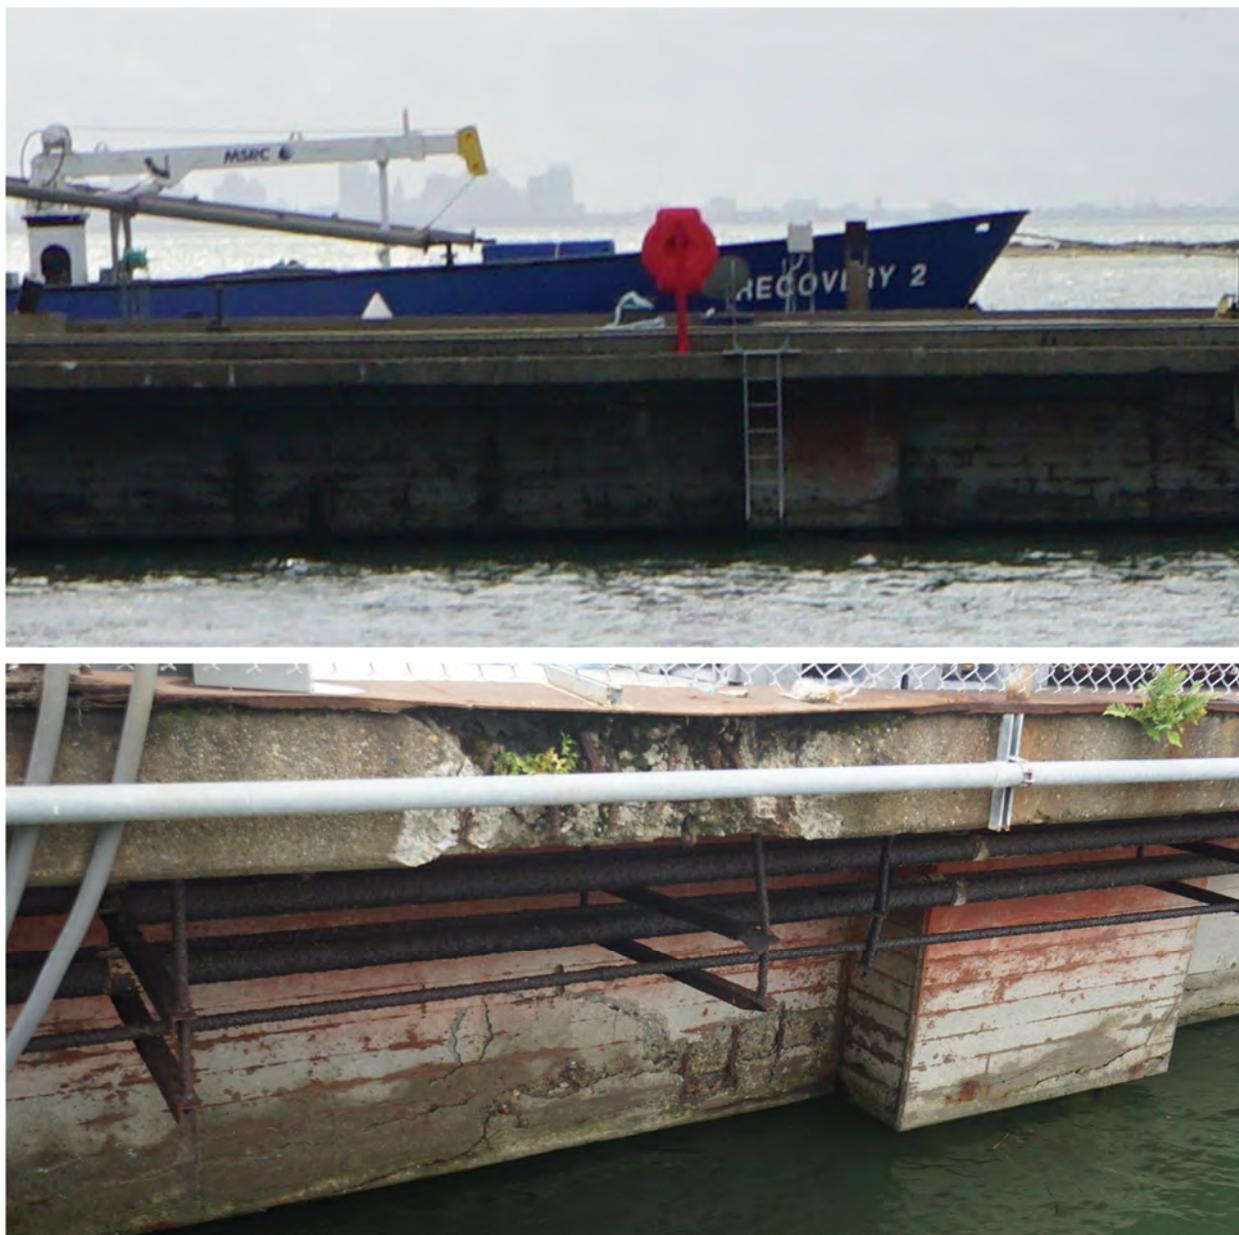
The tide elevation in Photo 28 is at 5.9' MLLW, and the water level is within 2 inches from the beam soffit. It should be noted that the tide reached 6.5' that day (MHHW = 6.04'). It can be concluded that, on average, the deep longitudinal and transverse beams are wet at least once a day for half of the year.

Photo 28 Beam Exposure at 5.9' MLLW

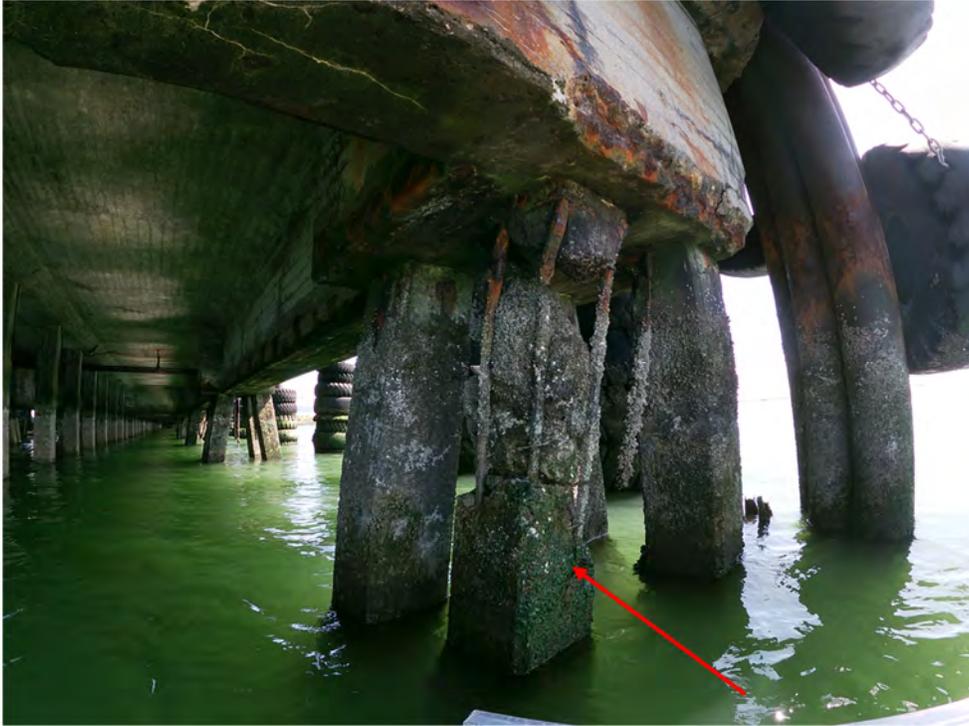
Similar to the columns of the graving basin, damage ratings were applied to the piles of the finger piers based on ASCE MOP 130. The pile clusters along the edge of the pier were typically in minor to moderate condition, while the square piles in the internal row were typically in moderate to major condition. The piles with major or severe damage, likely due to impact, were located at the south end of the piers.

Photo 29 Severely Damaged Pile at South End of Finger Pier 2

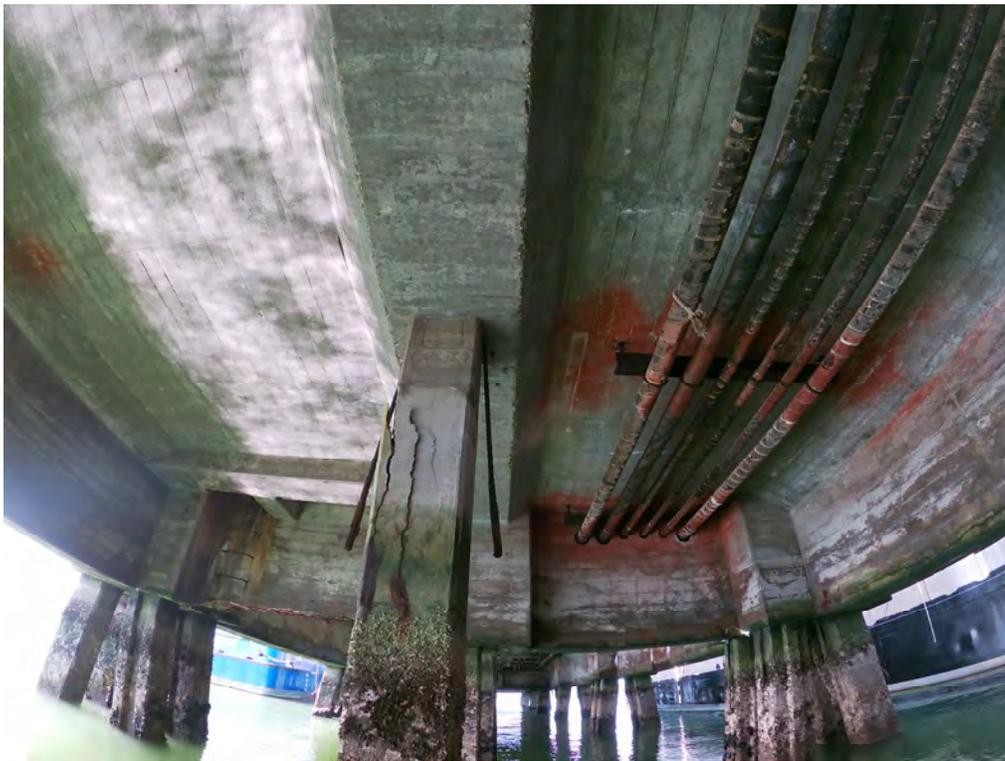
Photo 30 Typical Pile Damage, Middle Row

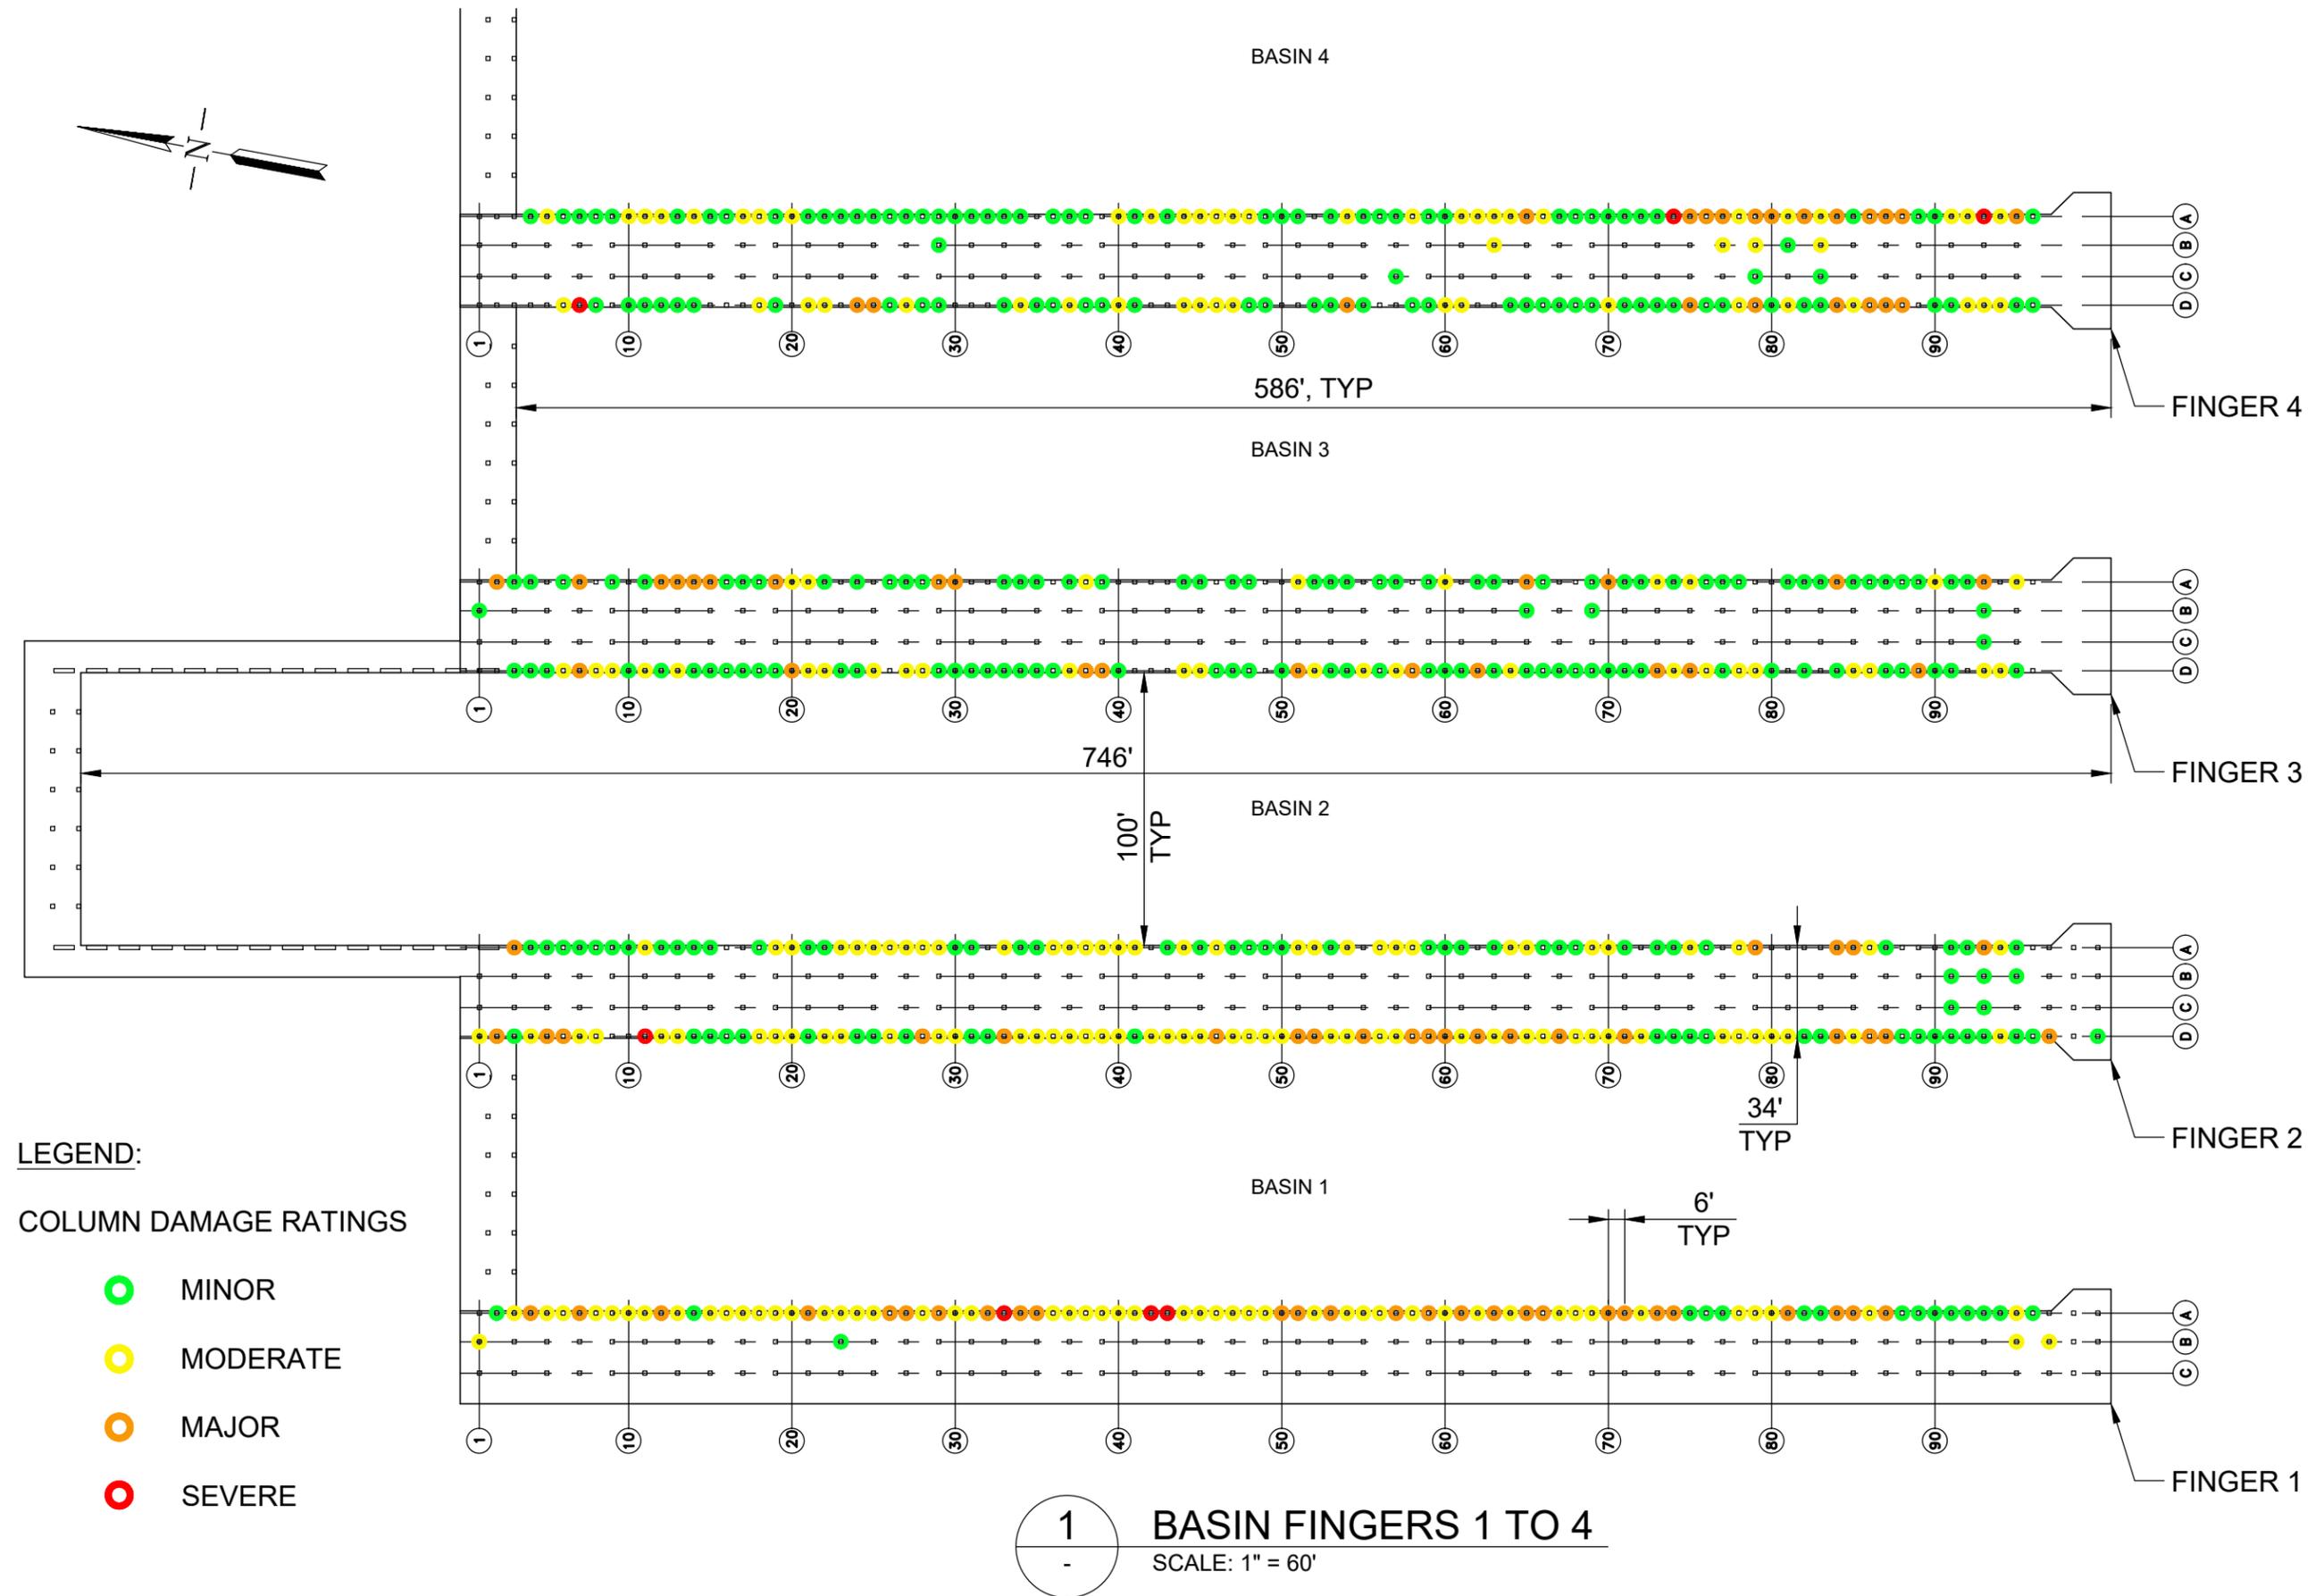
Figure 1 - BASIN FINGERS 1 TO 4

The inspection figures summarizing the damage observed for each graving basin finger is shown in Appendix B. The inspection figures depict the column damage observed and hatching where significant soffit damage was observed. Interior columns are not rated as they generally showed primarily minor damage. A summary of the exterior column damage for each graving basin finger is in Table 3. As depicted, the majority of the damage observed to the exterior columns is minor or moderate. Where there are severely damaged columns, Moffatt & Nichol recommends posting loads restrictions to the supported areas.
