1. Executive Summary

The Port of Richmond has undertaken a critical effort to assess the existing infrastructure at the Point Potrero Marine Terminal (PPMT). This assessment will be used to inform both the Port's strategic plan and the City of Richmond's goals to sustain and grow Port operations. The team, consisting of Moffatt & Nichol, Liftech Consultants, Inc., ENGEO, Inc., and Power Engineering Construction provided inspection services of the structures at the PPMT and worked to develop this condition assessment report that summarizes the findings of the inspections and provides a prioritized list of potential capital improvements projects that support ongoing Port operations and potential infrastructure improvements to increase Port revenue.

Point Potrero Marine Terminal (PPMT) is the former Historic Shipyard Number 3 at the Port of Richmond. The facility, originally constructed between 1941 and 1942, produced Liberty and Victory ships during World War II. This assessment is focused on Berths 5-8, the graving basins, and the finger piers, as well as the Whirley Crane currently at Graving Basin Number 5. Berths 5 and 6 are an inactive area, primarily used for lay berthing pre

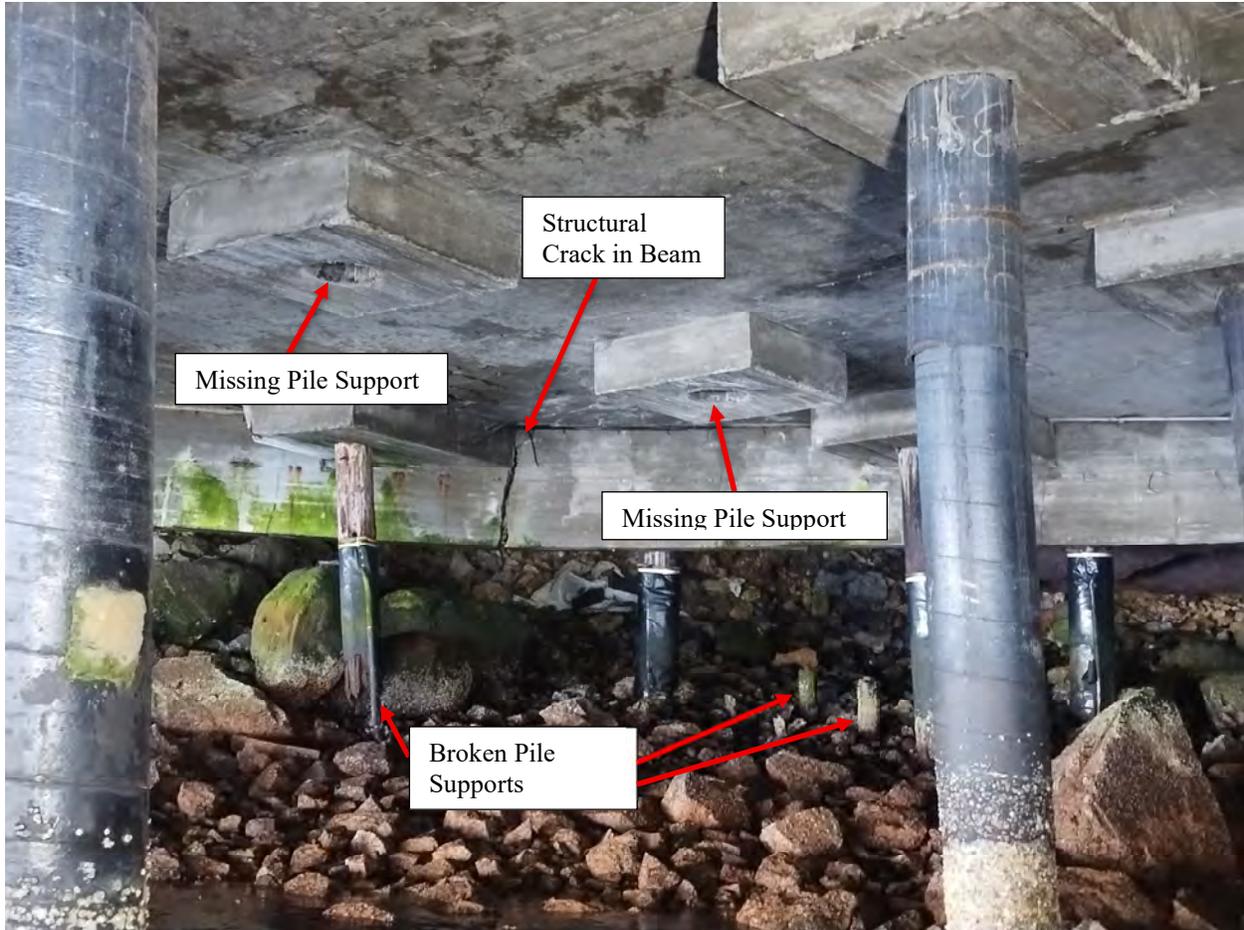
Liftech Consultants, Inc., with the support of Power Engineering Construction and ENGEO, Inc., performed inspections of Berths 5-8. Overall, the wharf structures at Berths 5-8 are in poor to serious condition due to the damage observed. At the southern limit of Berth 7, localized settlement of the wharf deck was observed due to a broken support beam that was overloaded as a result of severely deteriorated/broken timber pile supports, as depicted in Photo 1.

Photo 1 Broken Beam at Southern Limit of Berth 7

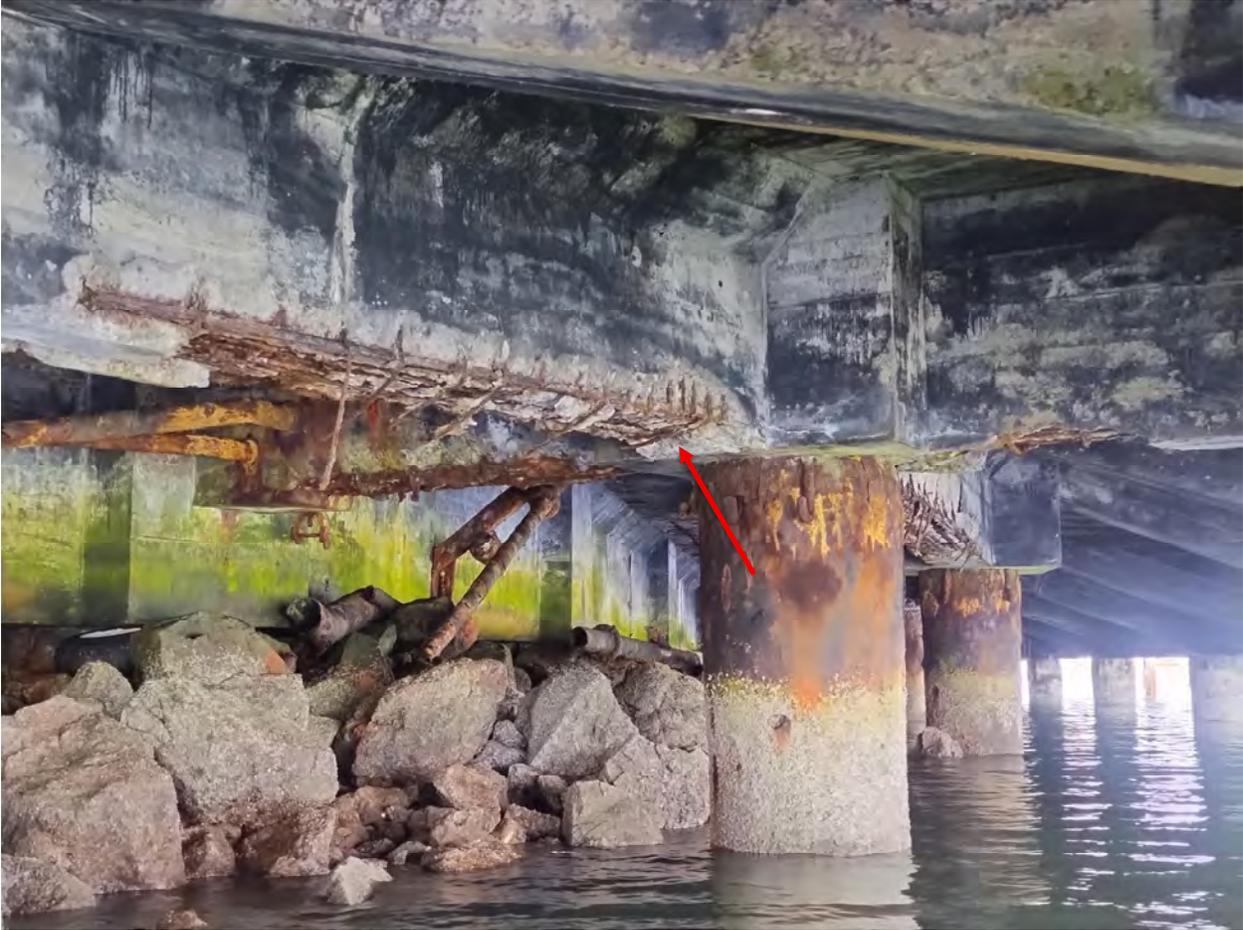
There is also tie beam failure and pavement settlement caused by various missing and damaged piles and soil erosion. There is typical chloride-induced corrosion deterioration of steel piles and concrete wharf structure elements, including face and crane beams and concrete struts, shown in Photo 2.

Photo 2 Exposed Reinforcing and Corrosion on Beam at Berth 7/8

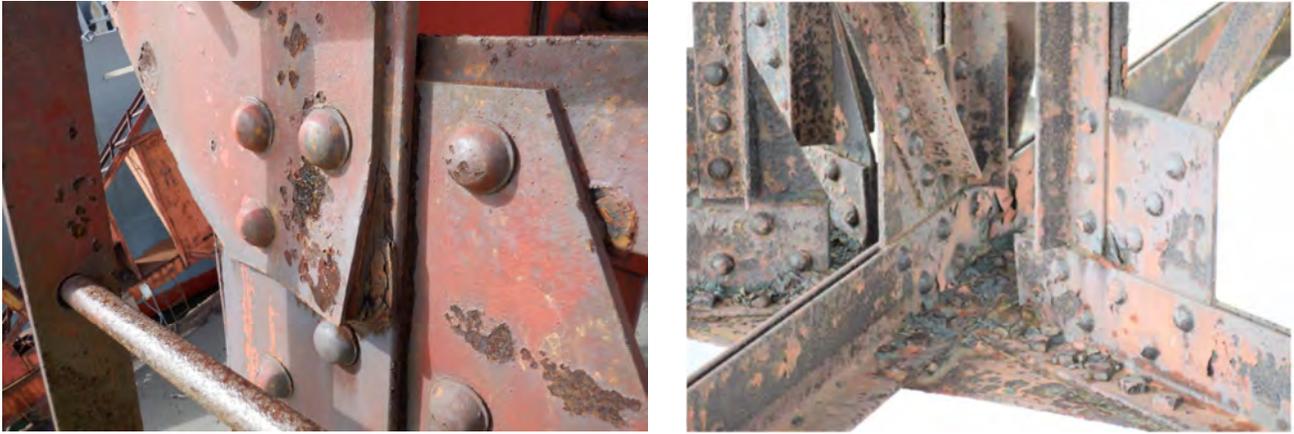
Liftech Consultants also completed an inspection and visual assessment of the Whirley Crane at Graving Basin 5. The Whirley Crane has extensive coating system failure and corrosion in various areas. While the corrosion was mostly minor with major corrosion in some localized areas, there are secondary structures such as ladders, railings, and gratings with major or severe corrosion damage. As a result, these structures are falling object hazards, and areas around the crane should be restricted to public access. Liftech developed recommendations and associated high-level cost estimates for immediate and near-term risk mitigation, long-term preservation, and demolition, shown in Table 1.

Photo 3 Structural elements with corrosion damage, rivets appear unbroken

#	Recommendation	Cost Estimate	Comments
1	Immediate and Near-Term Risk Mitigation	\$ 200,000	Falling object hazards; boom rope inspection, redundancy design, installation; crane restraint against motion.
2	Preservation On-Site with Wind and Seismic Reinforcing	\$ 2,500,000	Seismic & wind analyses; corrosion abatement including permitting, rust removal, painting; allowance for unknowns. Included in cost is \$1M structural reinforcing required for seismic and wind adequacy.
3	Museum Preservation Off-Site of Select Components	\$ 1,400,000	Partial demolition & rigging design; site dismantling; scrap majority; abate & preserve some components; transport to museum; allowance for unknowns.
4	Demolition	\$ 700,000	Demolition design & permitting; contractor dismantles using cranes; transit via barge and scrap.

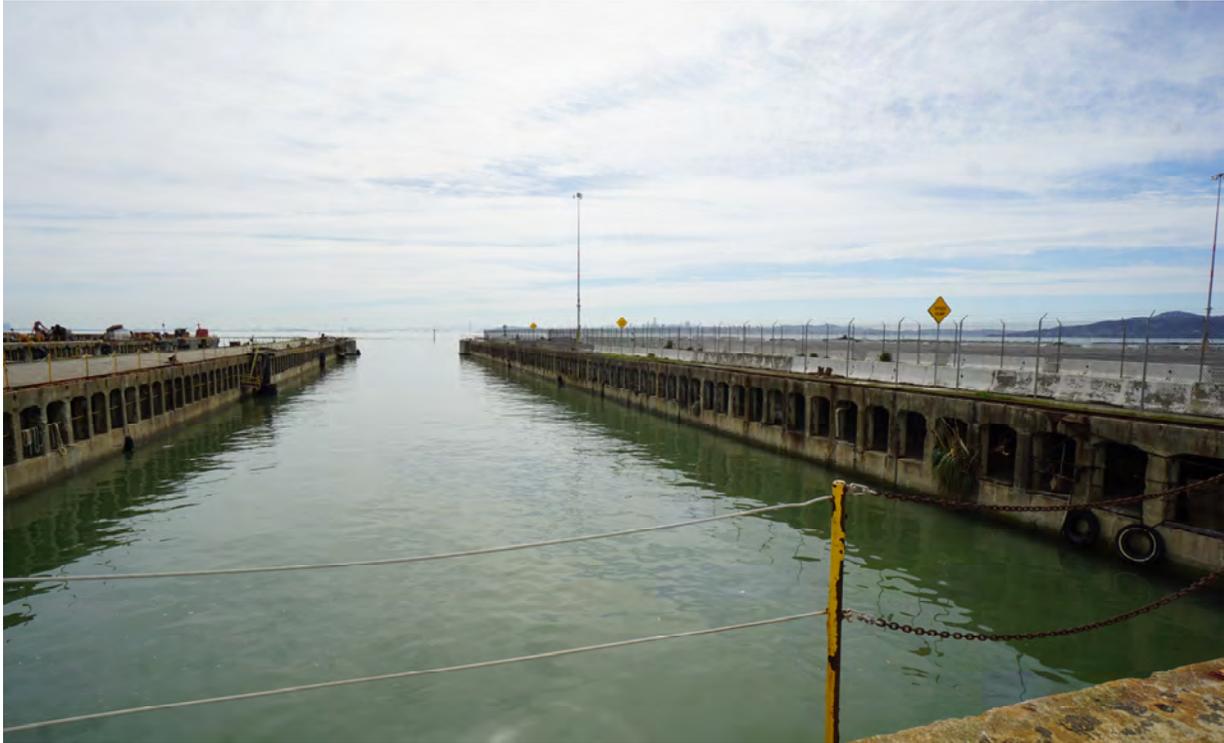
Photo 4 Graving Basin 1 looking south

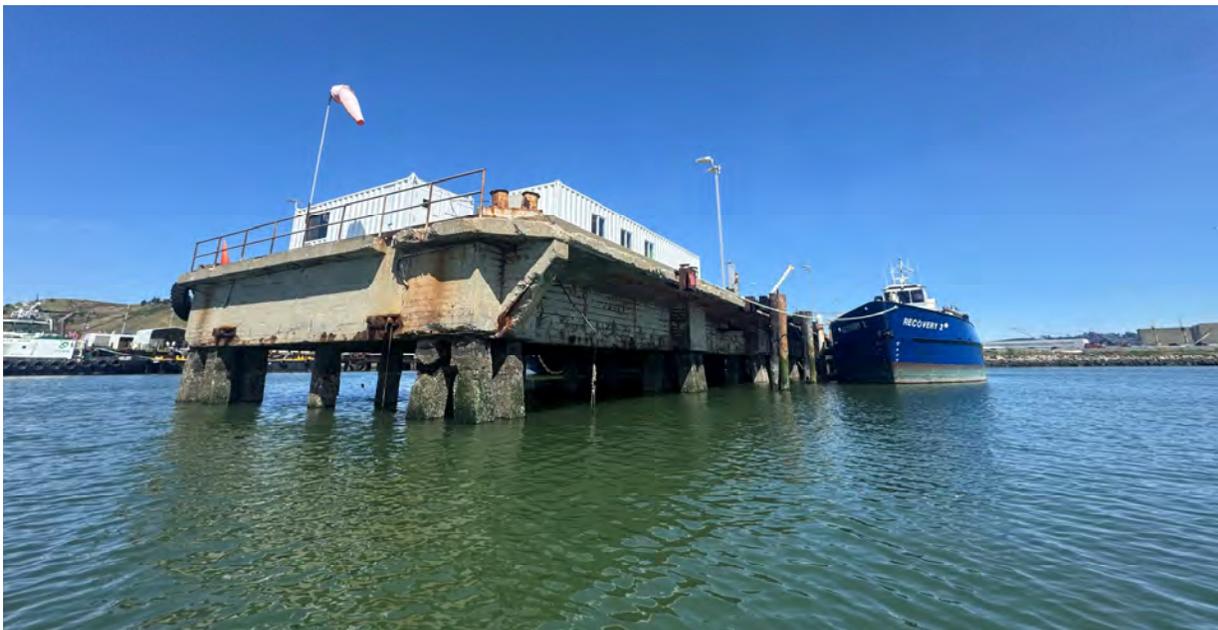
Photo 5 Distal end of Finger Pier 1 looking east

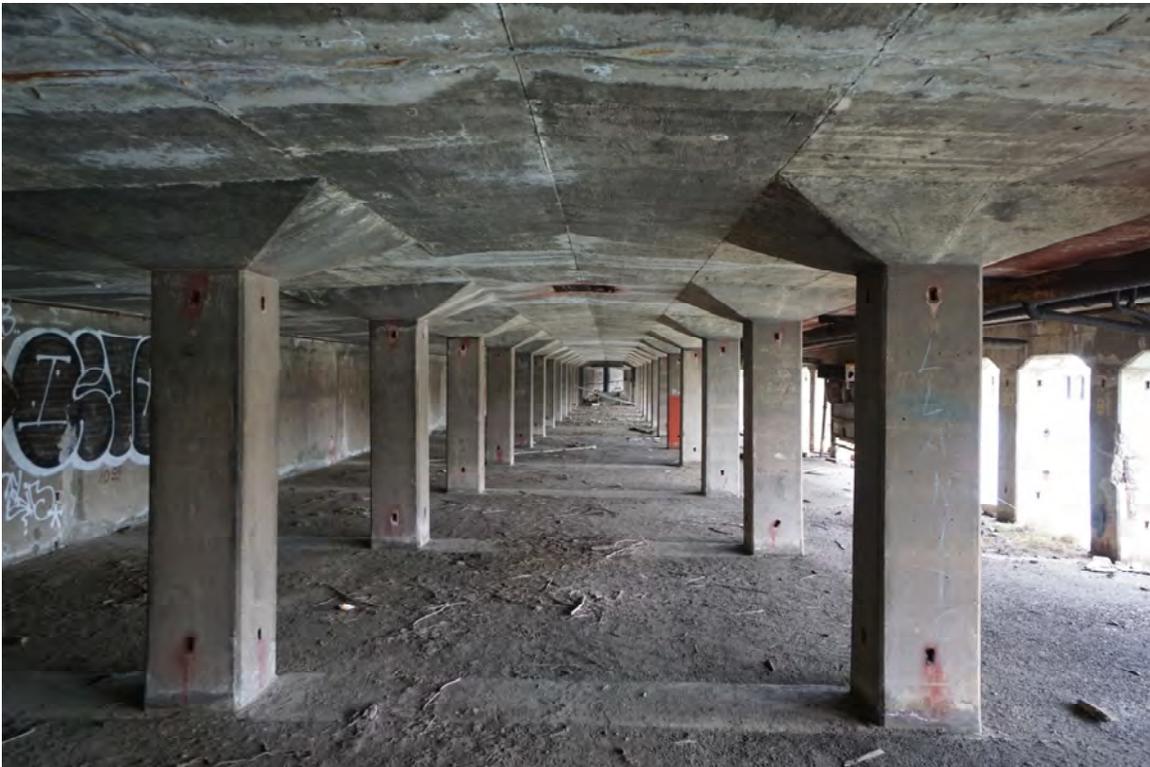
Overall, the graving basin structures are in fair condition. Varying degrees of concrete deterioration were observed throughout the graving basin structures. The interior columns were generally in good condition with little to no damage observed, as shown in Photo 6. The exterior columns typically exhibited moderate to major impact and surface wearing damage from the absence of suitable mooring and fender systems. Several columns had severe damage (complete loss of bearing), likely due to impact loads from vessels; an example of a severely damaged column is shown in Photo 7. Localized concrete delaminations due to chloride-induced corrosion were observed at various locations on the soffit and slab. Additionally, potential hazards observed include 1) large quantities of paints, solvents, and environmentally hazardous chemicals being stored in the basin structures with no visible methods of containment and 2) large penetrations in the deck presenting a falling hazard generally located at the ends of the basin structures with inadequate coverings, if any (as indicated in Photo 8).

Photo 6 Interior Columns at Finger 1, Typically No Damage Noted

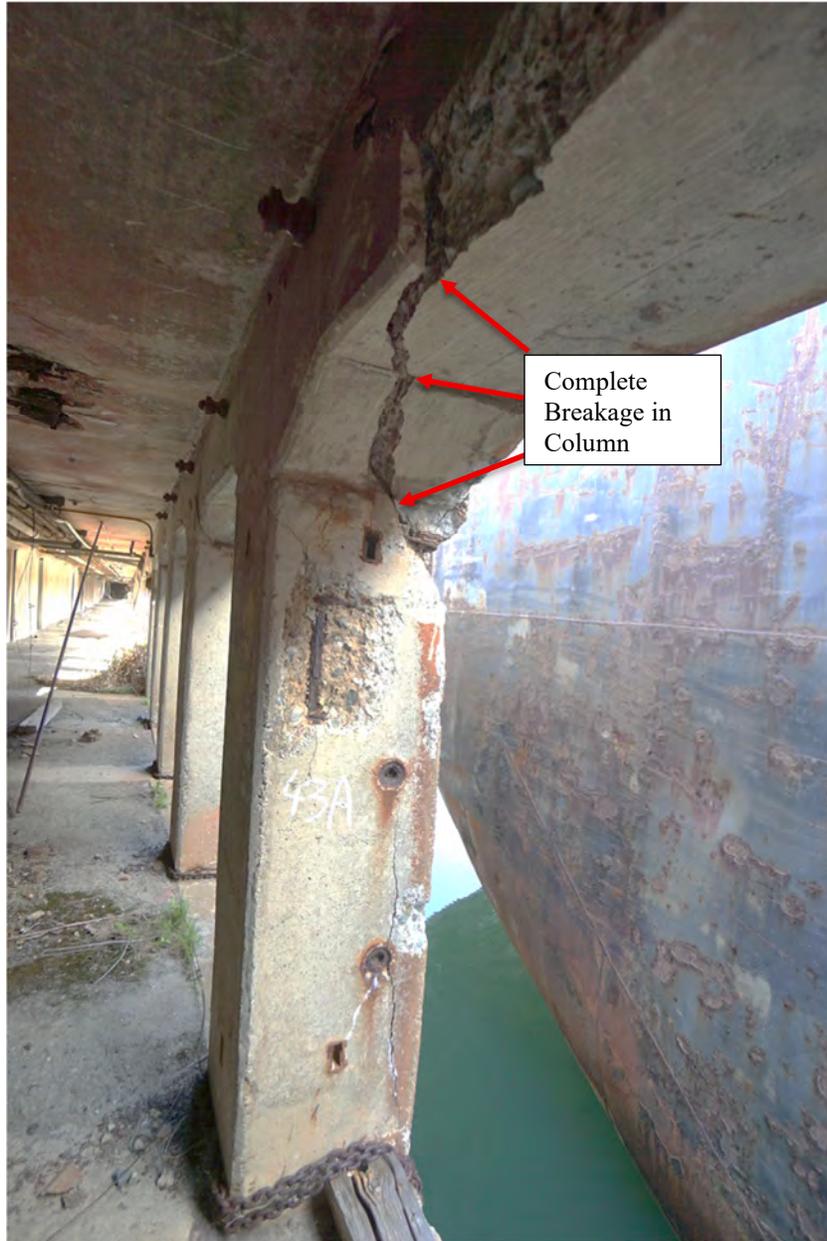
Photo 7 Exterior Column with Severe Damage

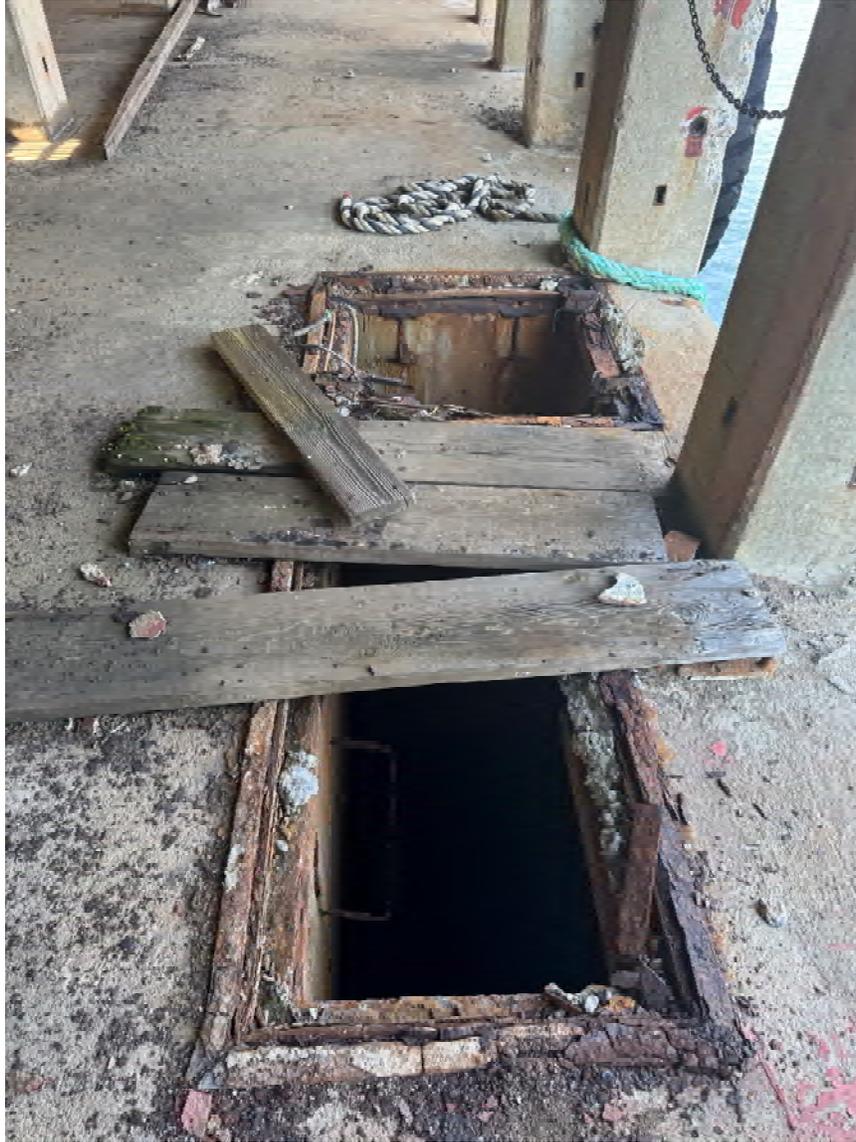
Photo 8 Penetration in Gallery Floor Slab, not Adequately Covered

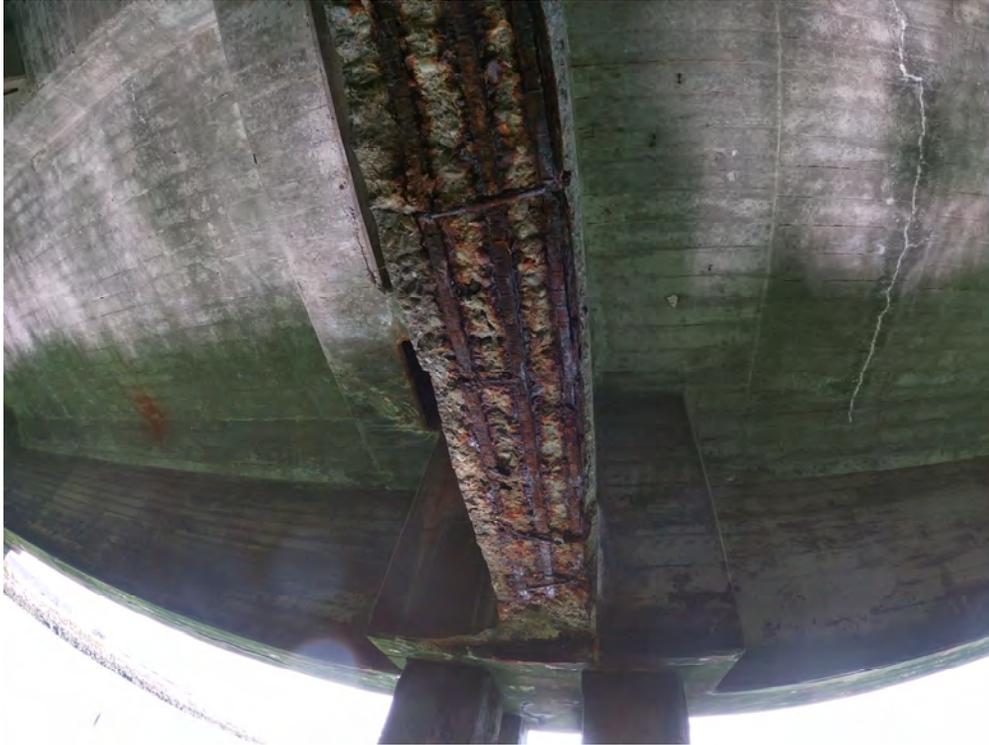
The finger piers are in fair to poor condition due to structural deterioration of the edge beams and moderate to major damage seen in the supporting piles. Areas of significant damage were observed at the transverse and longitudinal deep beams which were delaminated and spalled with exposed reinforcing, likely due to continuous exposure during high tide levels.

Photo 9 Exposed Reinforcing in Transverse Beam

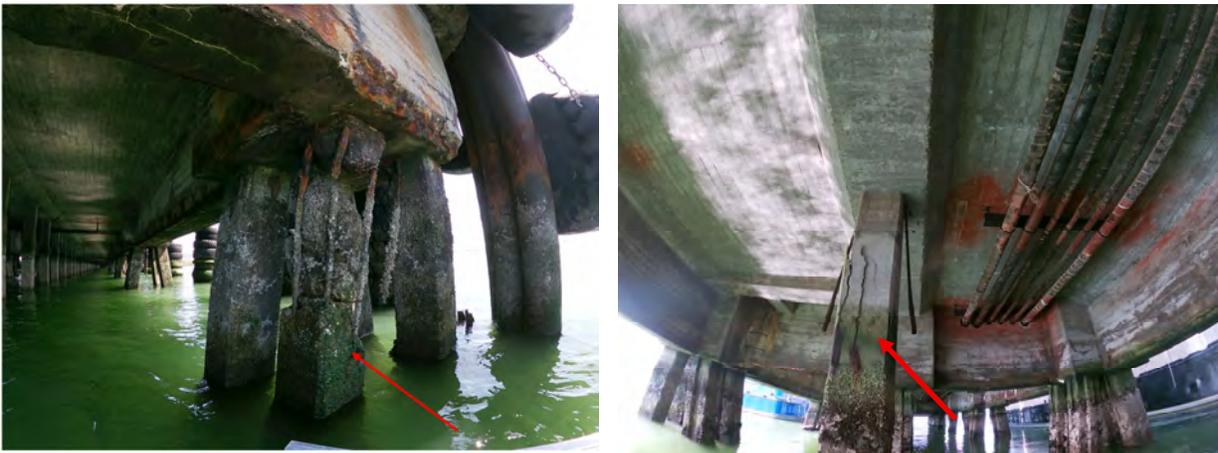
Photo 10 Severely Damaged Pile (left) and Typical Pile Damage (Right)

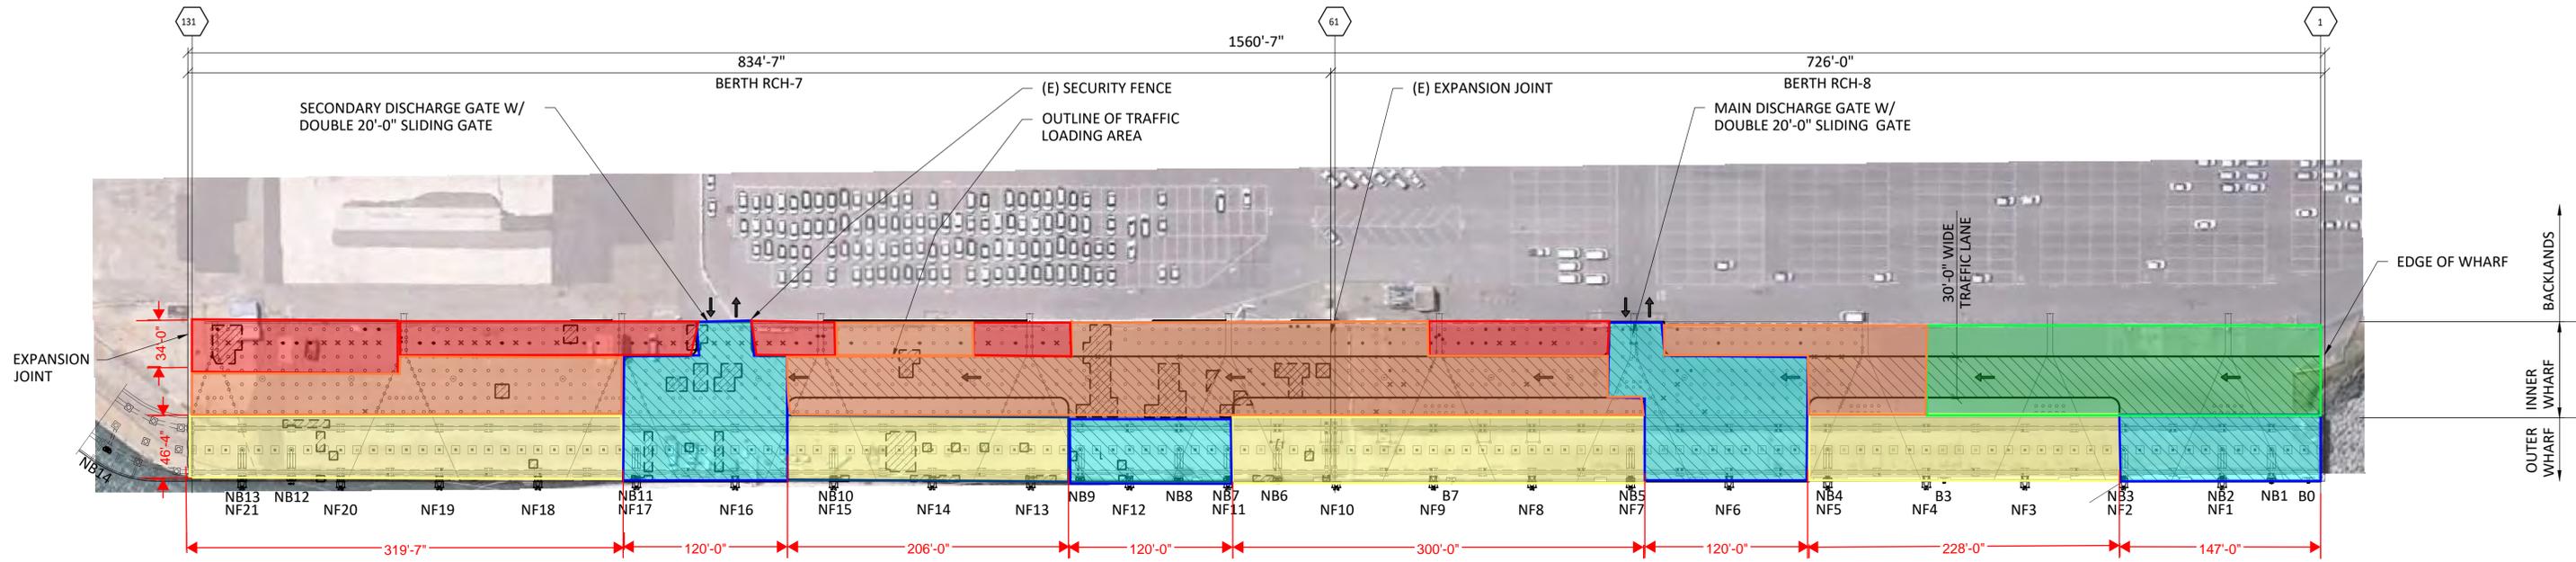
WHARF PLAN

1. DUE TO A SIGNIFICANT NUMBER OF DAMAGED AND MISSING PILES, NO LOAD IS ALLOWED UNTIL DAMAGED AND MISSING PILES ARE REPAIRED/REPLACED.
2. THIS AREA IS RECOMMENDED FOR AUTOMOBILE TRAFFIC LOADING ONLY DUE TO SPORADIC PILE DAMAGE AND MISSING PILES. LARGER LOADS MAY BE JUSTIFIED WITH FURTHER EVALUATION, E.G., LOCALIZED AREAS WHERE THERE ARE NO MISSING OR DAMAGED PILES.

3. THIS ALLOWABLE LOAD IS LIMITED TO OUTER WHARF ONLY AND ASSUMES THE UNREPAIRED CONCRETE PILES CAN SUSTAIN A DESIGN LIVE LOAD OF 250 PSF. THE 230 PSF LIVE LOAD IS TO ACCOUNT FOR THE WEIGHT OF 2" ASPHALT OVERLAY. LARGER LOADS MAY BE JUSTIFIED WITH FURTHER EVALUATION, E.G., LOCALIZED AREAS WHERE THERE ARE NO MISSING OR DAMAGED PILES, CRANE BEAMS SINCE THE BEAMS ARE SUPPORTED BY A GROUP OF PILES.

4. THE CONCRETE AND TIMBER PILES IN THESE AREAS WERE REPAIRED IN THE 2010 REPAIRS. ALLOWABLE LIVE LOADS ARE BASED ON THE STRENGTH OF THE WHARF DECK.
5. PAVEMENT OVER FILL. THE ALLOWABLE LIVE LOAD OF 600 PSF IS BASED ON THE ORIGINAL WHARF LIVE LOAD. ALLOWABLE LIVE LOADING PROBABLY LARGER.
