Port of Richmond Point Potrero Marine Terminal Assessment

Tuesday, October 21, 2025

moffatt & nichol

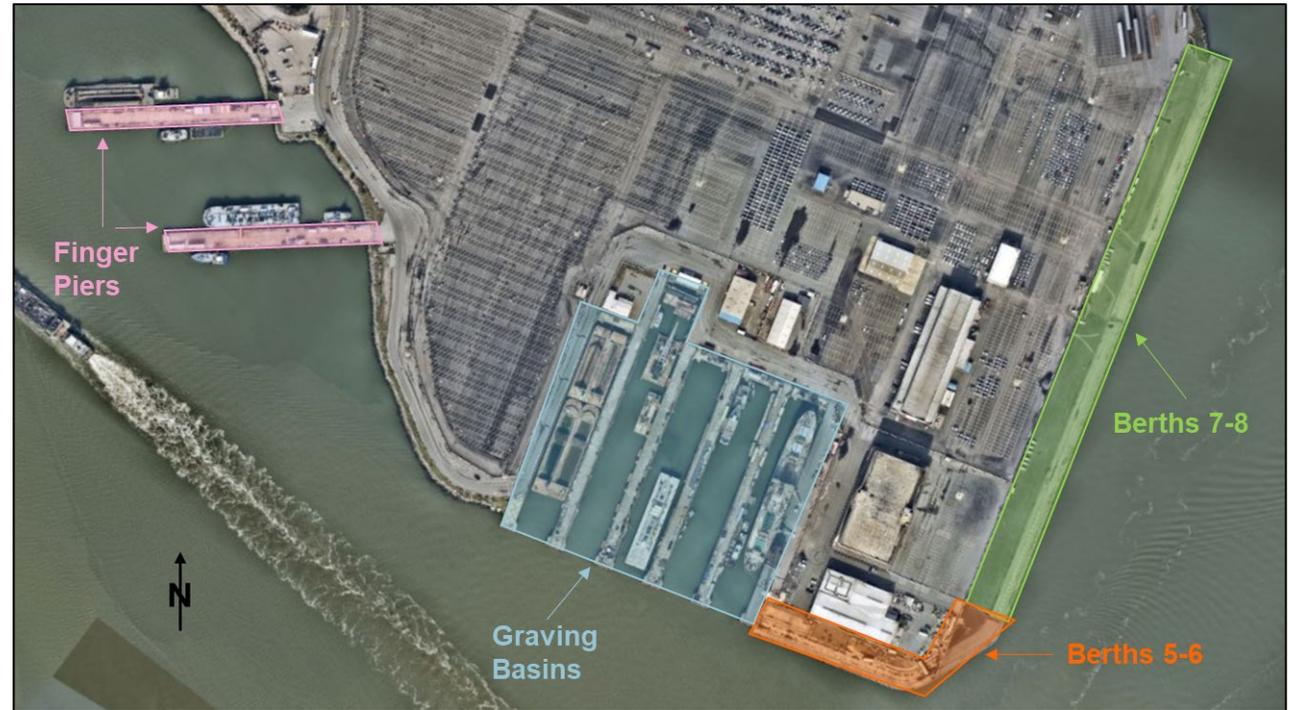
Outline of Areas to be Studied

- › Berths 5 & 6
 - › Limited use over the last 40 years, primarily as lay berthing
- › Berths 7 & 8:
 - › Active area, currently leased to Auto Warehousing Company for import of vehicles from Korea and Japan
- › Graving Basins and Finger Piers
 - › Used for berthing of vessels such as Red Oak Victory ship and other operating commercial vessels
 - › Piers on West side of facility constructed in the 1940s and have been updated by Port and tenants over the years

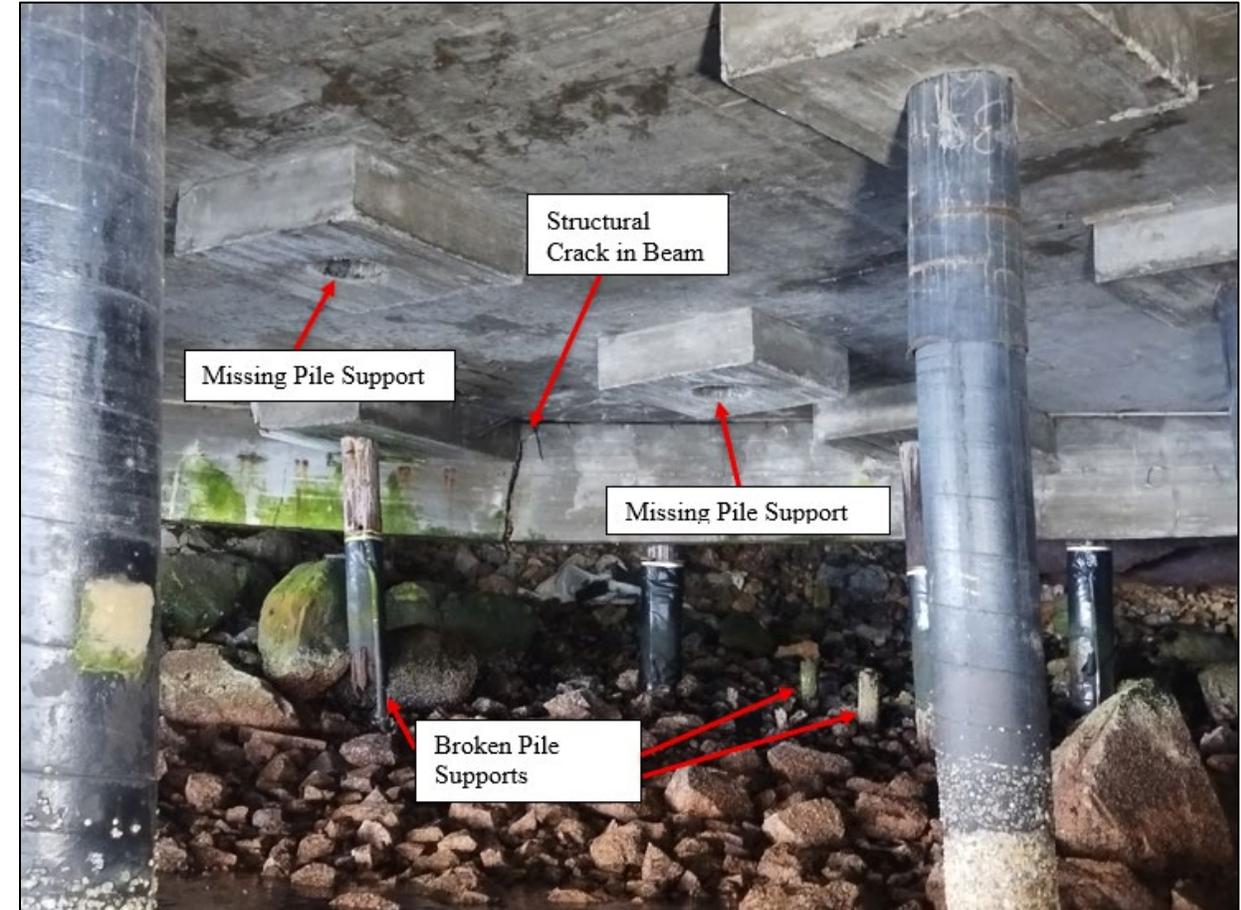
- › Slab sagging caused by localized beam failure below
- › Many damaged and missing timber piles
- › Pavement failure caused by soil erosion
- › Exposed reinforcing and corrosion damage below deck
- › Repaired piles in good condition; non-repaired piles are getting worse

Broken Beam at Berth 7

Structure	Condition Rating	Allowable Live Load	Action Required
Berths 5-6	Poor	Not Evaluated	Pavement failure repair, general concrete wharf repairs
Berths 7-8	Poor to Serious	50 psf except for at ramp loading areas: (200 psf Inner Wharf, 390 psf Outer Wharf)* AASHTO HS20-44 Vehicle Load	Critical repairs include restoring beam at Berth 7 to original position and strength, tie beam repair, and pavement failure repair

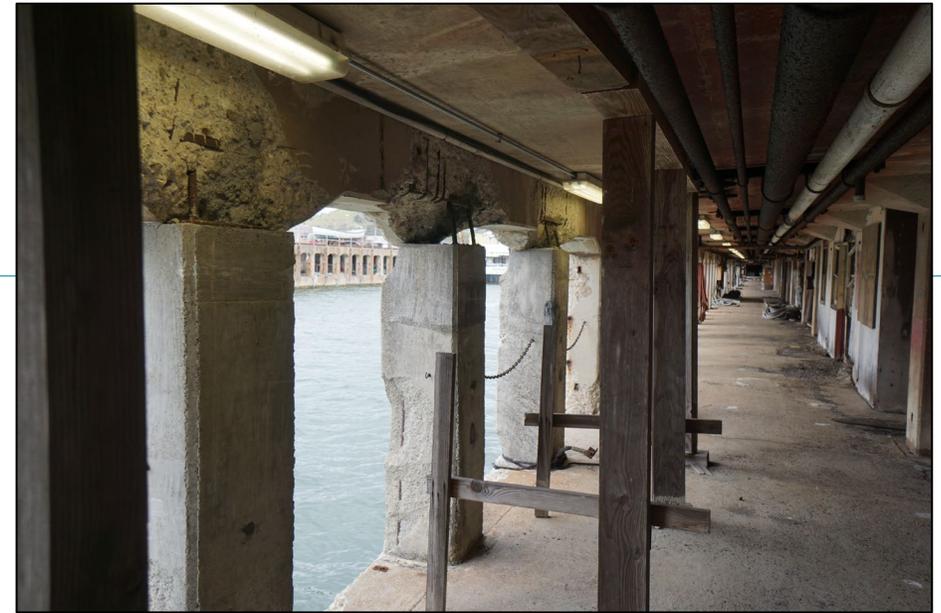
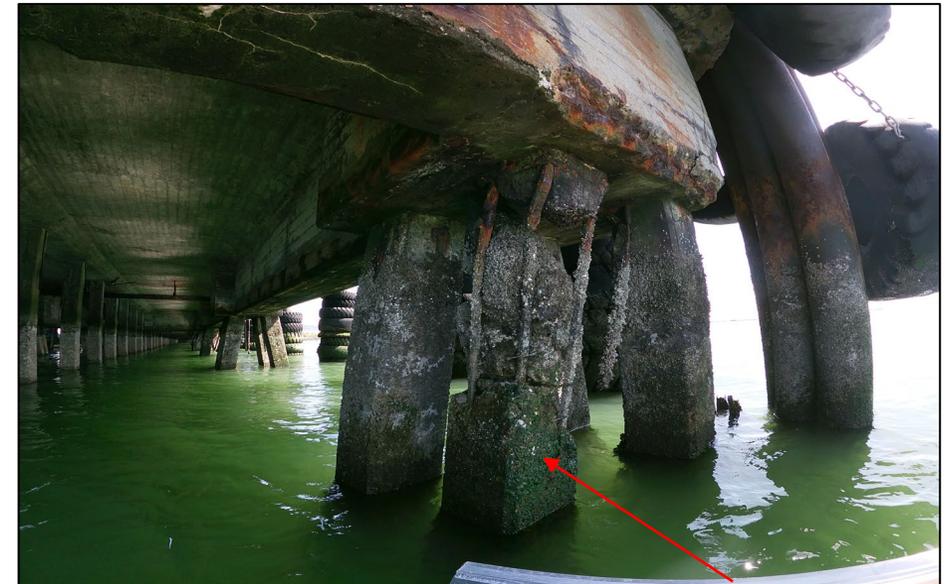
- › Graving Basins
 - › Exterior columns typically exhibit moderate to major damage
 - › Cracks, exposed reinforcing steel, delaminations on outside face of basins
- › Finger Piers
 - › Major or severe damage at (2) piles likely due to impact
 - › Deep beams are typically delaminated and spalled with exposed reinforcing

Columns in Serious condition at Graving Basin (above)
Severely damaged pile at Finger Pier 1 (below)

Structure	Condition Rating	Allowable Live Load	Action Required
Graving Basins	Fair	550 psf without load spreading (deck capacity controls) 2000 psf with load spreading that puts load directly into columns	Address potential safety hazards, develop mooring/fender system, restrict loading at columns with severe condition
Finger Piers	Fair to Poor	500 psf†	Restore edge beams to prevent further structural deterioration and decrease in capacity, upgrade fender systems depending on projected use

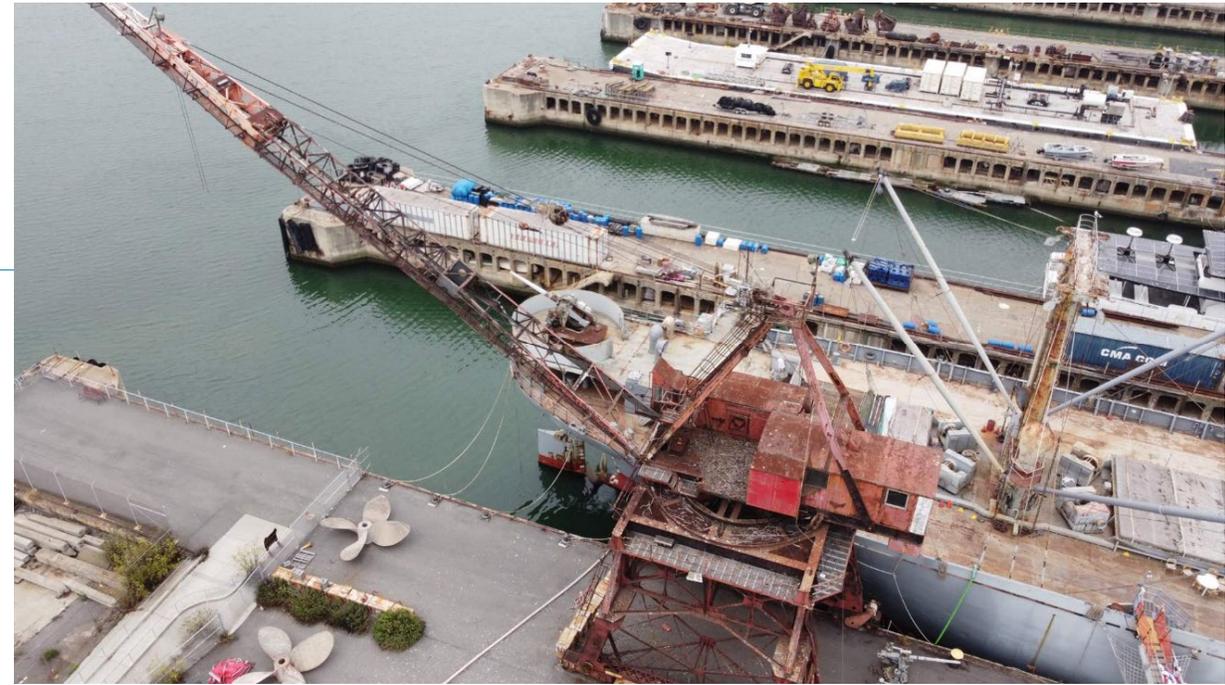
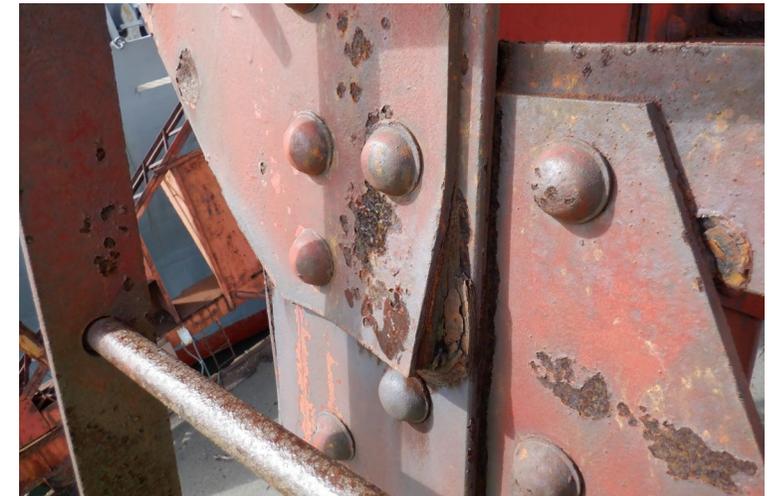
- › Extensive coating system failure and corrosion damage
- › Secondary structures (ladders, railings, and gratings) have major or severe corrosion damage
 - › Hazards for access and falling
 - › **Access on or under the crane to be restricted for safety**

*Whirley Crane position near edge of Graving Basin 6 (above)
Structural element with corrosion damage (below)*

#	Recommendation	Cost Estimate	Comments
1	Immediate and Near-Term Risk Mitigation	\$ 200,000	Falling object hazards; boom rope inspection, redundancy design, installation; crane restraint against motion.
2	Preservation On-Site with Wind and Seismic Reinforcing	\$ 2,500,000	Seismic & wind analyses; corrosion abatement including permitting, rust removal, painting; allowance for unknowns. Included in cost is \$1M structural reinforcing required for seismic and wind adequacy.
3	Museum Preservation Off-Site of Select Components	\$ 1,400,000	Partial demolition & rigging design; site dismantling; scrap majority; abate & preserve some components; transport to museum; allowance for unknowns.
4	Demolition	\$ 700,000	Demolition design & permitting; contractor dismantles using cranes; transit via barge and scrap.

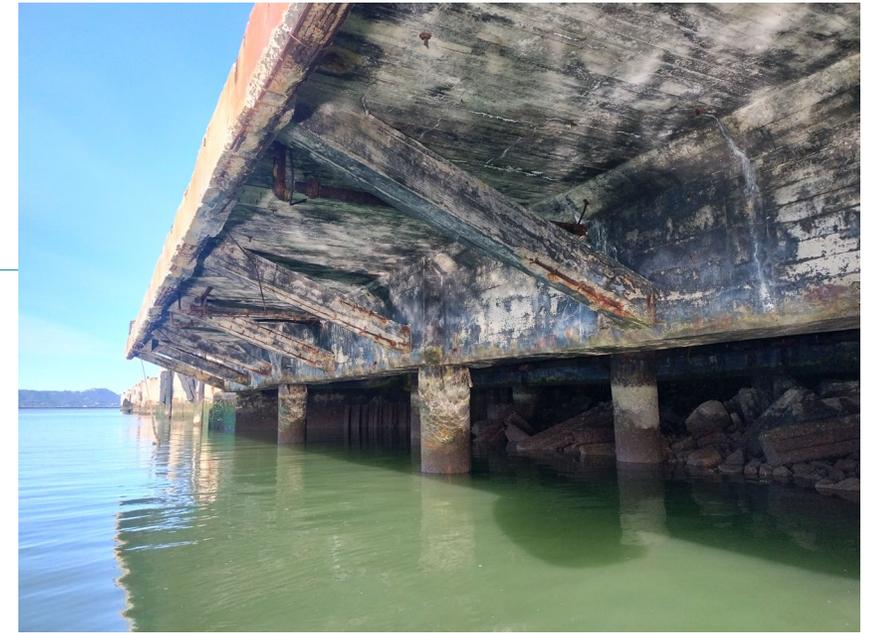
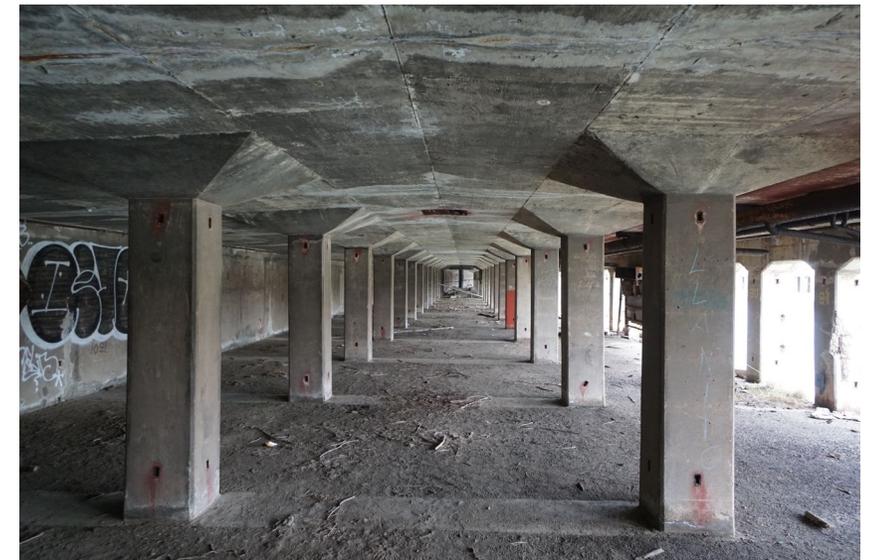
*Berths 5-6 from under deck (above)
 Interior columns at Graving Basin 1 (below)*
