MATERIAL SELECTION FOR REPAIR OF DAMAGED PROCESS PIPING IN HIGH-TEMPERATURE SULFIDATION SERVICE IN THE NO. 4 CRUDE UNIT

December 12, 2012

Edwin H. (Ned) Niccolls
Sr. Consulting Materials Engineer
Chevron Fellow

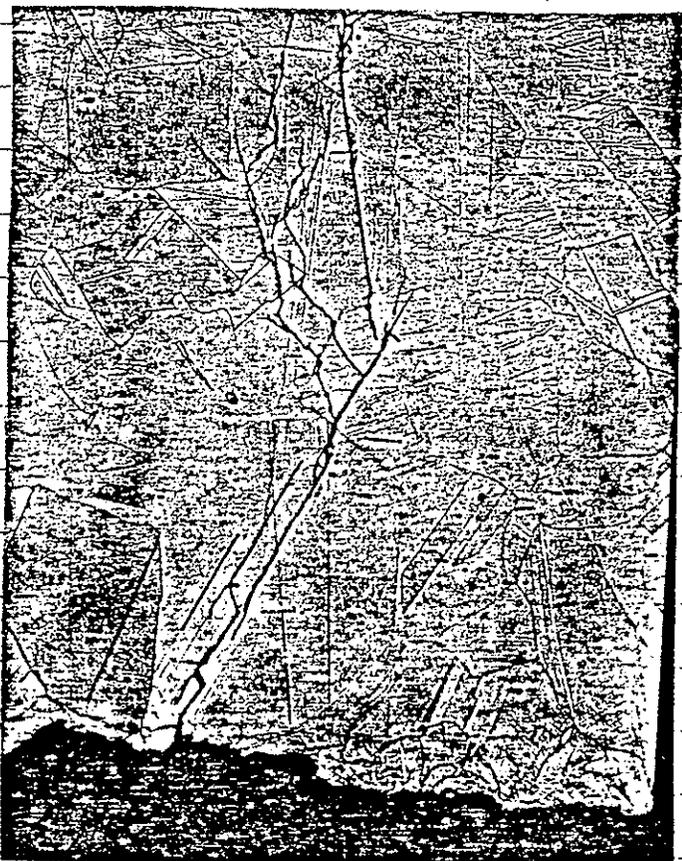
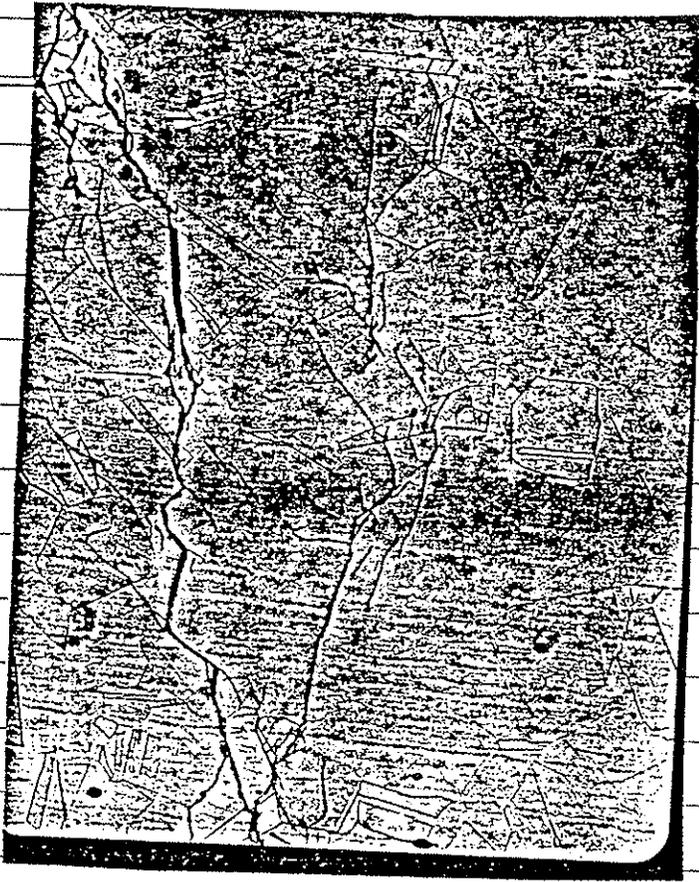
Typical branchy
transgranular crack
from pipe ID

Chloride stress
corrosion crack

Material = 304 S/S
Not sensitized
