**V.W. HOUSEN**  
& ASSOCIATES

This report summarizes approximately nine months of data review, field investigations, meetings, and hydraulic modeling activities that were conducted in 2017 for the Lift Station Master Plan project (“Project”). The objective of the Project was to consolidate and confirm available information, gather new field condition data, and identify system upgrades that are needed to improve overall reliability and wet weather capacity. Necessary improvements were identified and prioritized to address safety, reliability, capacity, and general maintenance. Conceptual costs were then developed for each of the recommended projects. The Project concluded with development of a 10-year Capital Improvement Program (“CIP”) that distributes costs across the planning horizon.

## ES.4 Lift Station Condition Assessment

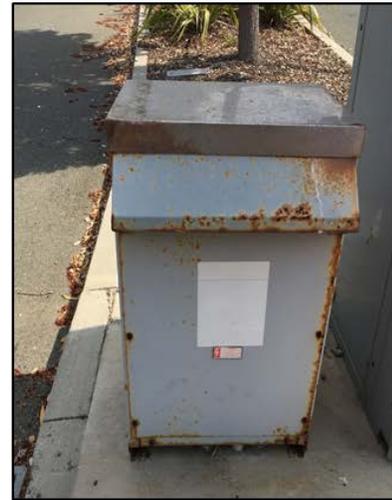
Corroded Transformer Enclosure

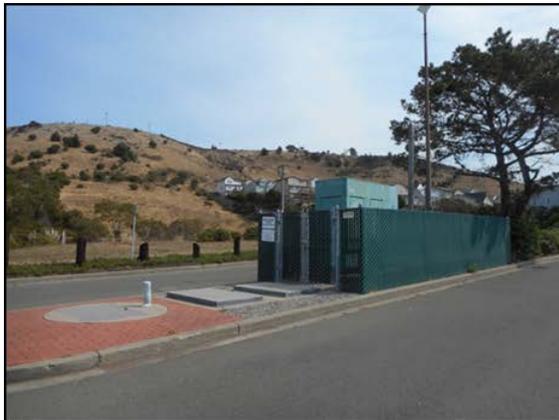
Constrained Site

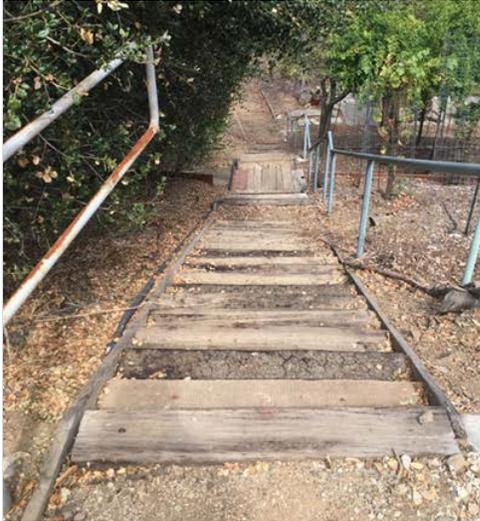
1. Access is very difficult at this station (See Figure 4-6). A separate study that includes a site-specific geotechnical analysis would be required if the City were to decide to improve access to this site. The scope of this study will depend on the work to be completed. Therefore, a cost estimate for this study was not included in this Report.

Current Site Access

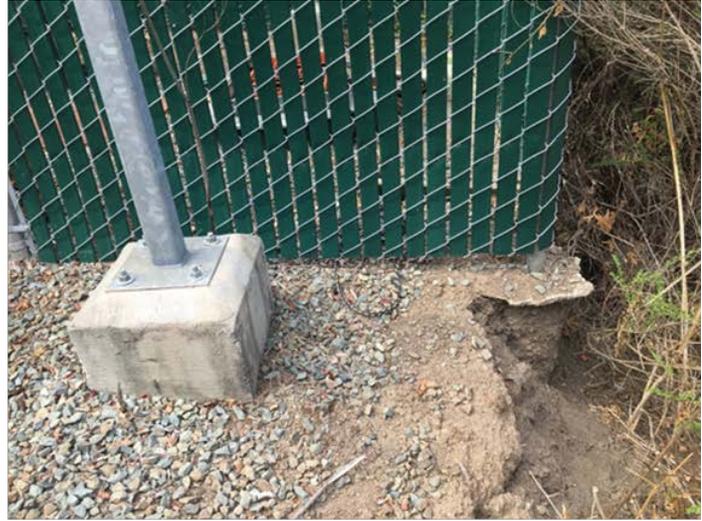
Erosion on East Side of Site

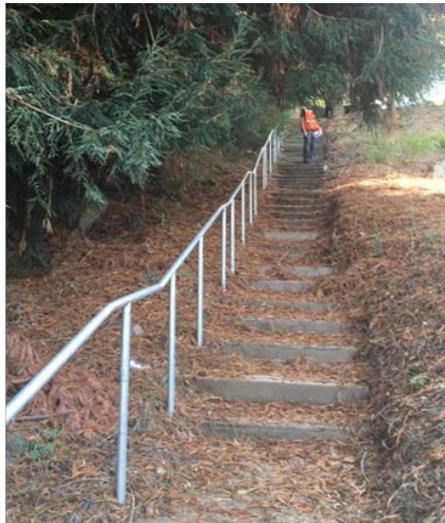
Current Site Access

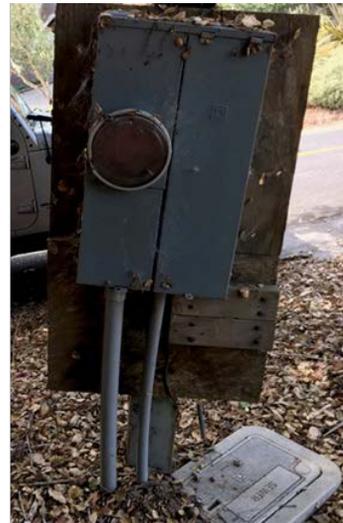
Abandoned Electrical Meter

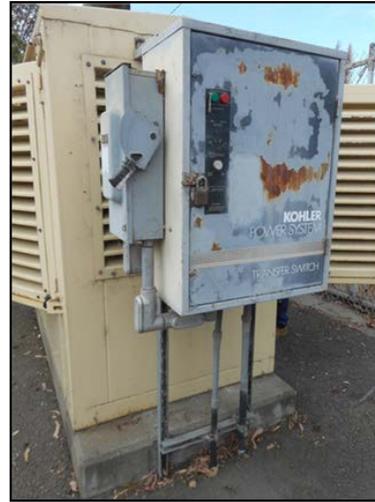
Original Generator Transfer Switch

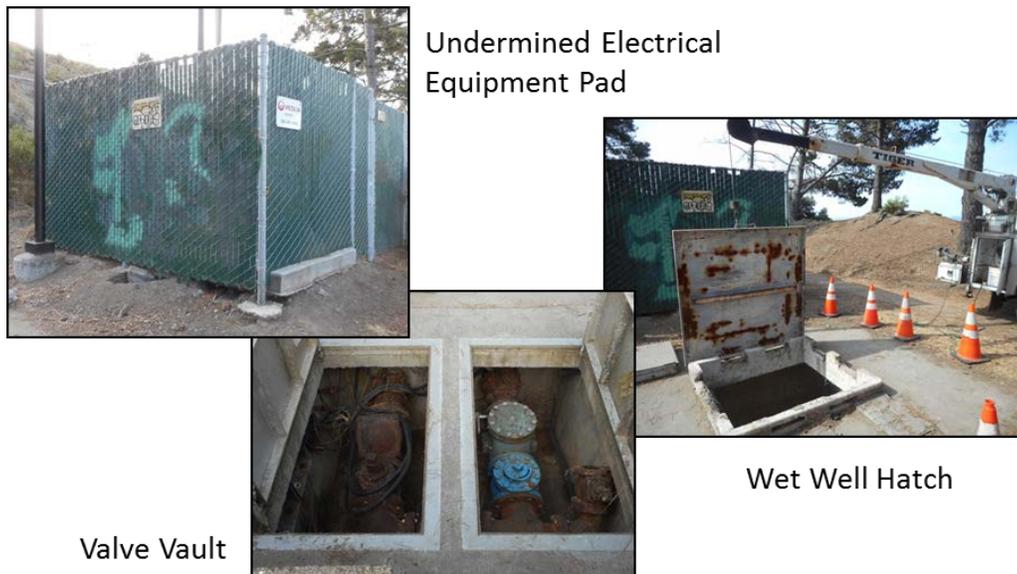
Figure 4-13. Keller Beach Lift Station Features

V&A's evaluation of the Keller Beach force main is included in the Force Main System Condition Assessment Report dated January 2016. The Keller Beach Pump Station force main is exposed on the steep hillside east of the lift station between Dornan Road and the railroad tracks. There is visible corrosion on the exposed portion of the force main. However, V&A concluded that only the immediate surface of the pipe exterior is corroded. Also, V&A determined that outside of the limits of the exposed pipe, the depth of cover along the hillside appears to be less than 12 inches.

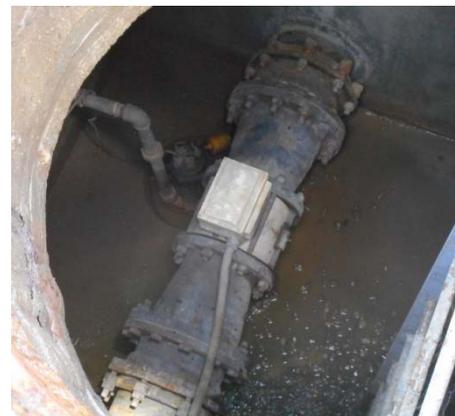
Figure 4-16. Non-Commissioned Flowmeter

2. There is minimal site lighting and no wet well lighting. This makes it difficult for maintenance personnel to work on the station at night during an emergency. Recommend installing manually controlled site and wet well lighting.
3. Recommend removal of antenna mast, which is not in use.
4. Replace PLC in existing enclosure.
5. Provide proper arc flash labels.
6. The 10" discharge pipe elbow within the wet well can be removed for connecting a temporary bypass pipe as needed. One option for a permanent bypass connection of the wet well could involve replacing the 10" elbow with a tee and installing a plug valve downstream of the tee in the wet well. Further design would be required to confirm the feasibility of this approach.
7. An existing flowmeter is currently not in service, and not listed as a system asset (See Figure 4-16). Recommend commissioning the existing flow meter.

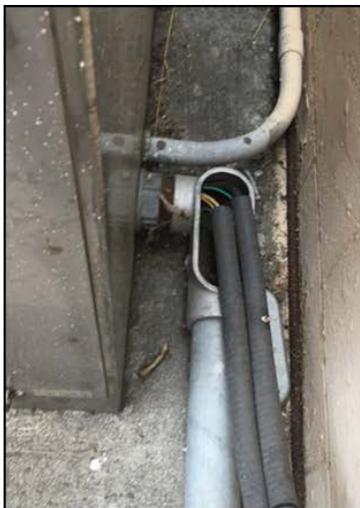
Exposed Wires Behind  
Electrical Panel

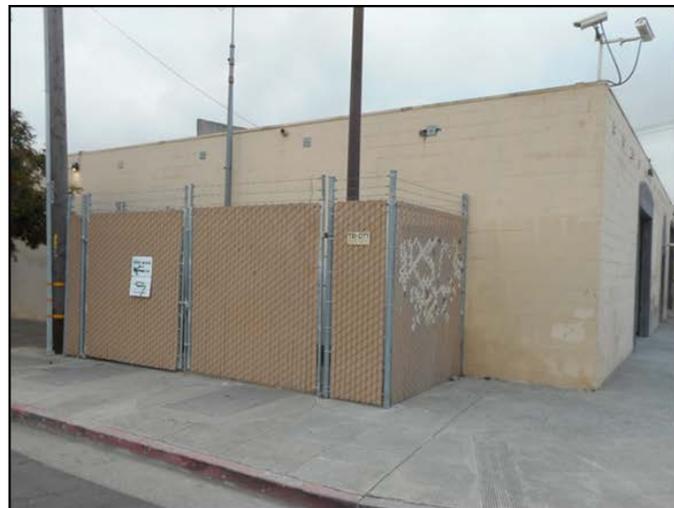
Adjacent Masonry Unit Structure

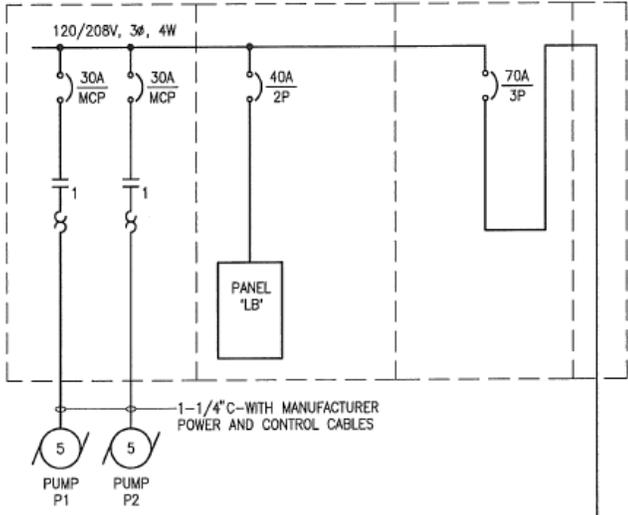
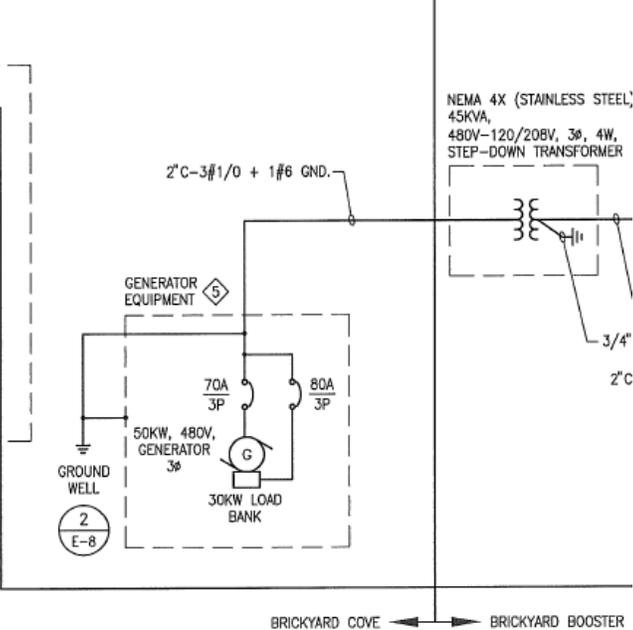
PUMP CONTROL POWER PEDESTAL 'MSB' (BRICKYARD COVE)

Service Size	Amps 70 Volts: 120/208, 3Ø, 4W Meter Number: N/A	Power is fed to this booster pump station from the panel at Brickyard Booster PS which is approximately 1300 feet east of this site. No arc flash labels.
--------------	--	--

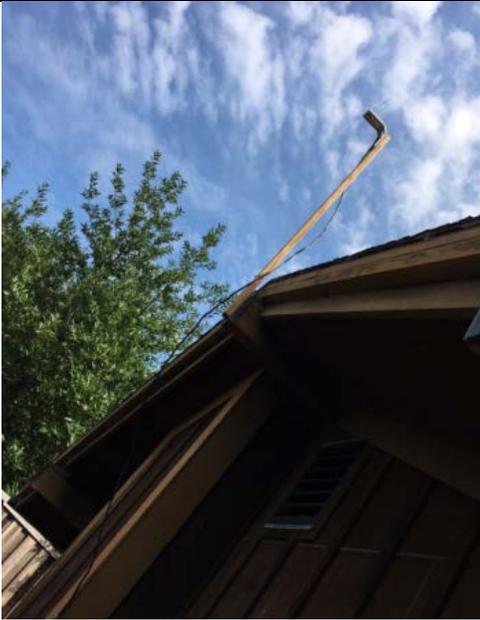
Building and Grounds Assessment – General		
Potential Site Hazards	Overgrown Trees On/Adjacent to Site	<input type="checkbox"/> Yes <input checked="" type="checkbox"/> No
	Adjacent Fire Hazards	<input checked="" type="checkbox"/> Yes; adjacent to a residential house and also at the border of Wildcat Canyon Regional Park <input type="checkbox"/> No
	Adjacent Flood Hazards	<input checked="" type="checkbox"/> Yes; culvert west of generator location. <input type="checkbox"/> No
	Landslide Hazards	<input checked="" type="checkbox"/> Yes; rain induced landslide area; within existing landslide distribution area; within earthquake induced study area <input type="checkbox"/> No
	Liquefaction	<input type="checkbox"/> Yes <input checked="" type="checkbox"/> No
	Lightening	<input checked="" type="checkbox"/> Yes; the antenna mast is made up of wood and attached to the wood building and could be subject to a lightning hit that destroys the Mission System Radio or starts a fire. The antenna shelf must be grounded and the mast should be replaced with grounded metal pole. <input type="checkbox"/> No

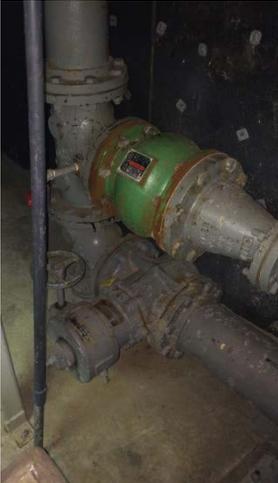
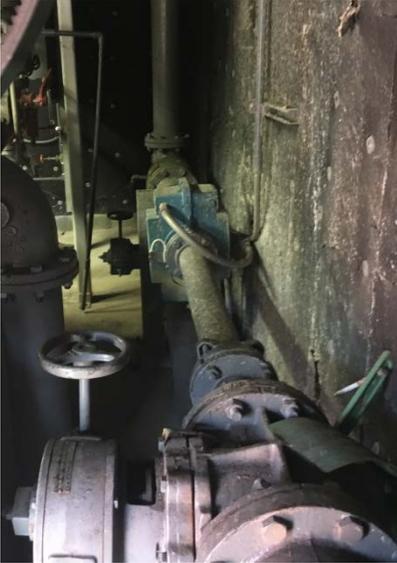
Mechanical Systems Assessment (cont'd)			
<p><b>Common Discharge Piping</b></p>	<p>Type: CIP? Size: 6"</p> <p>Isolation Valve Type: Plug (within PS along S wall Size: 6"</p> <p>Check Valve Type: Check style foot valve Size: 6" Manufacturer: Mueller 105M-AP</p>	<p>Year Constructed 1982</p>	<p>Condition: <input checked="" type="checkbox"/> Good <input type="checkbox"/> Fair <input type="checkbox"/> Poor</p> <p>Comments: The discharge piping from the two pumps is combined into a 6" pipe which is then routed to the south wall of the pump station. The piping is then split into parallel upper and lower piping. The upper pipe includes foot check valve, reducer, flow meter, increaser and plug valve. The lower pipe includes only a plug valve. It is then combined into a single pipeline before exiting the building. Access to piping in difficult.</p>

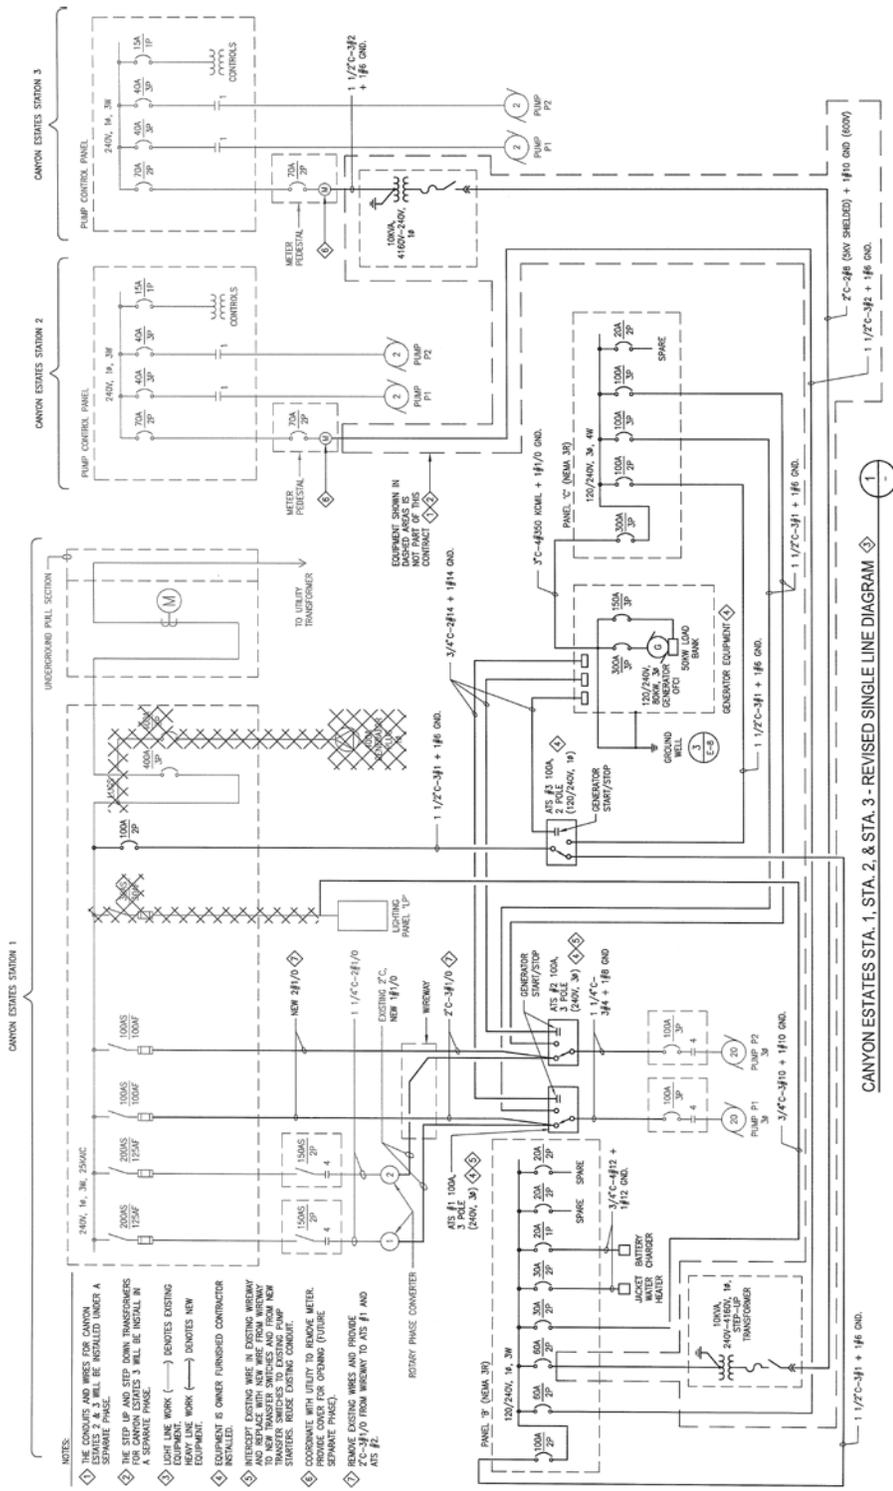
Service Size	Amps: 400 Volts: 120/240, 1P Meter Number: 5000024007	Single phase only. No arc flash labels.
--------------	---	--

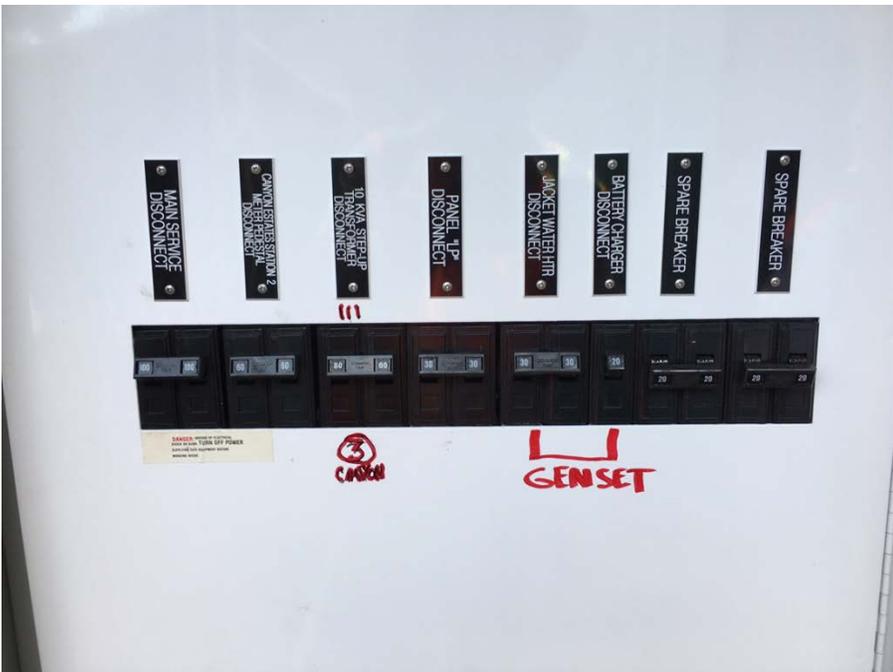
Electrical and Power System Assessment (cont'd)			
Electrical Distribution	Type _____ Manufacturer: Circle-AW Sylvania & Tesco	Year Constructed	Condition: <input type="checkbox"/> Good <input type="checkbox"/> Fair <input type="checkbox"/> Poor Comments: <ul style="list-style-type: none"> <li>The existing Circle AW meter/CT enclosure and Sylvania Distribution panel are past their useful life and should be replaced. Optimally, the new service would be three phase. The pump circuit breakers in the Sylvania panel are mis-labeled roto phase units and are a safety issue. The first [older] Sylvania pump starter enclosures are redundant and a safety issue because they are misleading; the Croy labels on them indicate power is from the non-existent Roto Phase units. All the equipment described herein should be removed and/or replaced.</li> <li>The newer VFD should be rewired to be after the three pole ATS if three phase power can be brought to the site (or possibly removed completely).</li> <li>All of the straightforward questions regarding manufacturers and ratings are impossible to answer on this project without deconstructing the controls. Veolia described how the system operated but it was so complex as to make these simple questions irrelevant.</li> <li>The breakers provided by Tesco in the 2005 expansion are panelboard type not molded case (the industry standard). This is likely because of the way the 2005 specifications were written in respect to 240/120 V, single phase systems.</li> <li>One of the Tesco panels has a breaker mis-labeled "Main Service Disconnect". This is a code violation and a safety issue and should be corrected.</li> <li>No arc flash labels.</li> </ul> MCC Industry Std. Remaining Life: 0 and 10 Years

Main Motor Protector Load : 100A Frame Amps: 400A Trip Amps: 400A	Year Constructed	
	Main Load Starter/VFD Load _____ Manufacturer _____ Model No. _____ Size: _____	Year Constructed	
	Main Load Starter/VFD Load _____ Manufacturer _____ Model No. _____ Size: _____	Year Constructed

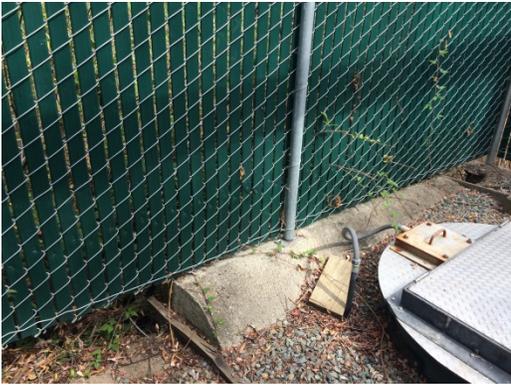
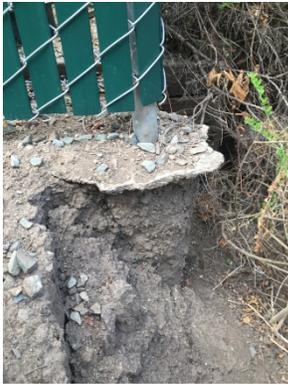
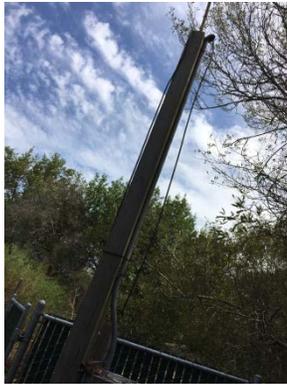
Building and Grounds Assessment – General		
Potential Site Hazards	Overgrown Trees On/Adjacent to Site	<input checked="" type="checkbox"/> Yes; There are trees/shrubs adjacent to the fence. There is minor overgrowth onto the site but in general it appears that the trees/shrubs are kept trimmed. <input type="checkbox"/> No
	Adjacent Fire Hazards	<input checked="" type="checkbox"/> Yes; Surrounded by vegetation, adjacent to open space. <input type="checkbox"/> No
	Adjacent Flood Hazards	<input type="checkbox"/> Yes <input checked="" type="checkbox"/> No, Outside FEMA flood zone (100/500).
	Landslide Hazards	<input checked="" type="checkbox"/> Yes; within rain induced landslide area; within existing landslide distribution area; within earthquake induced study area <input type="checkbox"/> No
	Liquefaction	<input type="checkbox"/> Yes <input checked="" type="checkbox"/> No
	Lightening	<input checked="" type="checkbox"/> Yes; The antenna mast is made up of wood and could be subject to a lightning hit that destroys the Mission System Radio or starts a fire. The antenna shelf must be grounded and the mast should be replaced with grounded metal pole. <input type="checkbox"/> No

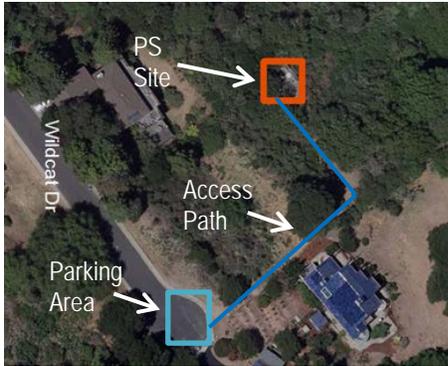
Building and Grounds Assessment – Site Evaluation			
<p><b>Fencing</b></p>	<p>Type</p> <p><input type="checkbox"/> Wood</p> <p><input type="checkbox"/> Steel</p> <p><input type="checkbox"/> CMU</p> <p><input checked="" type="checkbox"/> Chain Link</p> <p><input type="checkbox"/> Other _____</p> <p>Gate Type:</p> <p>Double swing 8' panels</p> <p>Lockable? Yes</p>	<p>Year Constructed</p>	<p>Condition:</p> <p>Exterior: <input checked="" type="checkbox"/> Good <input type="checkbox"/> Fair <input type="checkbox"/> Poor</p> <p>Interior: <input checked="" type="checkbox"/> Good <input type="checkbox"/> Fair <input type="checkbox"/> Poor</p> <p>Comments:</p> <ul style="list-style-type: none"> <li>• The fence itself is in good shape however the soil around the fence post piers has eroded; post is compromised.</li> <li>• Add barbed wire to top.</li> </ul>
<p><b>Access</b></p>	<p>Surfacing</p> <p><input type="checkbox"/> Asphalt</p> <p><input type="checkbox"/> Concrete</p> <p><input checked="" type="checkbox"/> All weather gravel</p> <p><input type="checkbox"/> Other _____</p> <p>Parking/Vehicle Access</p> <p>None</p> <p>Truck Accessible? No</p>	<p>Year Constructed</p>	<p>Condition: <input type="checkbox"/> Good <input type="checkbox"/> Fair <input type="checkbox"/> Poor</p> <p>Comments:</p> <ul style="list-style-type: none"> <li>• Access to the site is difficult. Site must be accessed via stairs and a dirt path. There is no vehicular access.</li> <li>• Stairs are in poor condition</li> </ul>

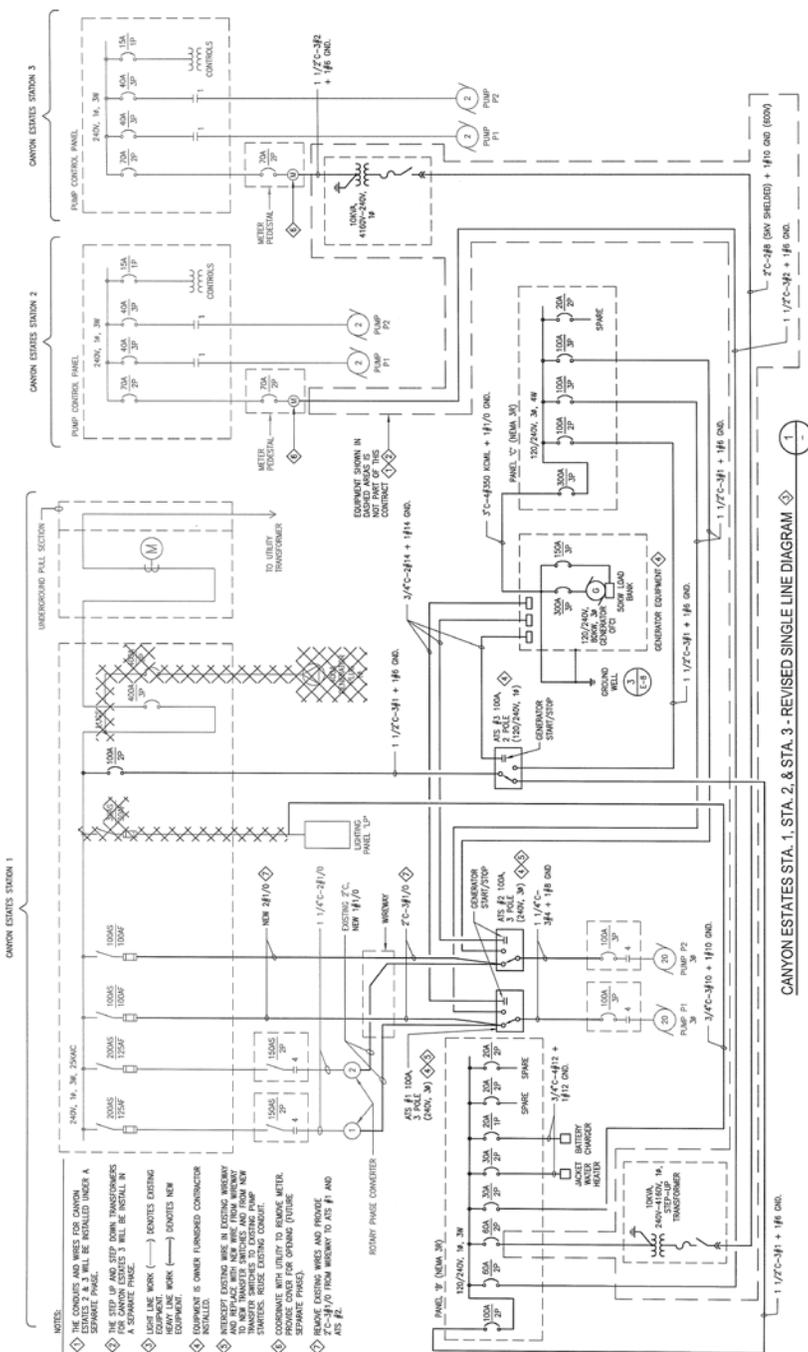
Amps: No utility service, but 60/2 breaker at Canyon Estates #1 and similar 70/2 main disconnect on site  
Volts: 240 1Ø  
Meter Number: N/A – Power is fed from Canyon Estates #1 PS

- Main breaker is not labeled as required by code.
- Both breakers should be replaced if the service at Canyon Estates #1 is upgraded.

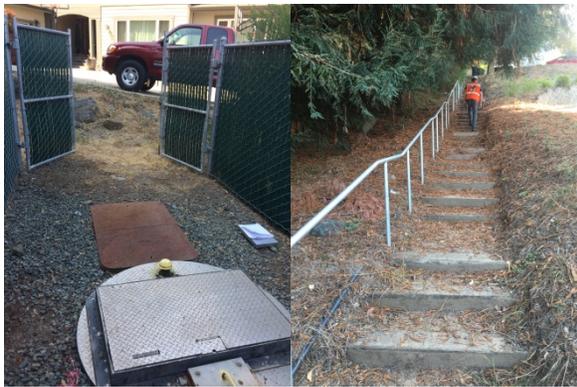
Building and Grounds Assessment – Site Evaluation			
<b>Fencing</b>	Type <input type="checkbox"/> Wood <input type="checkbox"/> Steel <input type="checkbox"/> CMU <input checked="" type="checkbox"/> Chain Link <input type="checkbox"/> Other _____  Gate Type: Double swing 8' panels  Lockable? Yes	Year Constructed	Condition: Exterior: <input checked="" type="checkbox"/> Good <input type="checkbox"/> Fair <input type="checkbox"/> Poor Interior: <input checked="" type="checkbox"/> Good <input type="checkbox"/> Fair <input type="checkbox"/> Poor Comments:
<b>Access</b>	Surfacing <input type="checkbox"/> Asphalt <input type="checkbox"/> Concrete <input checked="" type="checkbox"/> All weather gravel <input checked="" type="checkbox"/> Other: Dirt  Parking/Vehicle Access  Number of parking spaces There is an adjacent residence that allows trucks to park in the driveway if required.  Truck Accessible? Yes	Year Constructed	Condition: <input type="checkbox"/> Good <input type="checkbox"/> Fair <input type="checkbox"/> Poor Comments: <ul style="list-style-type: none"> <li>Access to the site is either by parking on the street and walking down a long set of stairs or by getting permission from nearby resident to park in the driveway.</li> <li>Stairs have non-standard riser/tread</li> </ul>

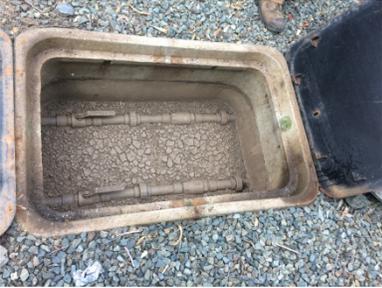
<b>Valve Box</b>	Size: 2' x 3' (approx.)  Material: Concrete Valve Box  Coating: N/A  Personnel Accessibility: N/A  Equipment Ingress/Egress: N/A  Housekeeping Good	Year Constructed 2001	Condition: Exterior: <input type="checkbox"/> Good <input type="checkbox"/> Fair <input type="checkbox"/> Poor <input checked="" type="checkbox"/> Not visible/below grade Interior: <input checked="" type="checkbox"/> Good <input type="checkbox"/> Fair <input type="checkbox"/> Poor Comments: <ul style="list-style-type: none"> <li>Flooded valve vault – seasonal. (TB under 'suction piping')</li> </ul> <div style="text-align: center;">

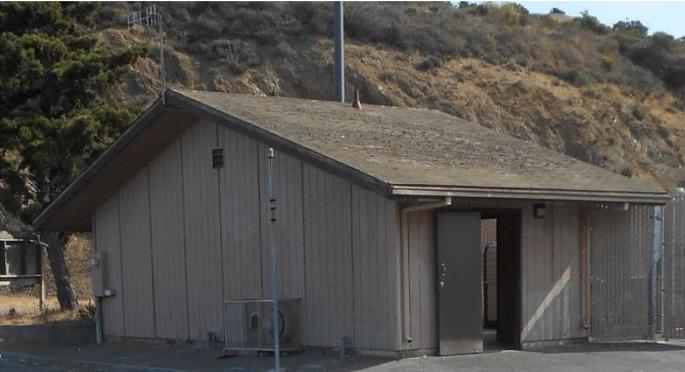
<b>Control/Electrical Building</b>	<p>Size: 31 ft by 14 ft divided into two separate rooms – area above dry well and separate storage area</p> <p>Material: Wood frame/Wood Siding</p> <p>Coating: Paint</p> <p>Roof type: Asphalt shingles</p> <p>Date of Latest Repair _____</p> <p>Roof Condition: Poor</p> <p>Personnel Accessibility Storage area – two 36” doors Above dry well – one 36” door</p> <p>Equipment Ingress/Egress Storage area – two 36” doors Above dry well – one 36” door</p> <p>Housekeeping Fair</p>	<p>Year Constructed</p> <p>1962</p>	<p>Condition: Exterior: <input type="checkbox"/> Good <input checked="" type="checkbox"/> Fair <input type="checkbox"/> Poor Interior: <input type="checkbox"/> Good <input checked="" type="checkbox"/> Fair <input type="checkbox"/> Poor</p> <p>Comments:</p> <ul style="list-style-type: none"> <li>• Superstructure is divided into two rooms. An approximately 16' x 14' room includes the electrical and telemetry panels and also the access to the dry well. The second room serves as a storage area.</li> <li>• Need drawings – when built? 1962 drawings don't show building.</li> <li>• Gutters/downspouts are corroded/non-existent</li> <li>• Roof shingles past expected life.</li> <li>• Abandoned and partially abandoned electrical equipment should be removed or removed and replaced (simplified).</li> <li>• Structural Evaluation Site specific spectral response acceleration short period (S<sub>s</sub>) → 1.512g Site specific spectral response acceleration 1-sec (S<sub>1</sub>) → 0.600g <u>FEMA P-154</u> Probability of collapse 1x10<sup>1.8</sup> (1 in 63 following MCE) <u>ASCE/SEI 41 Tier 1</u> 10 noncompliant conditions identified</li> </ul> <div style="text-align: center; margin-top: 10px;">

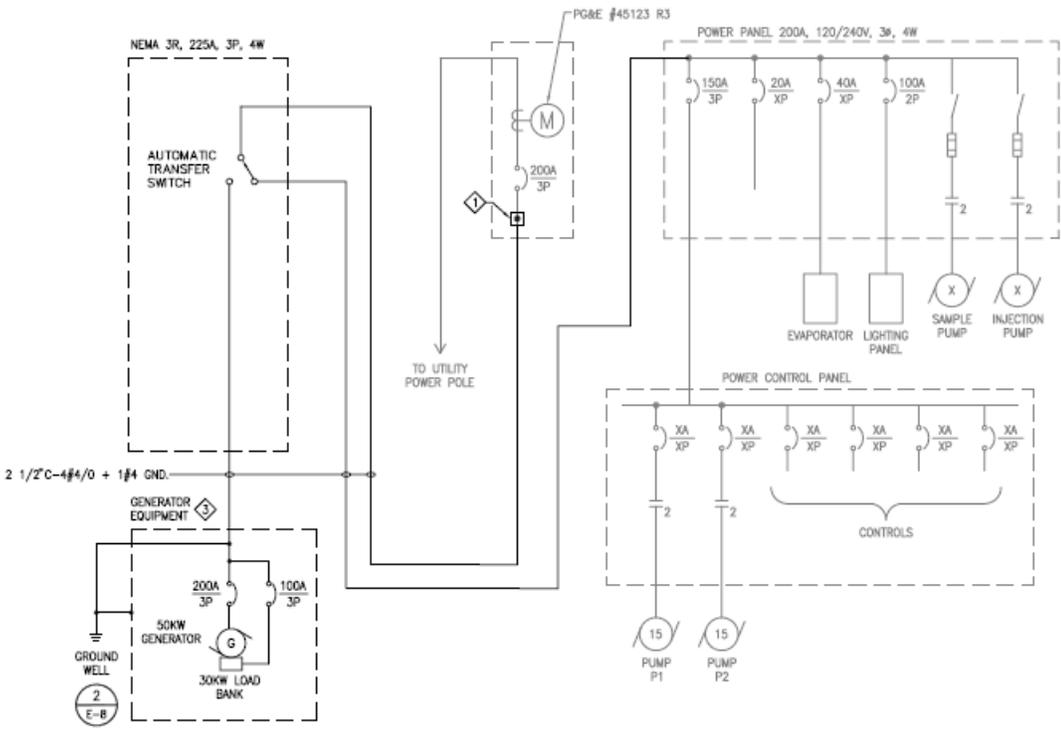
<b>Service Size</b>	Amps: 200 Volts: 120/240 3Ø Meter Number: 1009919762		Original 1962 unit in poor condition. No arc flash labels.
---------------------	--	--	---

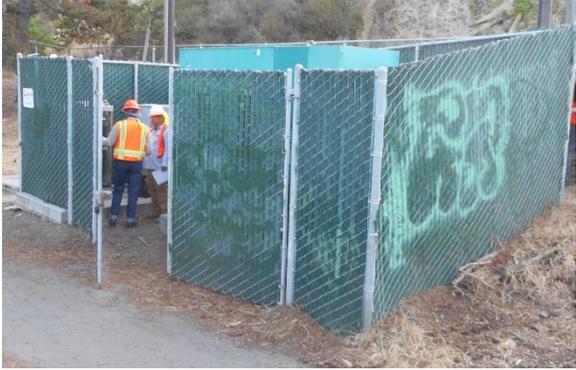
Building and Grounds Assessment – Site Evaluation			
<p><b>Fencing</b></p>	<p>Type</p> <p><input type="checkbox"/> Wood</p> <p><input type="checkbox"/> Steel</p> <p><input type="checkbox"/> CMU</p> <p><input checked="" type="checkbox"/> Chain Link</p> <p><input type="checkbox"/> Other _____</p> <p>Gate Type: 6' Double panels</p> <p>Lockable? Yes</p>	<p>Year Constructed</p>	<p>Condition:</p> <p>Exterior: <input type="checkbox"/> Good <input checked="" type="checkbox"/> Fair <input type="checkbox"/> Poor</p> <p>Interior: <input checked="" type="checkbox"/> Good <input type="checkbox"/> Fair <input type="checkbox"/> Poor</p> <p>Comments:</p> <ul style="list-style-type: none"> <li>• Problems with graffiti in this location.</li> </ul>

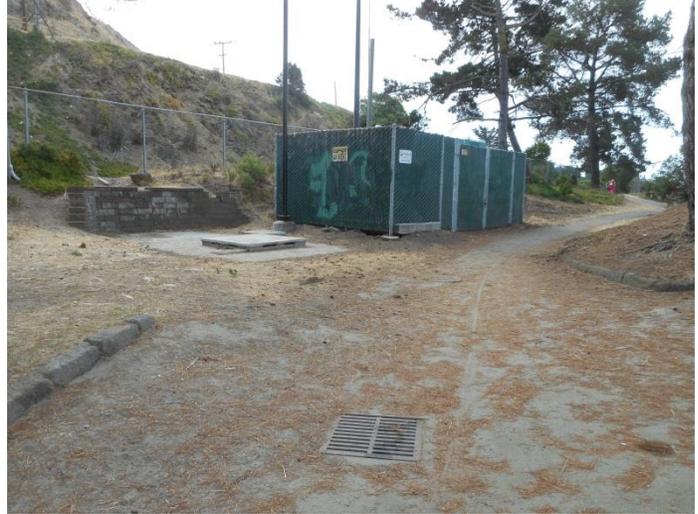
- A SSO would drain to nearby storm drain.

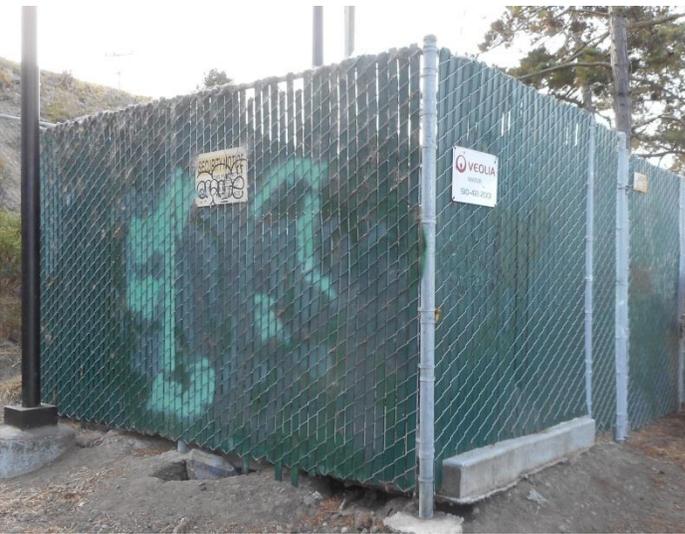
Building and Grounds Assessment – Structural - Other			
<p><b>Control/Electrical Enclosure Area</b></p>	<p>Fenced Area: Approx. 21' x 14'</p> <p>Includes: Concrete pad for telemetry and electrical panel and ATS : 6'-0" x 12'-8"</p> <p>Separate generator pad</p> <p>Balance of surface within fenced area is gravel.</p> <p>Equipment Ingress/Egress Via double swing 6' wide gates</p> <p>Housekeeping Good</p>	<p>Year Constructed 2006/11</p>	<p>Condition:  <input type="checkbox"/> Good   <input checked="" type="checkbox"/> Fair   <input type="checkbox"/> Poor</p> <p>Comments:  <ul style="list-style-type: none"> <li>• Concrete pad for panels and ATS has been undermined by ground squirrels.</li> <li>• Need site lighting.</li> <li>• Structural Evaluation  Site specific spectral response acceleration short period (S<sub>s</sub>) → 1.560g  Site specific spectral response acceleration 1-sec (S<sub>1</sub>) → 0.612g</li> </ul> </p> <div style="text-align: center;">

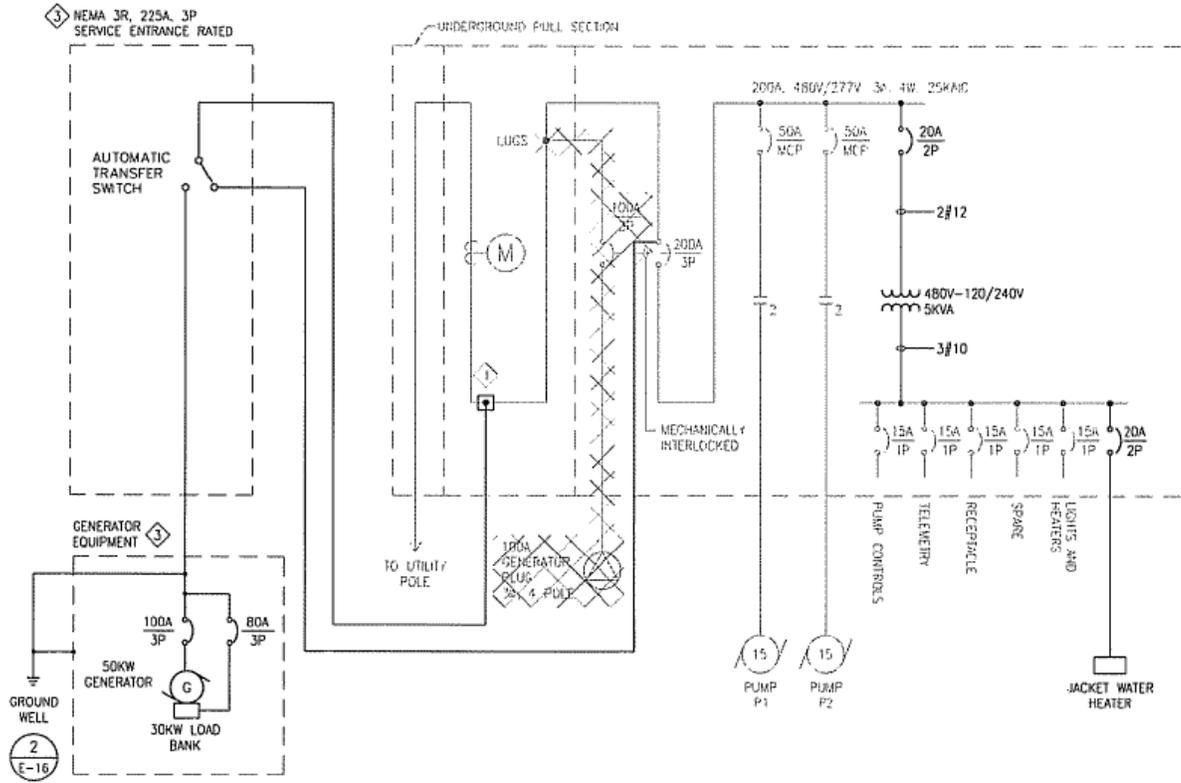
<p><b>Service Size</b></p>	<p>Amps : (200 Amps per Boyle Drawings) Volts: 480/277 Meter Number: 1006473169</p>	<p>Pedestal mounted meter in good condition No arc flash labels.</p>
----------------------------	---	--

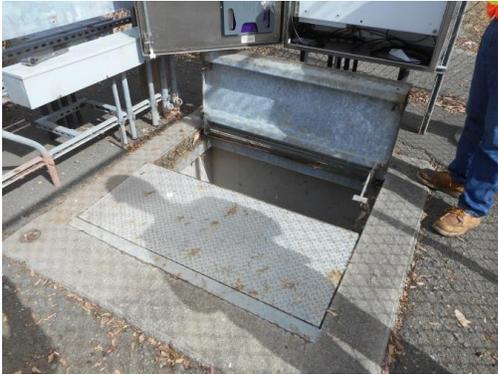
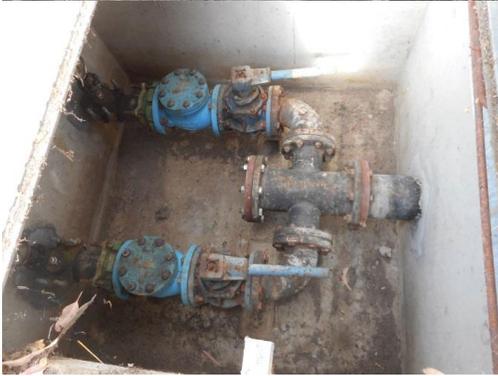
<p><b>Valve Vault</b></p>	<p>Size: 6' x 5' x 4'</p> <p>Material: Concrete</p> <p>Coating: None</p> <p>Personnel Accessibility                  Double leaf hatch approx. 5' x 5' opening</p> <p>Equipment Ingress/Egress                  Truck mounted crane</p> <p>Housekeeping                  Good</p>	<p>Year                  Constructed</p>	<p>Condition:                  Exterior: <input type="checkbox"/> Good <input type="checkbox"/> Fair <input type="checkbox"/> Poor <input checked="" type="checkbox"/> Not visible/below grade                  Interior: <input type="checkbox"/> Good <input checked="" type="checkbox"/> Fair <input type="checkbox"/> Poor</p> <p>Comments:</p> <ul style="list-style-type: none"> <li>• Hatch does not have safety grate.</li> <li>• Localized corrosion on hatch</li> </ul>

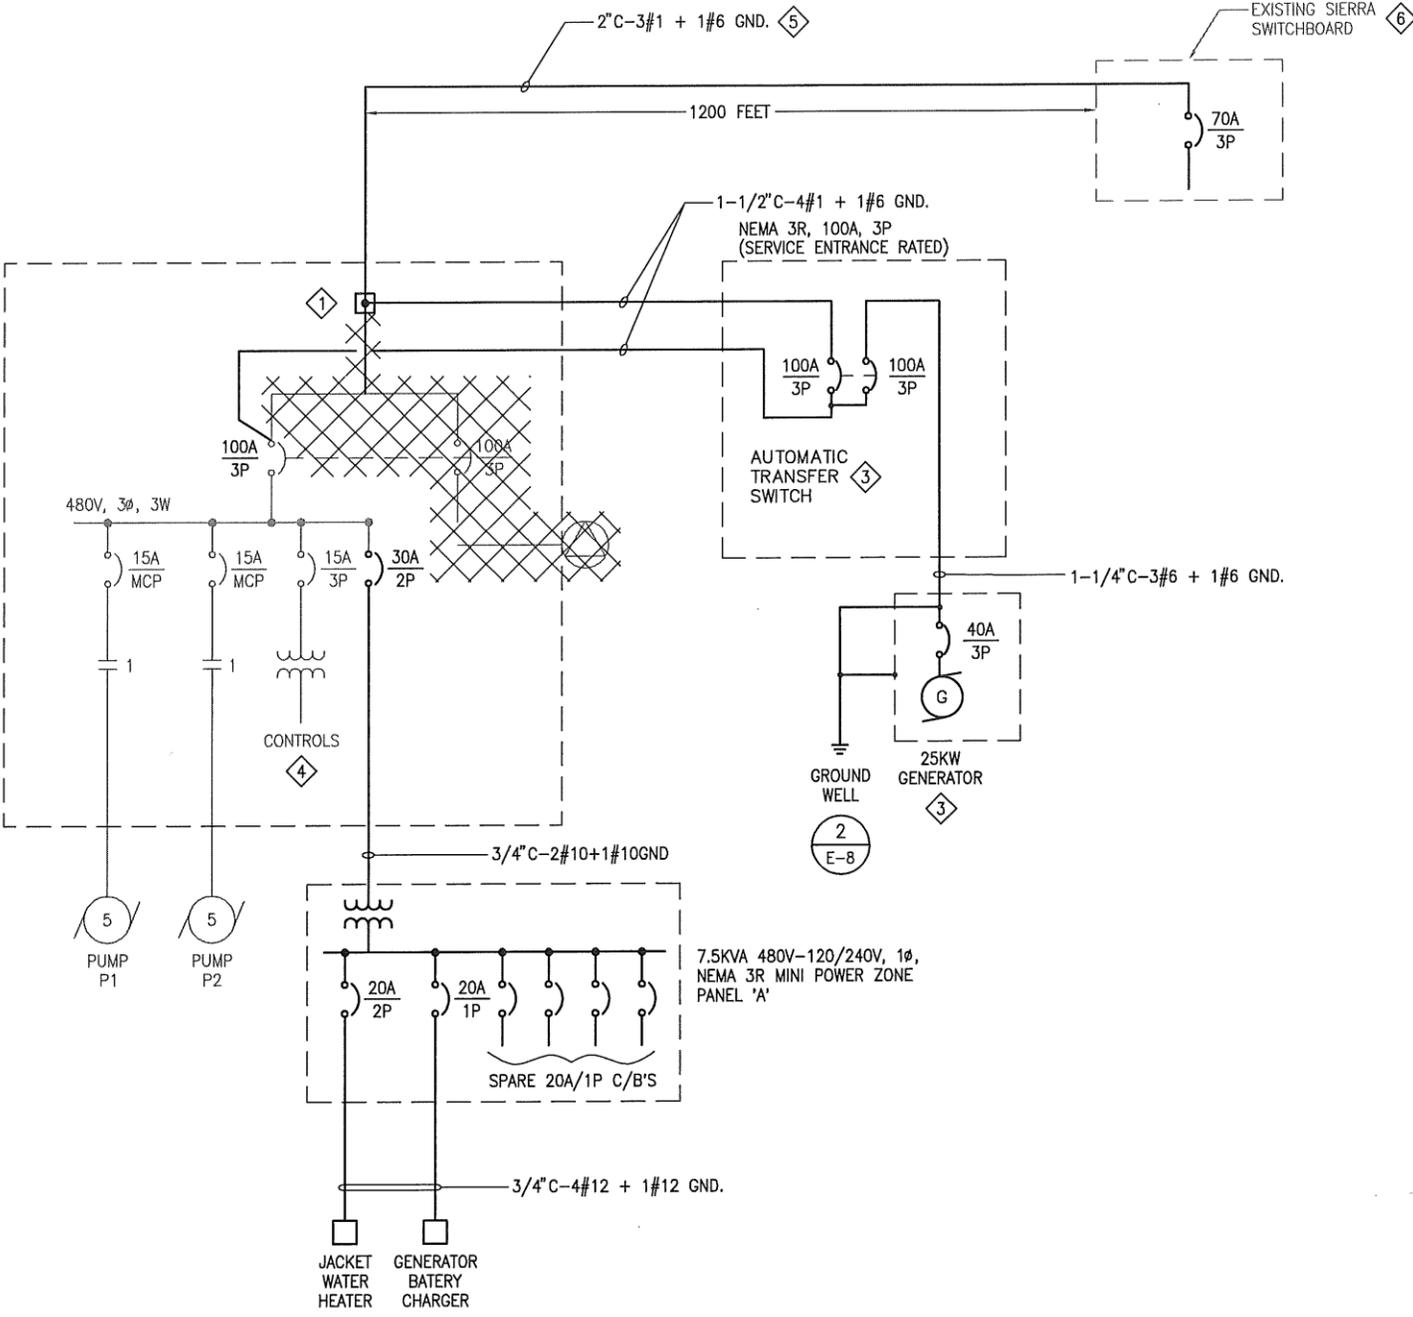
Service point is in the park in a common enclosure over 1000 feet away from the station. The remote equipment is in poor condition and poorly maintained. It appears to be near its end of life. There is a pullbox between the station and the service located in the landscaped area.  
No arc flash labels.

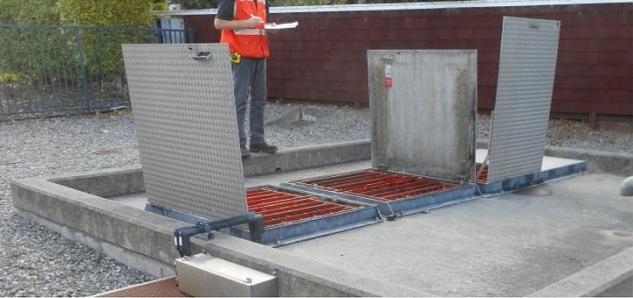
Building and Grounds Assessment – Structural – Pump Station			
<b>Wet Well</b>	<p>Size: 12'-11" x 14'-0" x 23'-9"</p> <p>Material: Concrete</p> <p>Coating: None</p> <p>Operating Volume: ____cf</p> <p>Personnel Accessibility There are two 3' x 4' hatches and one 5'x4' double leaf hatch, all with hold open arm and safety grate. Access ladder on south side of wet well.</p> <p>Equipment Ingress/Egress Via SST guide bars and the assistance of a utility truck.</p> <p>Grease/Cleanliness Some grease present. Wet well gets hosed down with potable water annually to eliminate grease buildup.</p>	<p>Year Constructed</p>	<p>Condition: Exterior: <input type="checkbox"/> Good   <input type="checkbox"/> Fair   <input type="checkbox"/> Poor   <input checked="" type="checkbox"/> Not visible/below grade Interior: <input checked="" type="checkbox"/> Good   <input type="checkbox"/> Fair   <input type="checkbox"/> Poor</p> <p>Comments:  <ul style="list-style-type: none"> <li>The 2006 drawings indicate that the 10" discharge pipe elbow within the wet well can be removed for connecting temporary bypass pipe as needed. Manhole in street in front of station can be used for bypassing directly to the pipe after removing the discharge pipe elbow. Need isolation valve between pump and bypass connection</li> <li>Access ladder is corroded.</li> </ul> </p> <div style="text-align: center;">

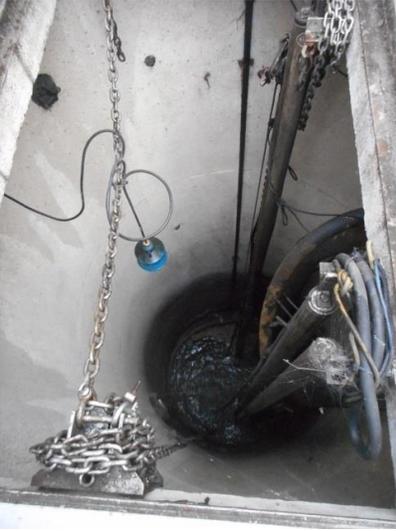
<b>Wet Well</b>	Size: 6' I.D. x 22.7'  Material: Concrete  Coating: None  Operating Volume: ____cf  Personnel Accessibility N/A  Equipment Ingress/Egress Single leaf hatch approx. 48' x 30", no safety grate SST Guide Bars  Grease/Cleanliness Good	Year Constructed	Condition: Exterior: <input type="checkbox"/> Good <input type="checkbox"/> Fair <input type="checkbox"/> Poor <input checked="" type="checkbox"/> Not visible/below grade Interior: <input checked="" type="checkbox"/> Good <input type="checkbox"/> Fair <input type="checkbox"/> Poor Comments: <ul style="list-style-type: none"> <li>Minor corrosion on hatch but hatch needs replaced for safety grate inclusion anyway.</li> <li>Minor area of exposed aggregate but overall in good condition.</li> </ul>

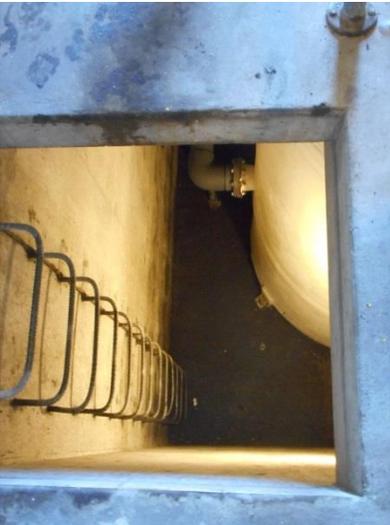
Building and Grounds Assessment – Structural – Pump Station			
<b>Wet Well</b>	<p>Size: 7' dia. x 13'-5"</p> <p>Material: FRP</p> <p>Coating: None</p> <p>Operating Volume: ____cf</p> <p>Personnel Accessibility Access into area outside of FRP tank via ladder in 2'x2' opening</p> <p>Equipment Ingress/Egress Through double leaf safe-hatch in conjunction with ceiling mounted hoist or floor mounted jib crane</p> <p>Grease/Cleanliness Good</p>	<p>Year Constructed</p>	<p>Condition:                      Exterior: <input checked="" type="checkbox"/> Good    <input type="checkbox"/> Fair    <input type="checkbox"/> Poor                      Interior: <input checked="" type="checkbox"/> Good    <input type="checkbox"/> Fair    <input type="checkbox"/> Poor                      Comments:                      • New round FRP wet well tank was installed within a rectangular room below grade. The wet well room is accessed through a 2' x 2' opening in the northwest corner of the room via a ladder. Confined space</p> <div style="text-align: center;">

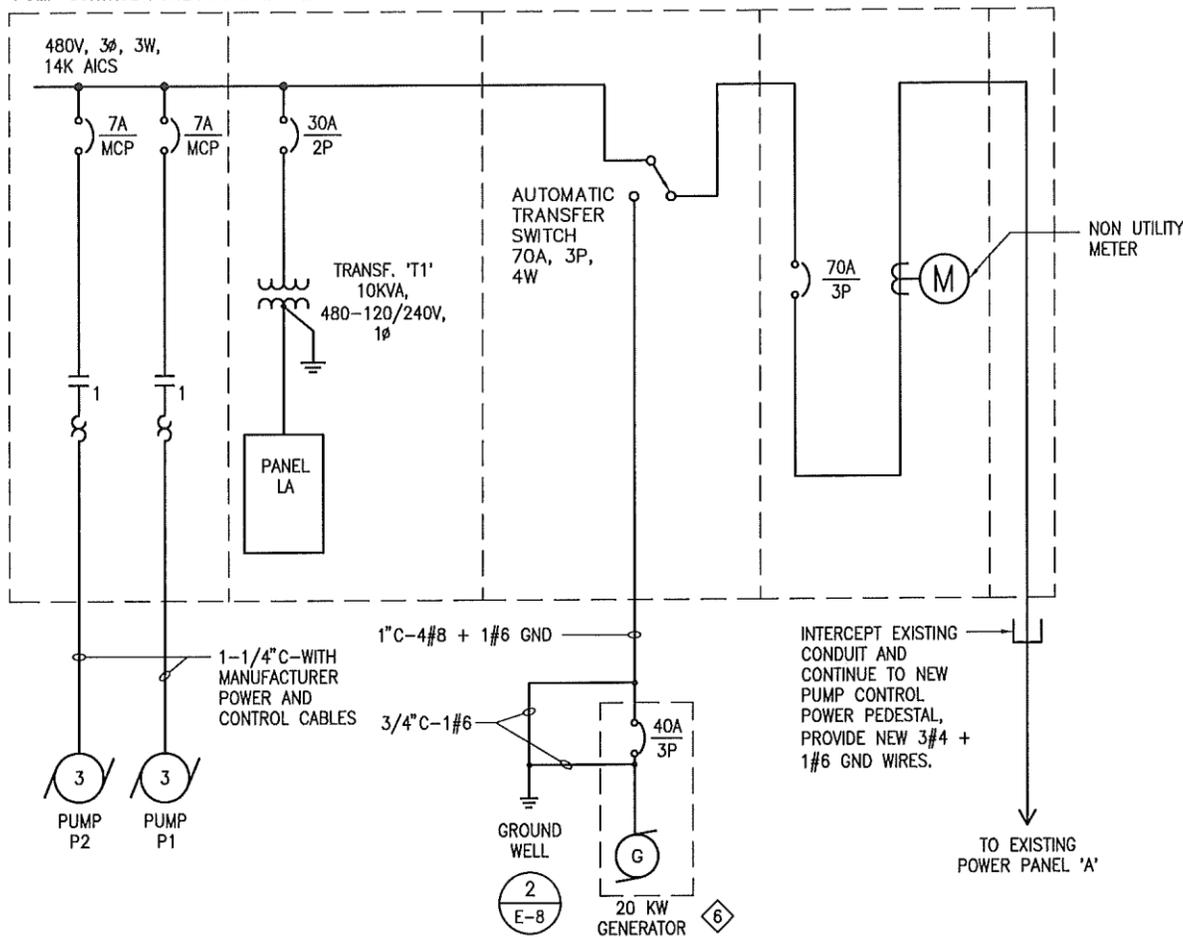
PUMP CONTROL POWER PEDESTAL 'MSA'

No arc flash labels.

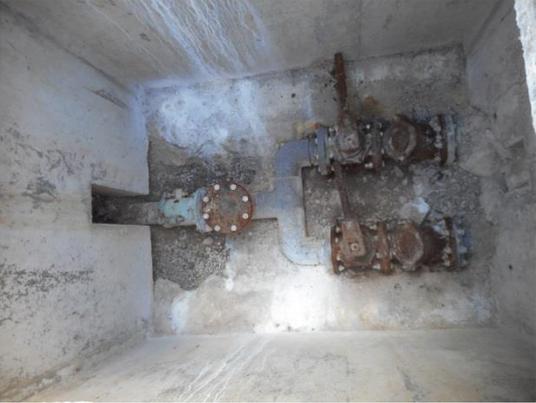
Building and Grounds Assessment – Structural – Pump Station			
<b>Wet Well</b>	Size: 5 ft. dia. X 16 ft.  Material: Concrete  Coating: None  Operating Volume: ____cf  Personnel Accessibility N/A  Equipment Ingress/Egress Single leaf hatch approx. 48' x 30", no safety grate SST Guide Bars  Grease/Cleanliness Fair	Year Constructed	Condition: Exterior: <input type="checkbox"/> Good <input type="checkbox"/> Fair <input type="checkbox"/> Poor <input checked="" type="checkbox"/> Not visible/below grade Interior: <input checked="" type="checkbox"/> Good <input type="checkbox"/> Fair <input type="checkbox"/> Poor  Comments: <ul style="list-style-type: none"> <li>• Reentrant corner cracks at hatch.</li> </ul>
<b>Valve Vault</b>	Size: ____ft by ____ft by ____ft  Material: Concrete  Coating: None  Personnel Accessibility N/A  Equipment Ingress/Egress Via utility truck  Housekeeping Fair	Year Constructed 1995	Condition: Exterior: <input type="checkbox"/> Good <input type="checkbox"/> Fair <input type="checkbox"/> Poor <input checked="" type="checkbox"/> Not visible/below grade Interior: <input type="checkbox"/> Good <input checked="" type="checkbox"/> Fair <input type="checkbox"/> Poor  Comments: <ul style="list-style-type: none"> <li>• Pipe penetrations enlarged with sledge hammer.</li> <li>• Piping has extensive corrosion.</li> </ul> <div style="text-align: center;">
