REVITALIZATION OF HISTORIC RICHMOND MAIN LIBRARY

EXECUTIVE SUMMARY

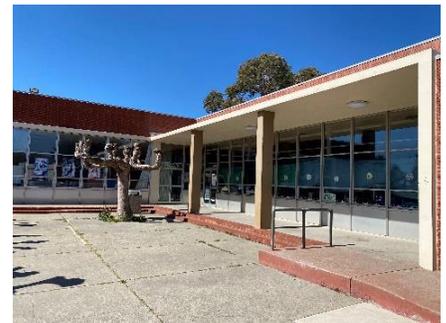
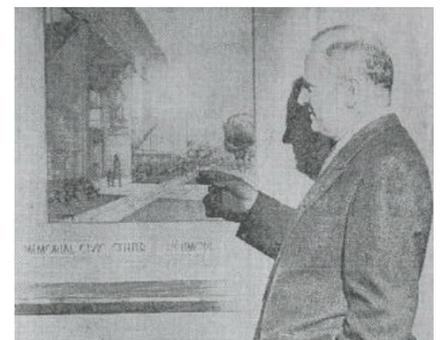
Challenge: The Main Library does not have a fire alarm system or an automatic fire sprinkler system.

Solution: Install a modern fire alarm and automatic fire sprinkler system.
