CITY OF RICHMOND, CA. FORCE MAIN SYSTEM CONDITION ASSESSMENT REPORT

Prepared for: Veolia Water North America
601 Canal Blvd
Richmond, CA 94804

Date: January 2016

V&A Project No. 14-0338

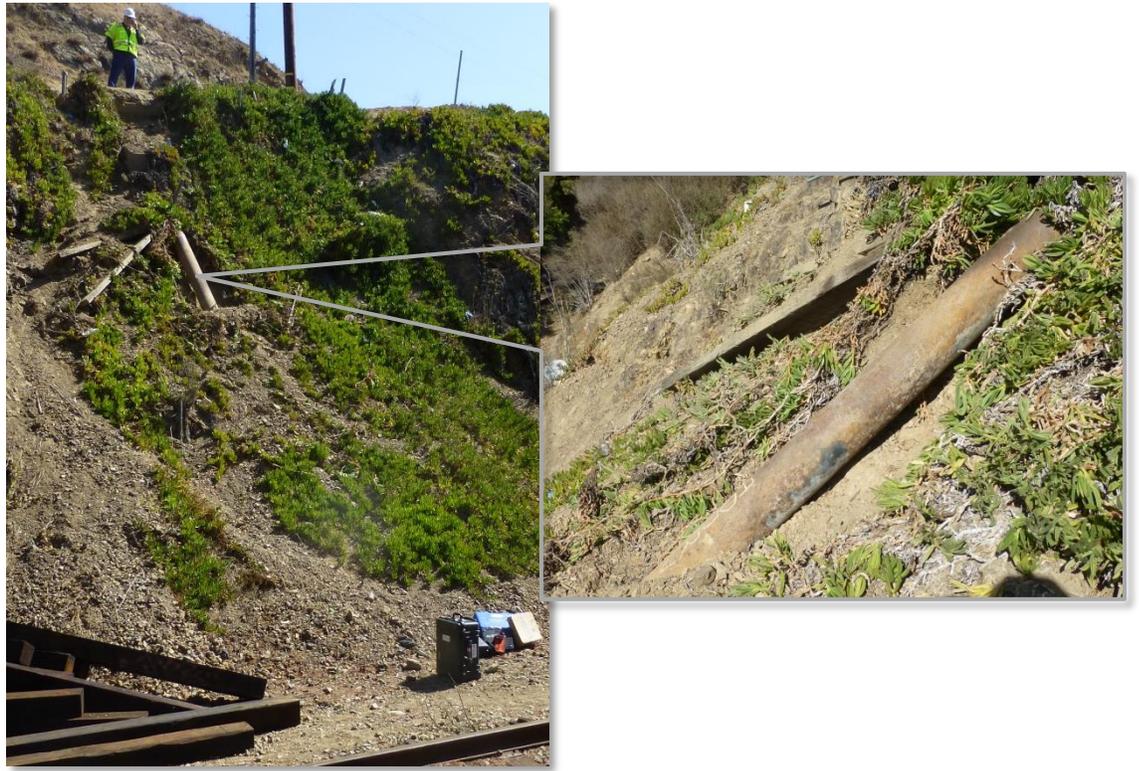
Photo 2-2. Exposed Force Main near Keller Beach: prepared site prior to assessment

The 8-inch diameter ductile iron pipe (DIP) discharge force main at the Keller Beach Pump Station was exposed on a steep hillside above the railroad tracks between the pump station and Dorman Drive (Photo 2-2). The pipe exterior is corroded, but only at the immediate surface. No significant pitting or pipe wall thinning was visually observed. A second partially buried DIP was noted west of the exhumed pipe. The tested pipe was confirmed as the force main by an Lmic sonic test conducted while the wet well pump was running.

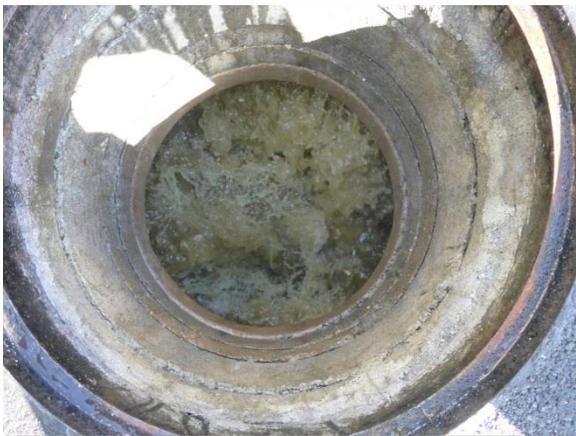
Photo 3-1. Plan View of Marina Bay Discharge Manhole During Discharge

The discharge manhole in the Marina Bay Parkway force main system was generally in good condition and was sealed well to the pipe connections. The pipe connections included the force main and a gravity outlet. The force main was black plastic (possibly HDPE) and was approximately 9.375 inches in diameter in the vertical direction and 9.5 inches in diameter in the horizontal direction. The gravity outlet was white plastic (also possibly HDPE) measuring approximately 14.25 inches in diameter, and oriented 90 degrees to the influent pipe. During the pump cycle, the discharged water became quite turbulent (Photo 3-1). The pipes are clear of debris and buildups except for minor thin apparent grease coatings on the wall surfaces (Photo 3-2 and Photo 3-3). A thin mortar layer on the manhole concrete surface is chipping off in places (Photo 3-4).

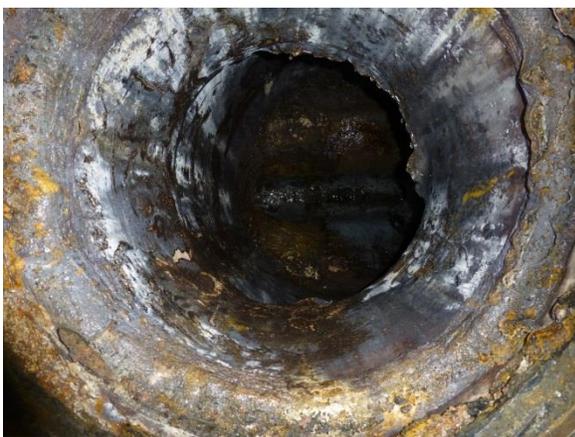
Photo 3-10. Plan View into the Ferry Point & Keller Beach Discharge Manhole

The Ferry Point & Keller Beach discharge manhole is located in the eastbound lane of Dorman Drive at Garrard Boulevard, which is at the east entrance to the Ferry Point Tunnel. The manhole is completely coated on the inside surfaces (Photo 3-10), and the coating has completely failed in the manhole (Photo 3-11). Near the top of the manhole the liner has pulled away from the wall below the ring, and the underlying concrete is soft and crumbly (Photo 3-12). Similar liner detachment from the concrete substrate is observed at the bottom of the manhole riser (Photo 3-13). The liner is brittle and easily punctured. An in situ pH reading could not be made because the concrete was too soft. From past experience, it is likely the concrete pH is 4 or lower. The concrete, where exposed, is rated a VANDA Level 3. No exposed reinforcing steel was seen.

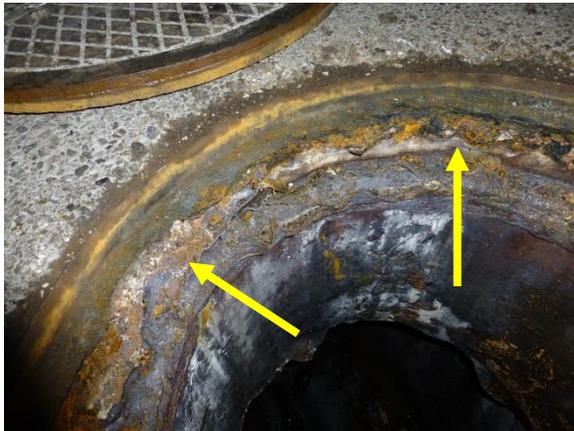
Photo 3-12. Liner Pulled Away From the Concrete Near the Manhole Ring

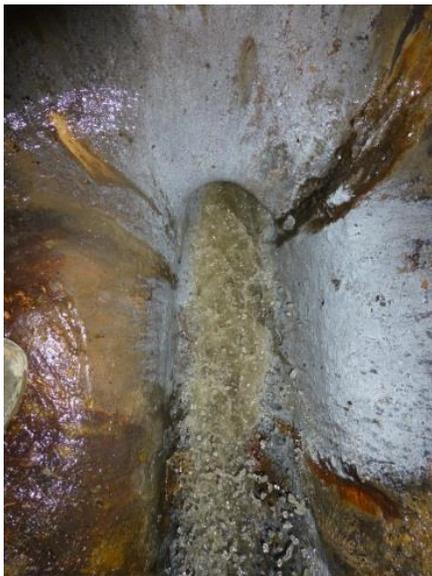
The influent and effluent pipes are 8 inches in diameter. Their compositions are difficult to determine, but the influent pipe is thought to be an RCP or VCP (clay) pipe, and the effluent pipe is thought to be PVC. The force main discharge is turbulent and accompanied by considerable splashing (Photo 3-14). The force main flowed for approximately 10 minutes during the assessment.

Photo 3-14. Wastewater Spraying from the Force Main into the Discharge Manhole

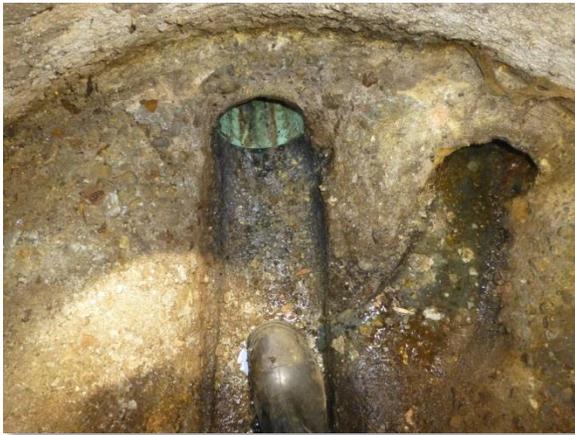
Photo 3-15. Plan View of the Canyon Estates Discharge Manhole Bench and Channel. North is at the Top of the Photo.

The Discharge Manhole is located in the center of Rifle Range Road. Two inlets are on the north side of the manhole (Photo 3-15). One is a 6-inch diameter PVC pipe, which is the force main (Photo 3-16). The other influent pipe is a 6-inch diameter apparent iron pipe that is a lateral collecting from nearby residences (Photo 3-18). Photo 3-17 and Photo 3-19 are upstream views into the PVC and the iron lateral, respectively. Photo 3-20 shows active flow from the PVC force main. Photo 3-16 and Photo 3-18 show soft, chalky concrete in the bench area with protruding coarse aggregate. The concrete is rated a VANDA Level 2 to Level 3 based on criteria presented in Table 2-1. Concrete in the bench channel, the cone, and the barrel sections underneath a thin veneer of mortar is hard, has no exposed aggregate, and is rated VANDA Level 1 Condition.

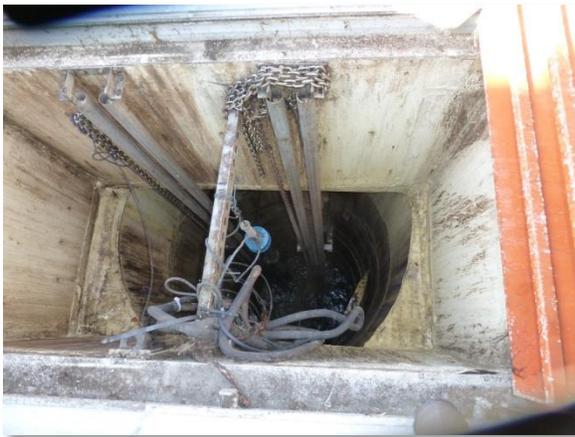
Photo 3-21. Plan View Looking into the Brickyard Booster Pump Station

The Brickyard Booster Pump Station Wet Well was assessed as a substitute for a discharge manhole since it was thought that the Brickyard Cove Force Main discharged directly into the Booster Pump Station Wet Well. The wet well is cylindrical in shape and is completely lined with T-Lock (Photo 3-21). The weld strips at the horizontal joints between sheets are failing, and in places, are exposing the underlying concrete (Photo 3-22 and Photo 3-23). Two vertical discharge pipes from the submerged pumps show moderate surface corrosion exfoliation (Photo 3-24). Stainless steel flange bolts and other stainless steel hardware in the wet well are in good condition (Photo 3-25). The concrete exposed where the T-Lock liner strips have failed is hard beneath a thin soft, chalky surface layer. The concrete is rated VANDA Level 2 Condition per Table 2-1. The wet well liner is pliable and intact, but is being undermined in places by moisture penetration behind it.

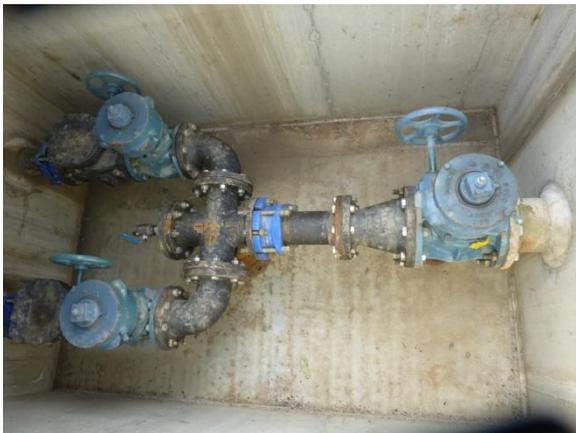
Photo 3-26. Topside View into Valve Vault Discharge Force Main from Wet Well

A precast pipe vault is located downstream of the wet well. The two discharge pipes join into a single force main in this structure (Photo 3-26). The concrete and metallic piping and valves are in good condition. Metal corrosion is minor (Photo 3-27). No leakage at joints and sealed wall-to-floor seams was observed (Photo 3-28).

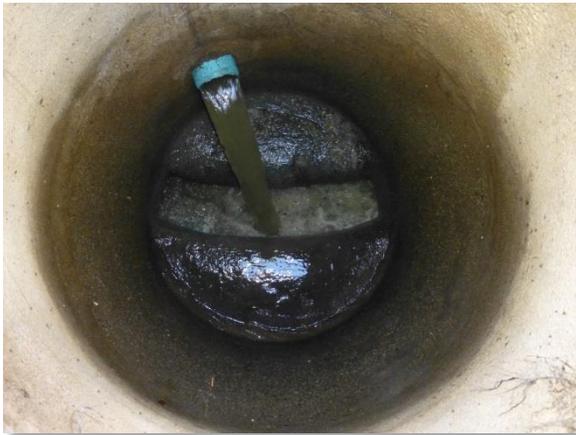
Photo 3-29. Topside View into Brickyard Cove Discharge Manhole (Top is to the Northeast Direction)

The Discharge Manhole has a 6-inch diameter PVC drop inlet force main from the Brickyard Cove PS entering the manhole from the northeast (Photo 3-29). An 8-inch diameter black HDPE influent pipe and an 8-inch diameter white PVC effluent pipe are connected by a channel in the bench. Views into these pipes are shown in Photo 3-30 through Photo 3-32. The manhole barrel displays exposed medium size aggregate, but not significant aggregate protrusion (Photo 3-33). The concrete is hard from the bench and barrel upward through the cone and riser sections.

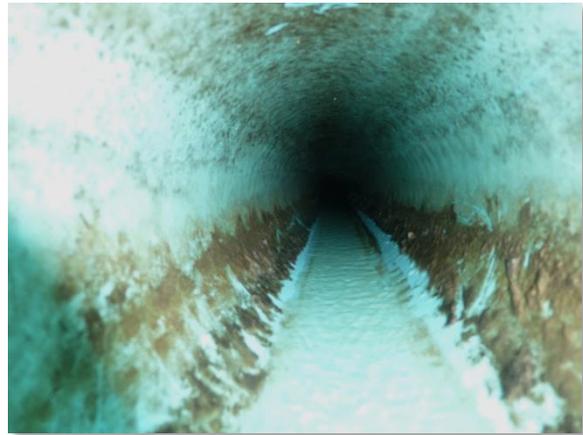
Photo 3-30. Upstream View into the 6-inch Diameter PVC Force Main from the Brickyard Cove PS

The CCTV that began at the Brickyard Cove discharge manhole was successful. The Brickyard Cove force main was identified as plastic; probably PVC given the blue-green color. The force main looked relatively new and was in good condition. A joint was approximately 27 feet from the manhole and was in good condition (Photo 3-44). At approximately 39 feet, there was a 45 degree bend that prohibited further advancement. This alignment was previously not documented nor understood well, and the Brickyard Cove discharge manhole location was previously unknown.

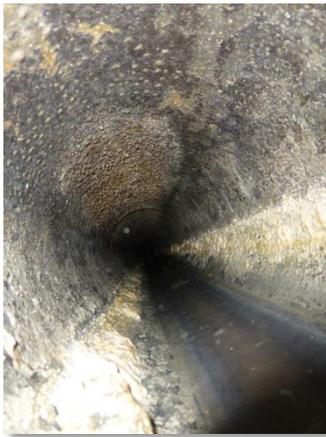
Photo 3-31. Upstream View into 8-inch Diameter Black HDPE Influent Pipe from Local Collection Systems

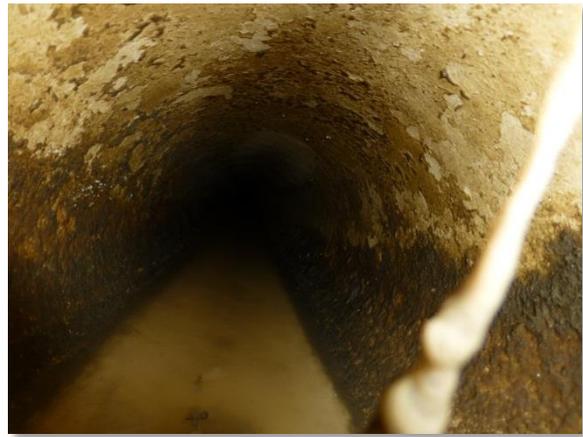
Photo 3-32. View Downstream in the 8-inch Diameter White PVC Effluent Pipe to the Brickyard Booster PS

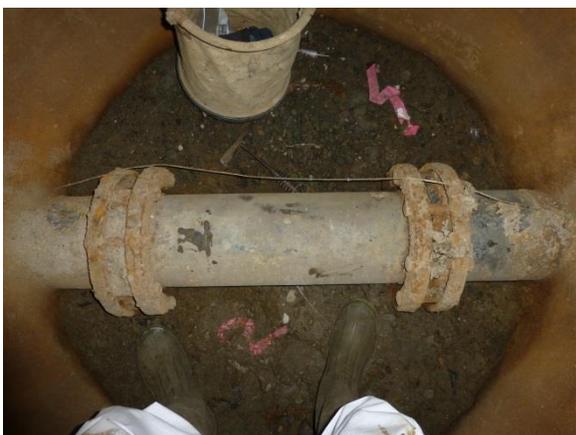
The Brickyard Booster Pressure Manhole No. 2 was assessed on the night of October 12th at 9:15 pm. The pipe is an 8-inch diameter black HDPE plastic composition with a spool section joined to the pipe penetrations at the manhole wall by two flange coupling adapters (Photo 3-34). The pipe surface has a thin coating of mud and mortar debris. The metal flanges have a thicker coating of debris. Underneath the surface debris the flange rings are moderately corroded and the stainless steel nuts and bolts are not corroded (Photo 3-35). The pipe is lying on, or near to, the gravelly bottom of the manhole. The lower portion of the flange couplings are buried in the gravelly fill. The fill is moist although there is no standing water in the manhole.

Photo 3-34. 8-inch Diameter Black HDPE Brickyard Booster Force Main.

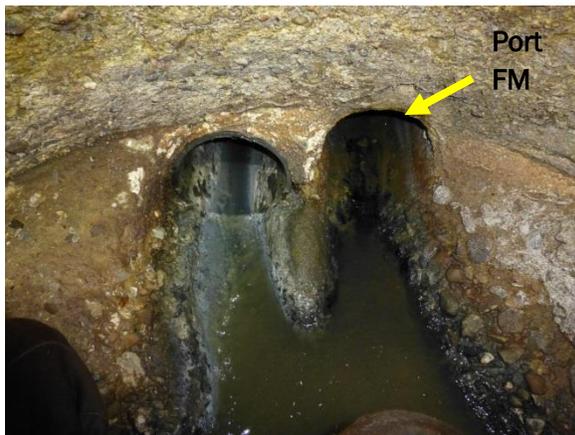
The manhole is approximately 5 feet deep and unlined concrete. Coarse concrete aggregate is exposed and protruding in the manhole bench around the influent force mains and gravity inlets (Photo 3-38 to Photo 3-40). Grease buildup was observed in the black HDPE inlet pipe, and in the concrete inlets and effluent pipe (Photo 3-41 and Photo 3-42). Thin crown peel wear is occurring in the concrete inlets and effluent pipe. Mortar coating is peeling off the manhole riser surface and the corroded manhole ring surface is exfoliating (Photo 3-43). The deep aggregate embayment and mortar peeling in the upper manhole are a VANDA Level 2 Concrete Condition per Table 2-1 rating criteria. The exfoliation on the manhole ring is a VANDA Level 2 Condition per Table 2-2 guidelines.

Photo 3-38. 8-inch Diameter Inlets on Southwest Side of Discharge Manhole.

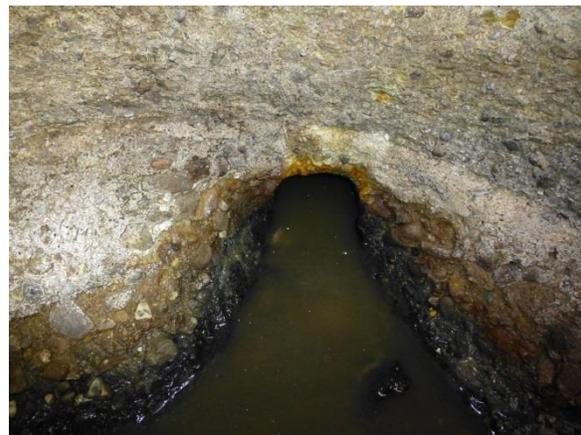
Photo 3-39. 8-inch Diameter Concrete Pipe from the Brickyard Booster PS.

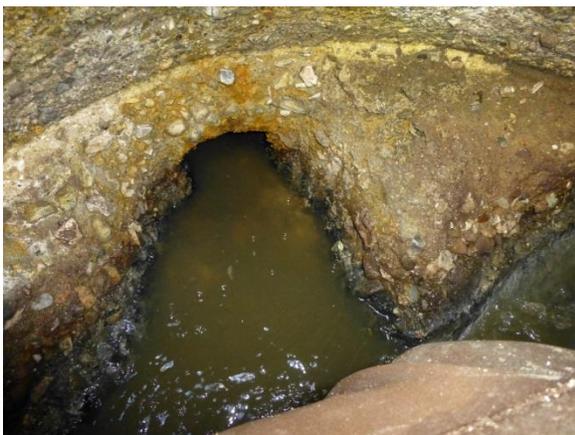
Photo 3-40. 6-inch Diameter Concrete Gravity Inlet on Southeast Side of Manhole

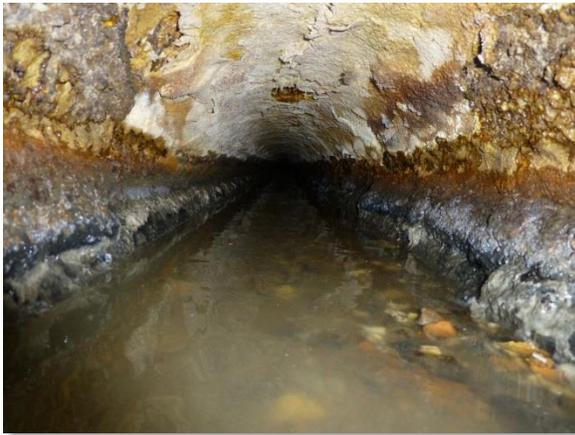
Photo 3-42. Grease Deposit in Springline Area of Concrete Pipe. Crown is Peeling

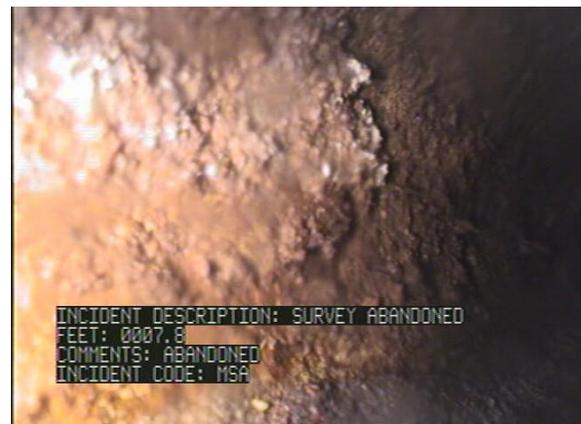
The CCTV that began at the Brickyard Booster discharge manhole had some challenges. Roots, worms and debris were encountered about 7 feet into the pipe as shown in Photo 3-45 and Photo 3-46, which indicates the force main would benefit from more regular cleaning. The pipe was cleaned to allow further progression of the CCTV and better viewing of the pipe surface. Photo 3-47 shows a possible fracture at the pipe-crown. This was a similar location to where roots were observed prior to cleaning. There was a bend about 8 feet upstream of the discharge manhole that inhibited further progress.

Photo 3-46. CCTV of Brickyard Booster Force Main showing Slime and Dirt before Cleaning

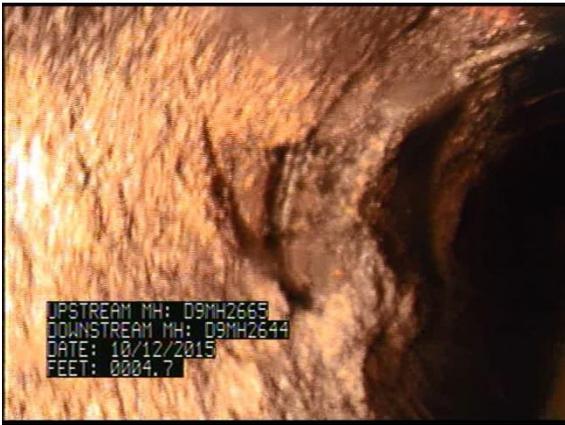
Photo 3-47. CCTV of Brickyard Booster FM after Cleaning

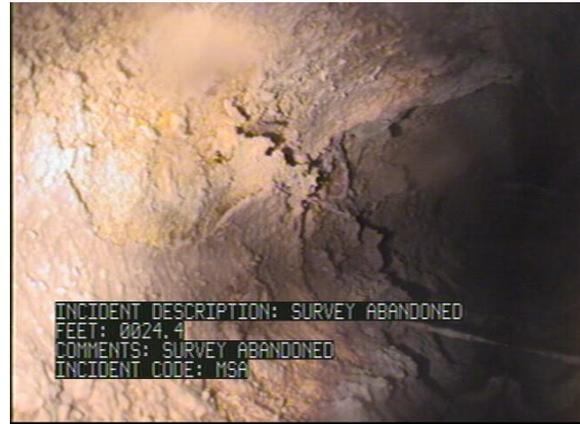
The CCTV that began at the Port discharge manhole was challenging. The Port force main appears to be in poor condition. The CCTV from the Port discharge manhole showed lots of grease in the Port force main (Photo 3-51). About 16 feet down the line, the pipe was halfway full of water. After approximately 24 feet, there was a partial cave-in, as shown in Photo 3-52.

Photo 3-52. Port Force Main- partial cave-in at ~24 feet from discharge MH

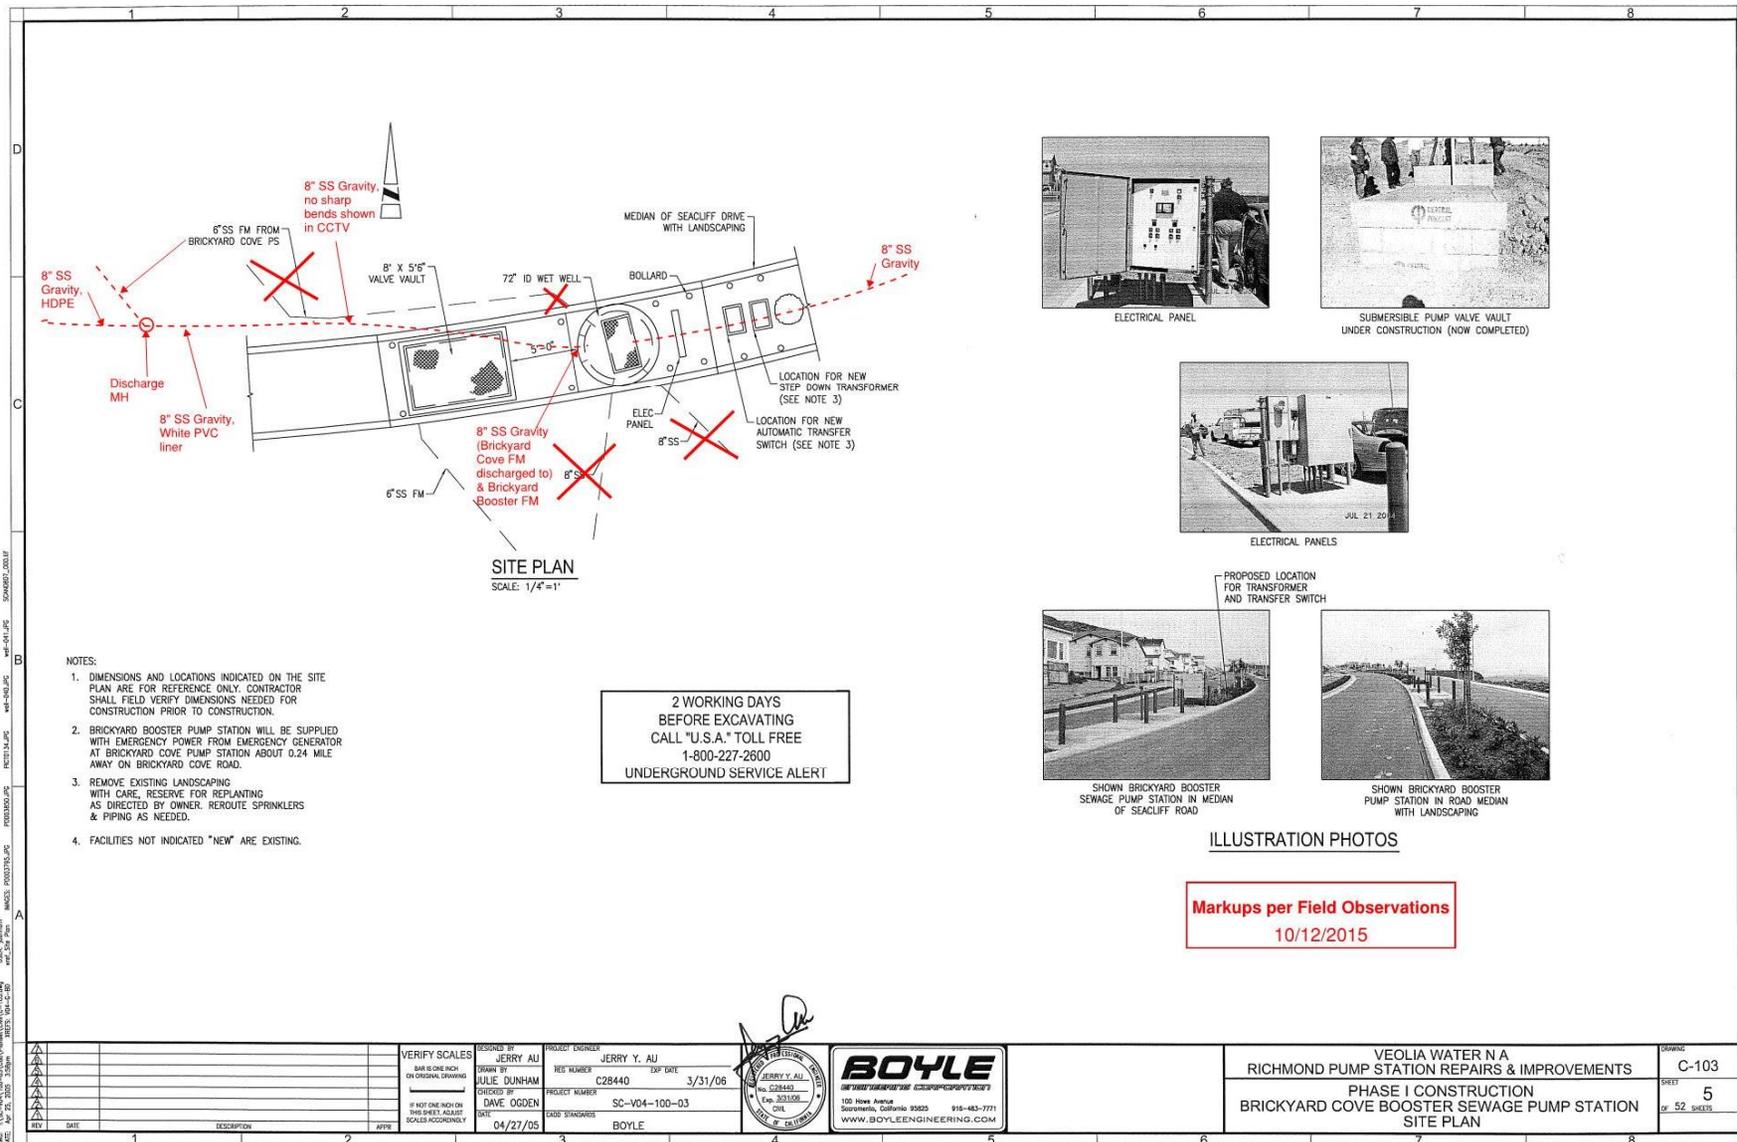
• Figure A-2. Brickyard Booster Pump Station Site Plan with Field Markups

The CCTV that began at the Brickyard Booster wet well actually examined a gravity line. Through this CCTV work, it was discovered that the Brickyard Booster force main does not discharge directly into the wet well, but instead into this gravity line. The gravity line began as PVC that was in good condition. After approximately 171 feet, the pipe transitioned from PVC to clay. At approximately 301 feet, there was a manhole with daylight, which is indicative of a gravity line, not a force main. There was a clay joint at approximately 340 feet, a crack at 358 feet, a sealed crack and joint at 396 feet, and another manhole with daylight was at 420 feet. At 427 feet, there were cobwebs, which indicate there is low flow through that pipe section. The pump was turned on while the CCTV sat at 430 feet, and no increase in flow was noted, indicating that the CCTV was sitting upstream of the force main discharge point. See Figure A-2 of the alignment found in the field.
