STREETLIGHT MASTER PLAN

January 2011

Republic ITS
Intelligent Transportation Services

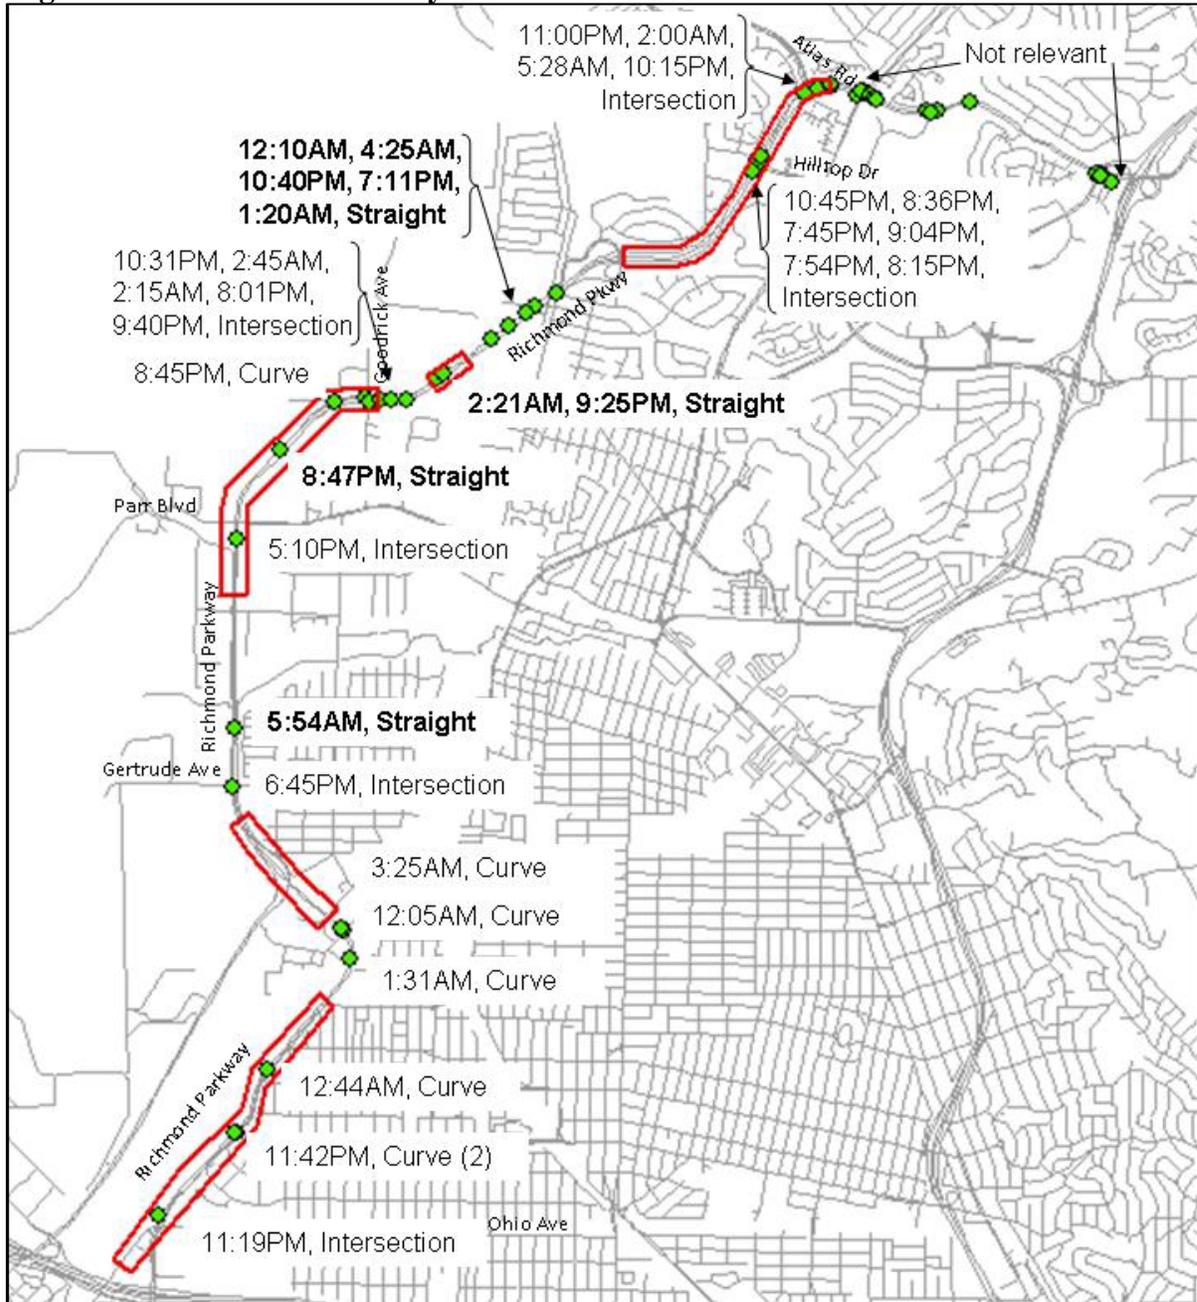
Figure 16 – Richmond Parkway Crash Records

- ❖ The majority of the crashes occurred at night. The next largest group occurred in the evening peak hour when lighting would not be an issue.
- ❖ Four clusters of accidents are labeled in bold font, and they occurred on straight sections of the Parkway. There are 9 accidents total in this category, 6 of them occurred on segments where the streetlights are working and 3 where they are not.

There is a tilt in the data suggesting that lighting on straight segments is not mandatory. However, three accidents in the darkened straight sections make it ill-advised to remove all the lighting. At best, the data suggests that repairing circuits near intersections and curves can take priority over circuits in straight sections.

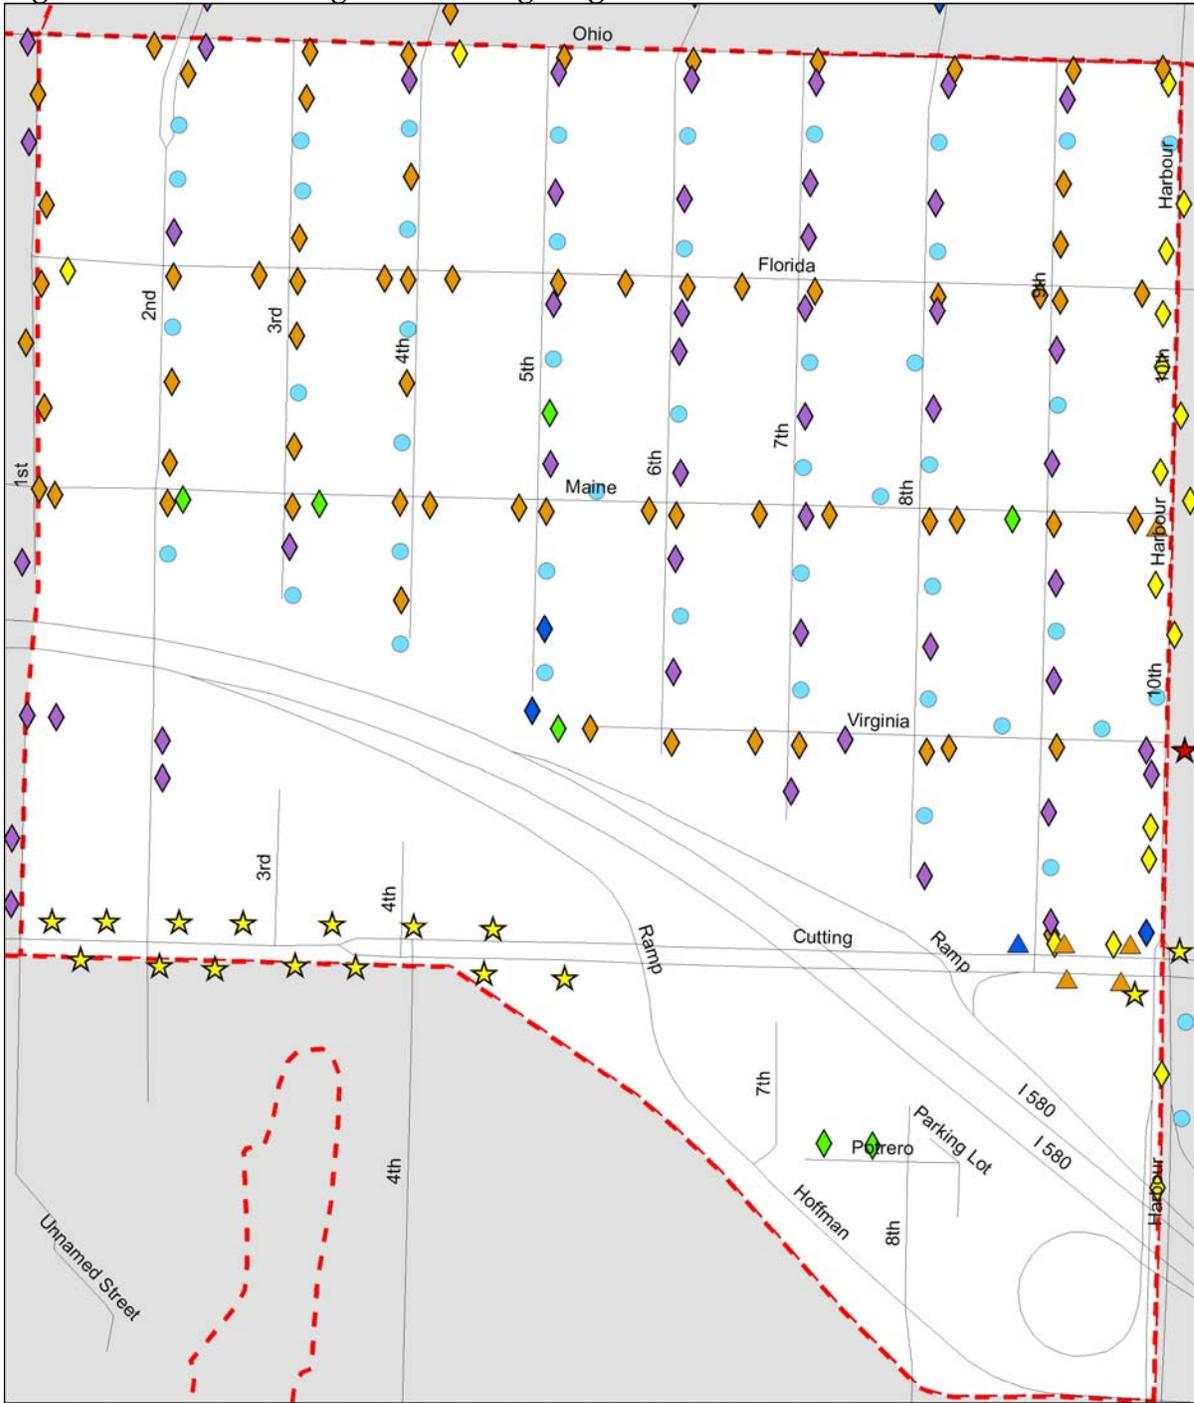
Figure 18 – Santa Fe Neighborhood Lighting

The Santa Fe neighborhood was identified by Richmond PD as the highest priority location where streetlight upgrades may help reduce criminal activity. The lighting in this neighborhood is primarily PG&E-owned on wood utility poles, and fixtures are a variety of wattages, with more 70W than any other size. The lighting in this neighborhood is shown in Figure 18, which shows pole locations, ownership, and wattages.

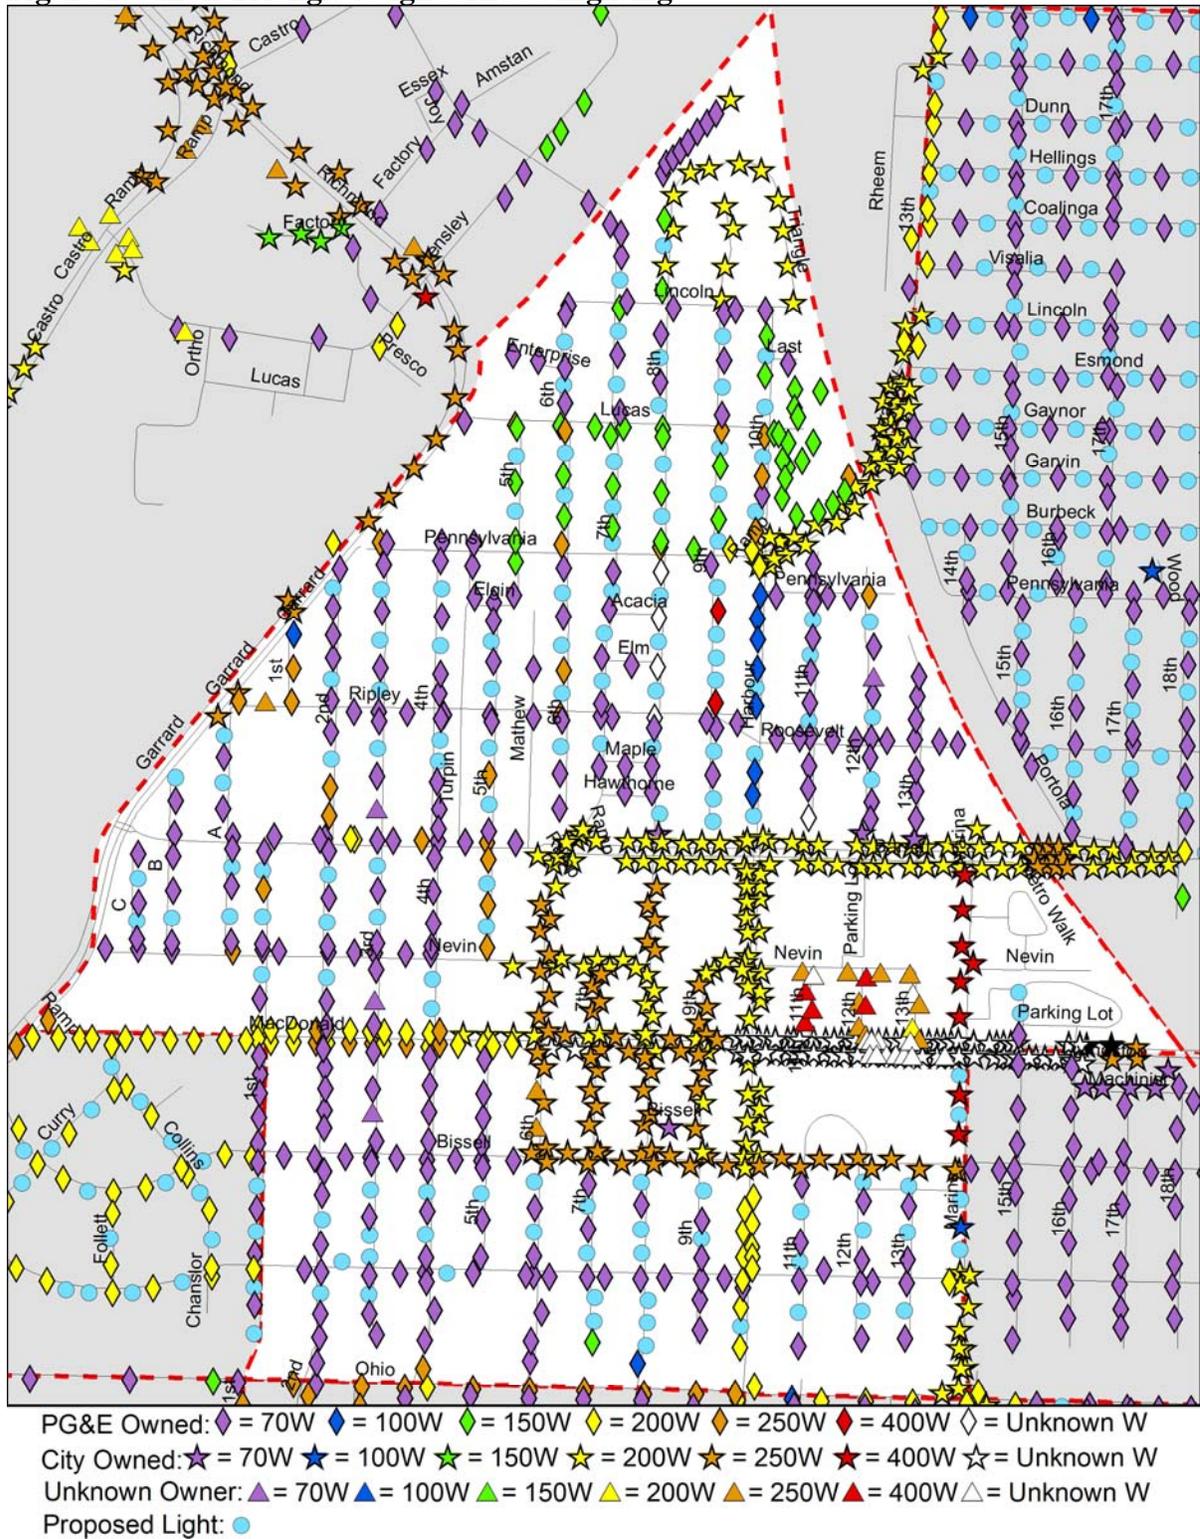
Figure 19 – Iron Triangle Neighborhood Lighting

The Iron Triangle neighborhood was identified by Richmond PD as the second highest priority for lighting upgrades. It is shown in Figure 19.

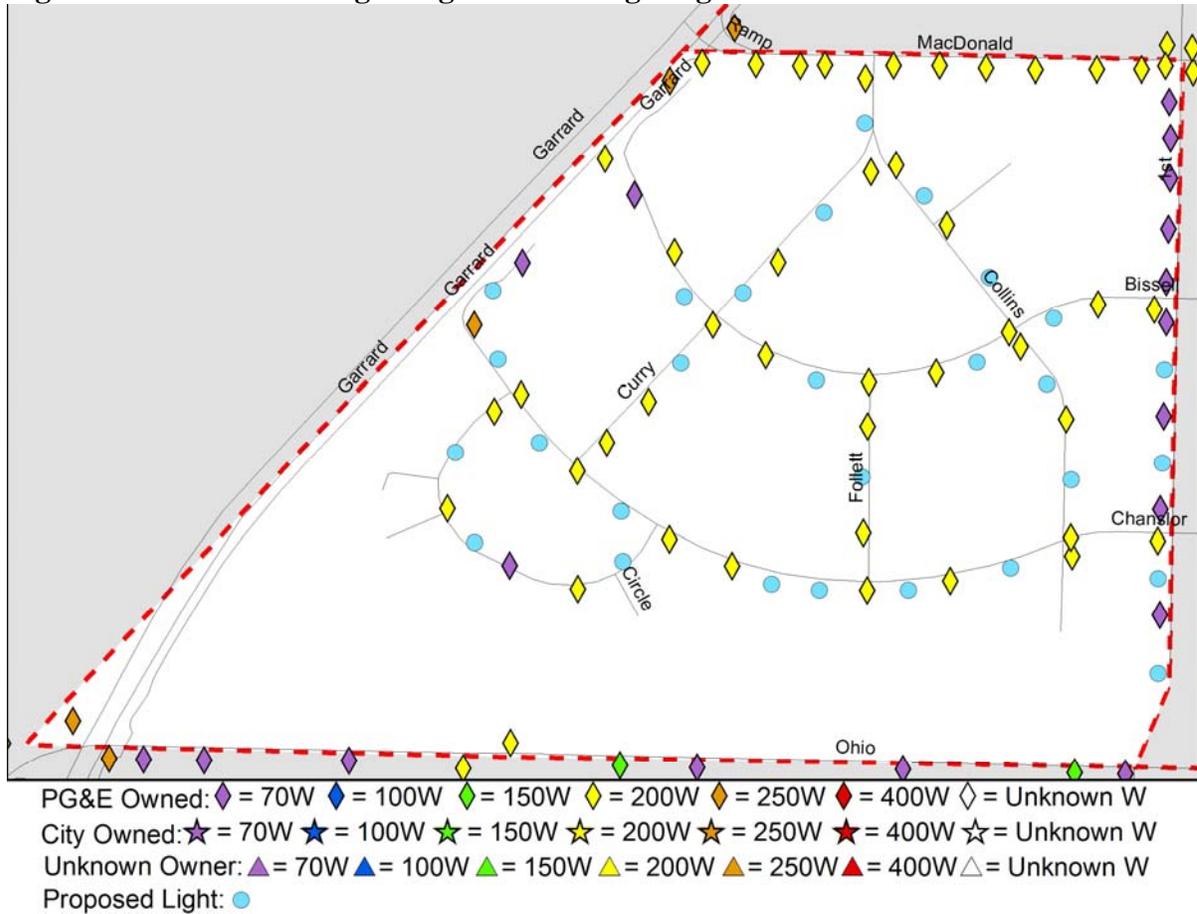
Figure 20 –Atchison Village Neighborhood Lighting

The neighborhood has 59 existing streetlights, and a cursory analysis indicates the need for 28 additional pole and fixtures. The estimated cost for upgrading the entire neighborhood is \$411,000.

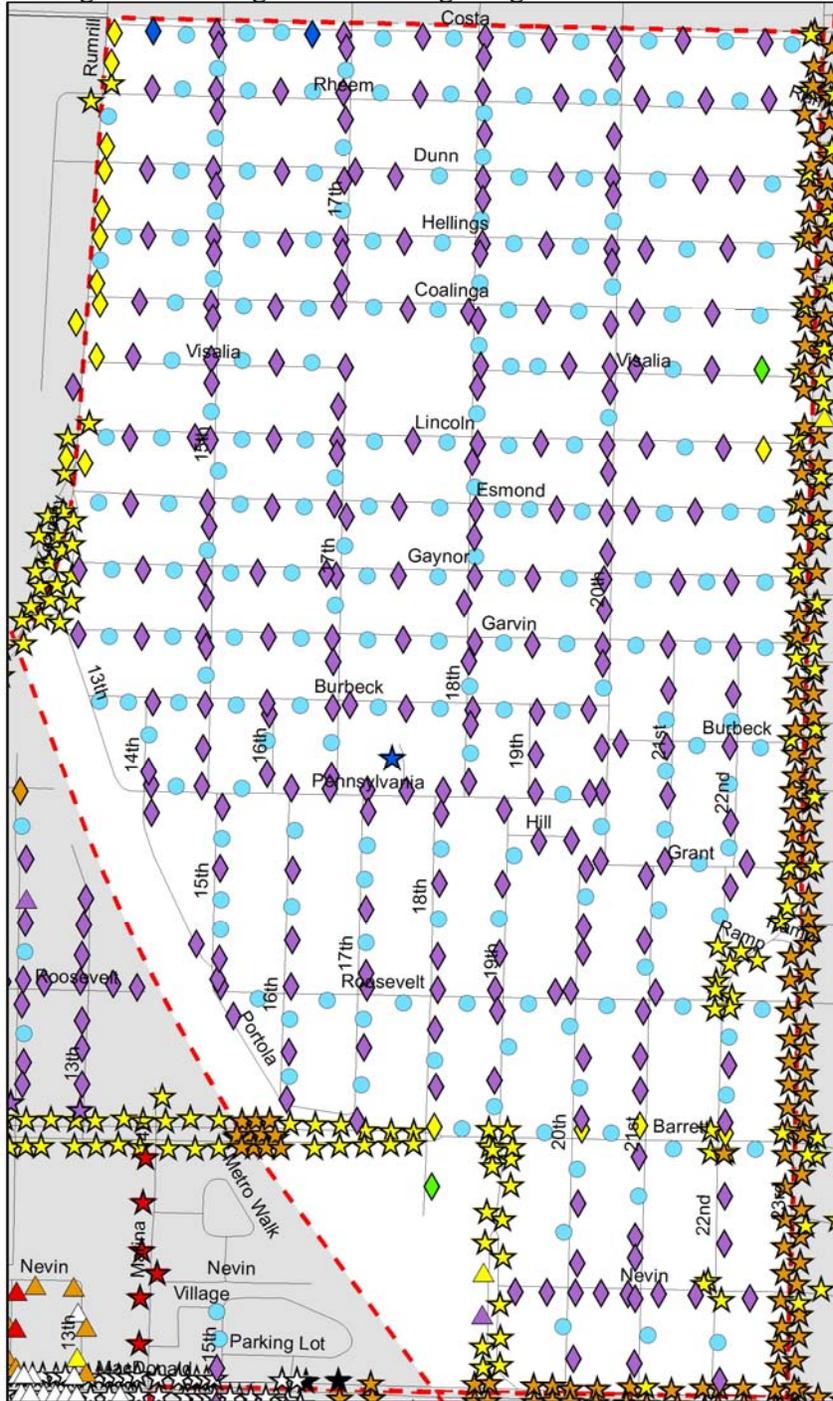
Figure 21 –Belding/Woods Neighborhood Lighting

This neighborhood has 414 existing streetlights, and a cursory analysis indicates the need for 197 additional. The estimated cost for upgrading the entire neighborhood is \$2,098,500.

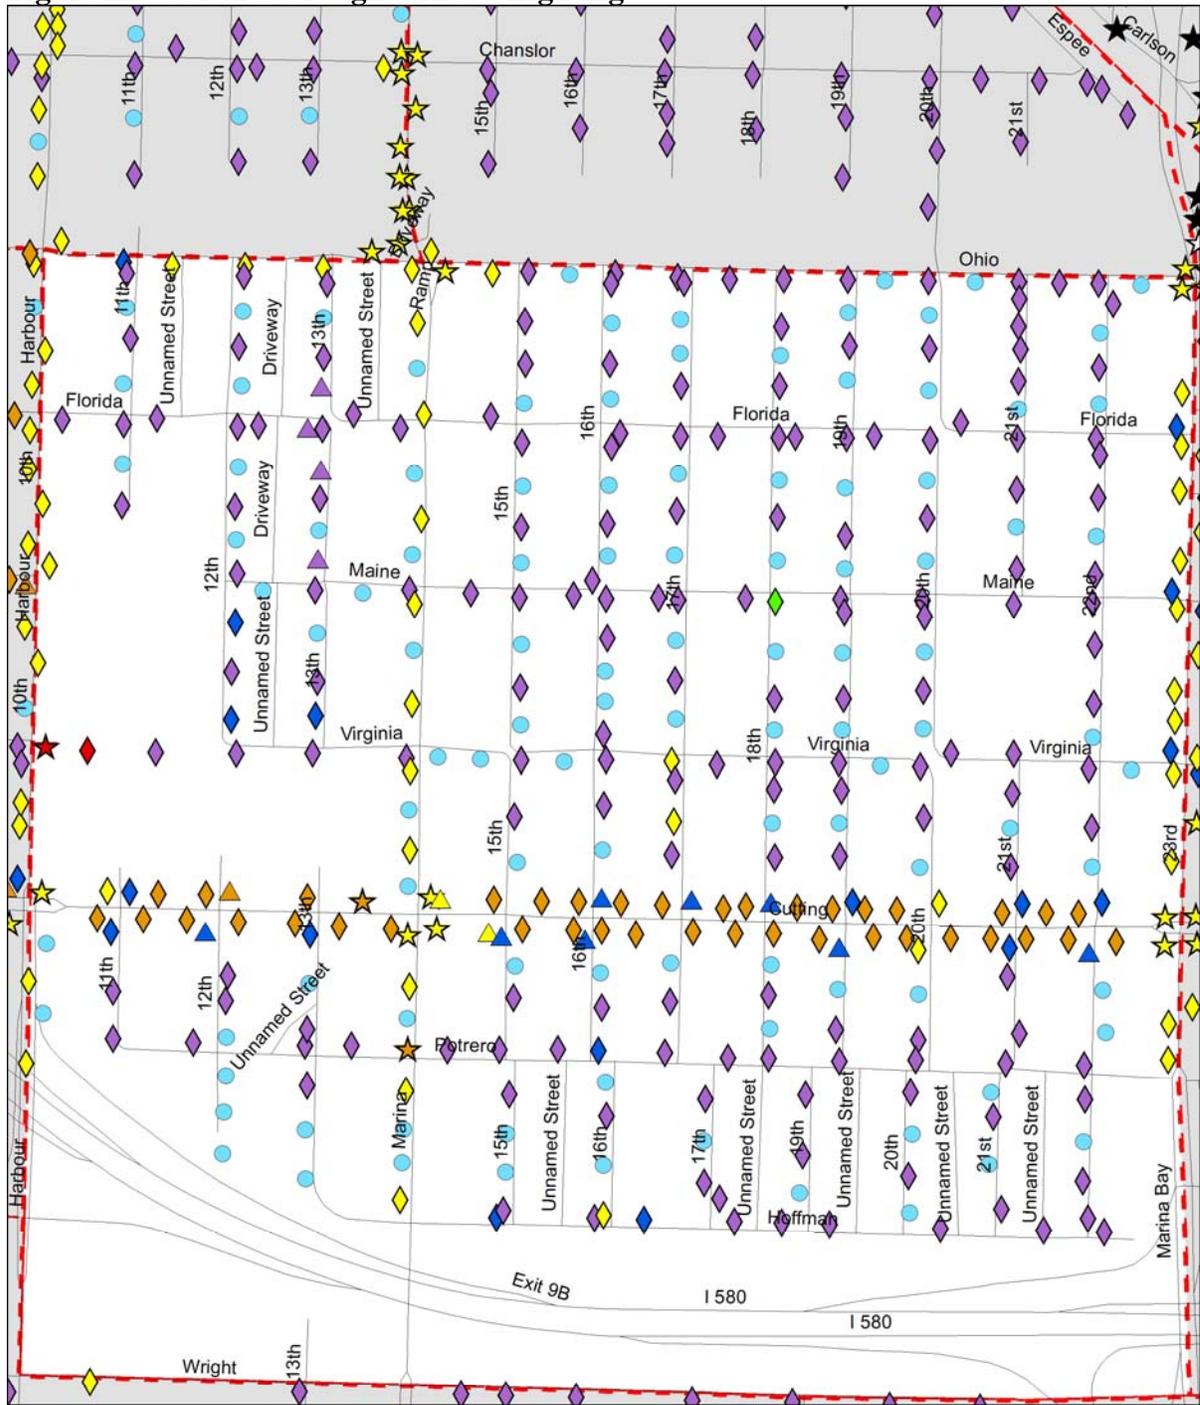
Figure 22 – Coronado Neighborhood Lighting

This neighborhood has 291 existing streetlights, and a cursory analysis indicates the need for 105 additional. The estimated cost for upgrading the entire neighborhood is \$1,224,000.

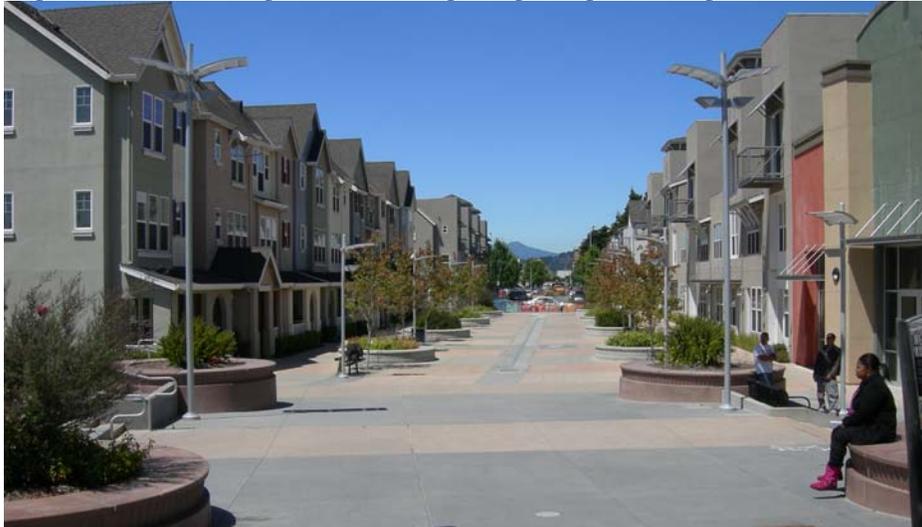
Figure 23 – Existing Metro Village Lighting (looking west)

Lighting within Metro Village is privately-owned, as are the streets. It is therefore outside the scope of this study. Figure 23 shows Nevin Plaza, the main corridor leading to the Village from the BART station. The corridor is very well lit, and the pedestrian-scale lights shown in Figure 20 are supplemented by lighting on the front of each house.

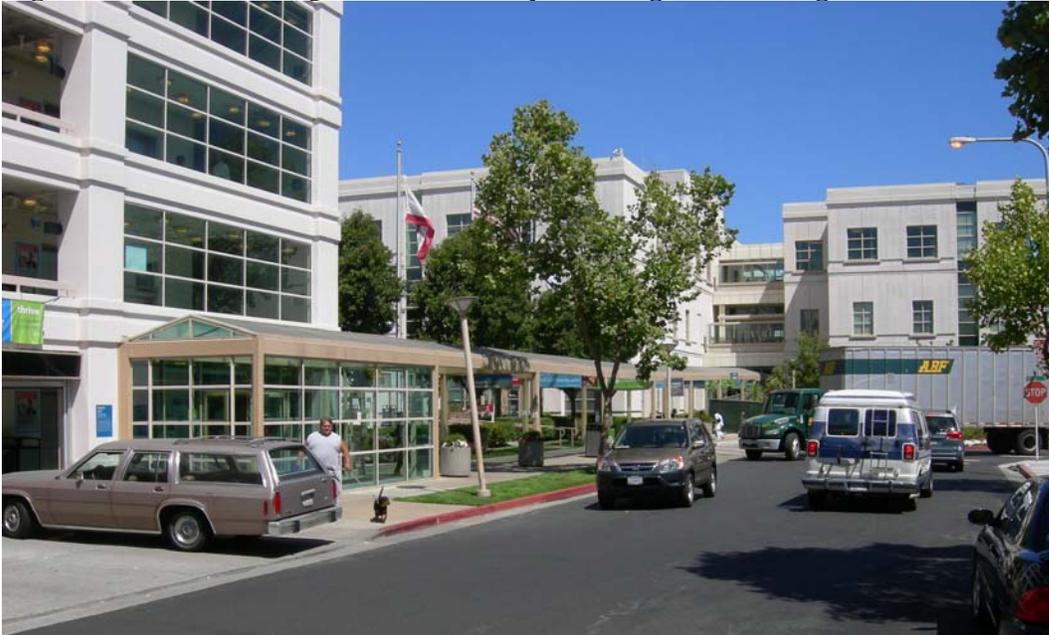
Figure 25 - Kaiser Hospital Front Entry (looking north along 9th St)

The parking structure, shown in the left portion of the fixture, is connected to the hospital via a covered walkway. There are City-owned ‘acorn’ lighting fixtures along the walkway, and also pedestrian scale lighting within the walkway cover. It appears lighting on this primary pathway is more than adequate.
