1. Executive Summary

The Port of Richmond has undertaken a critical effort to assess the existing infrastructure at the Point Potrero Marine Terminal (PPMT). This assessment will be used to inform both the Port's strategic plan and the City of Richmond's goals to sustain and grow Port operations. The team, consisting of Moffatt & Nichol, Liftech Consultants, Inc., ENGEO, Inc., and Power Engineering Construction provided inspection services of the structures at the PPMT and worked to develop this condition assessment report that summarizes the findings of the inspections and provides a prioritized list of potential capital improvements projects that support ongoing Port operations and potential infrastructure improvements to increase Port revenue.

Point Potrero Marine Terminal (PPMT) is the former Historic Shipyard Number 3 at the Port of Richmond. The facility, originally constructed between 1941 and 1942, produced Liberty and Victory ships during World War II. This assessment is focused on Berths 5-8, the graving basins, and the finger piers, as well as the Whirley Crane currently at Graving Basin Number 5. Berths 5 and 6 are an inactive area, primarily used for lay berthing pre

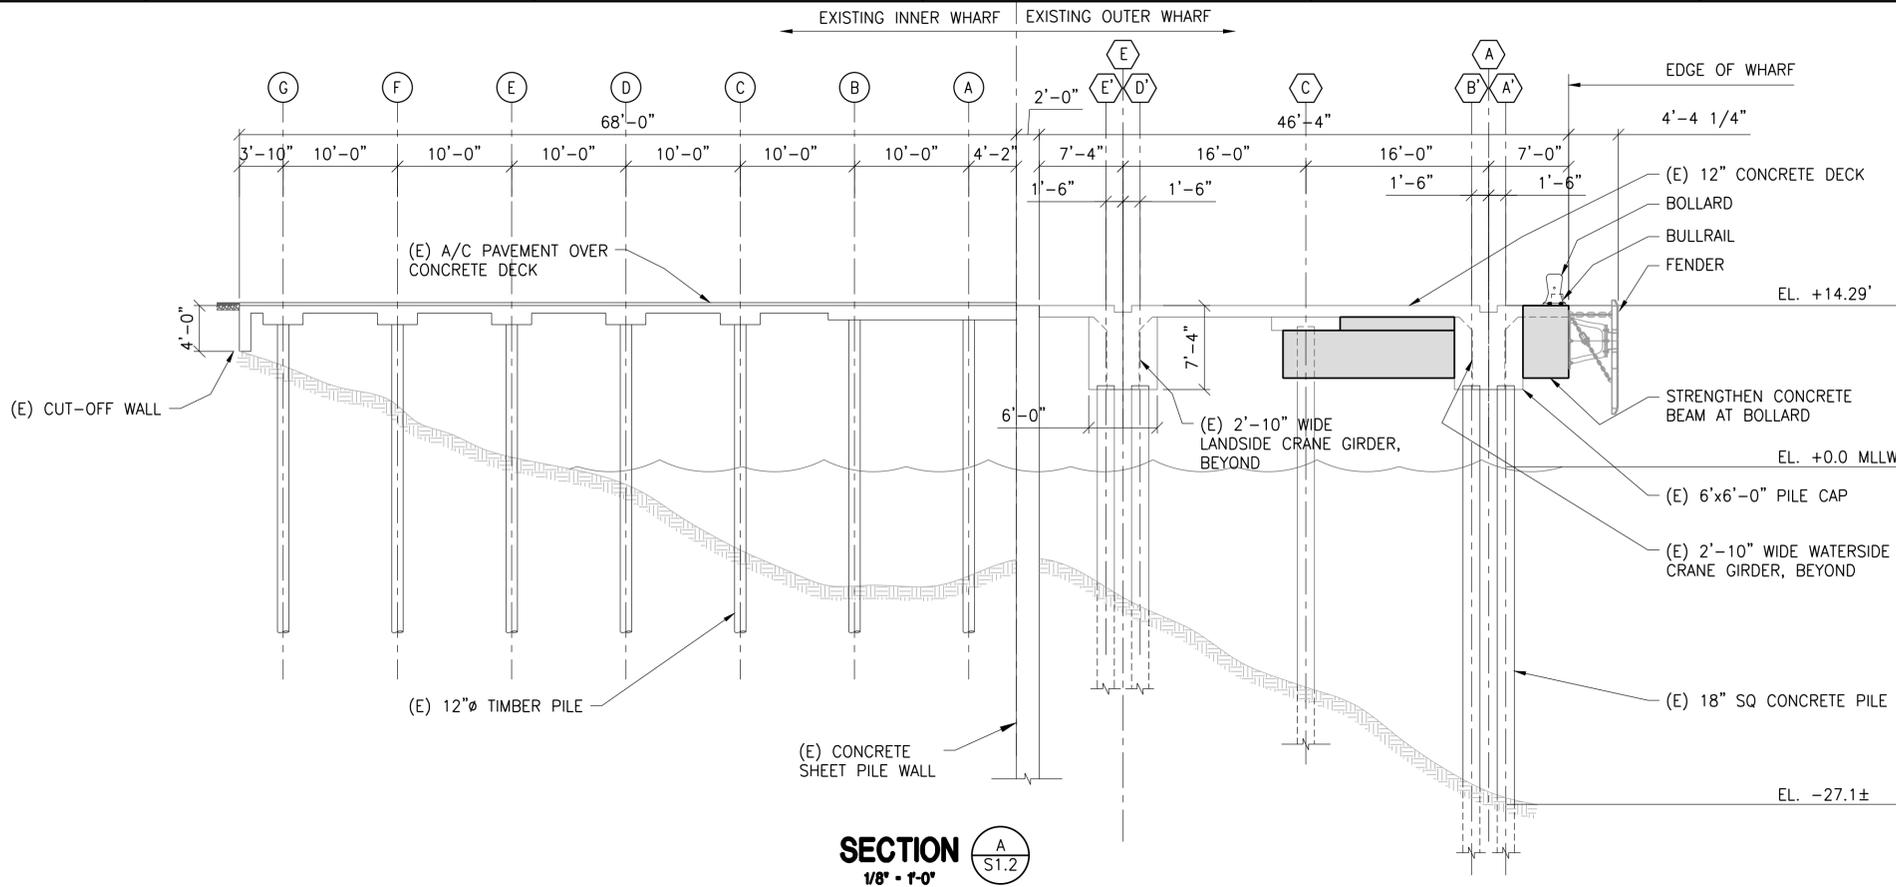
SECTION A
S1.2
1/8" - 1'-0"

NOTE:
AT BOLLARD USE ALTERNATE BOLLARD SUPPORT
DETAILS SHOWN ON SHEET S4.13 PER PORT'S
DIRECTIVE.

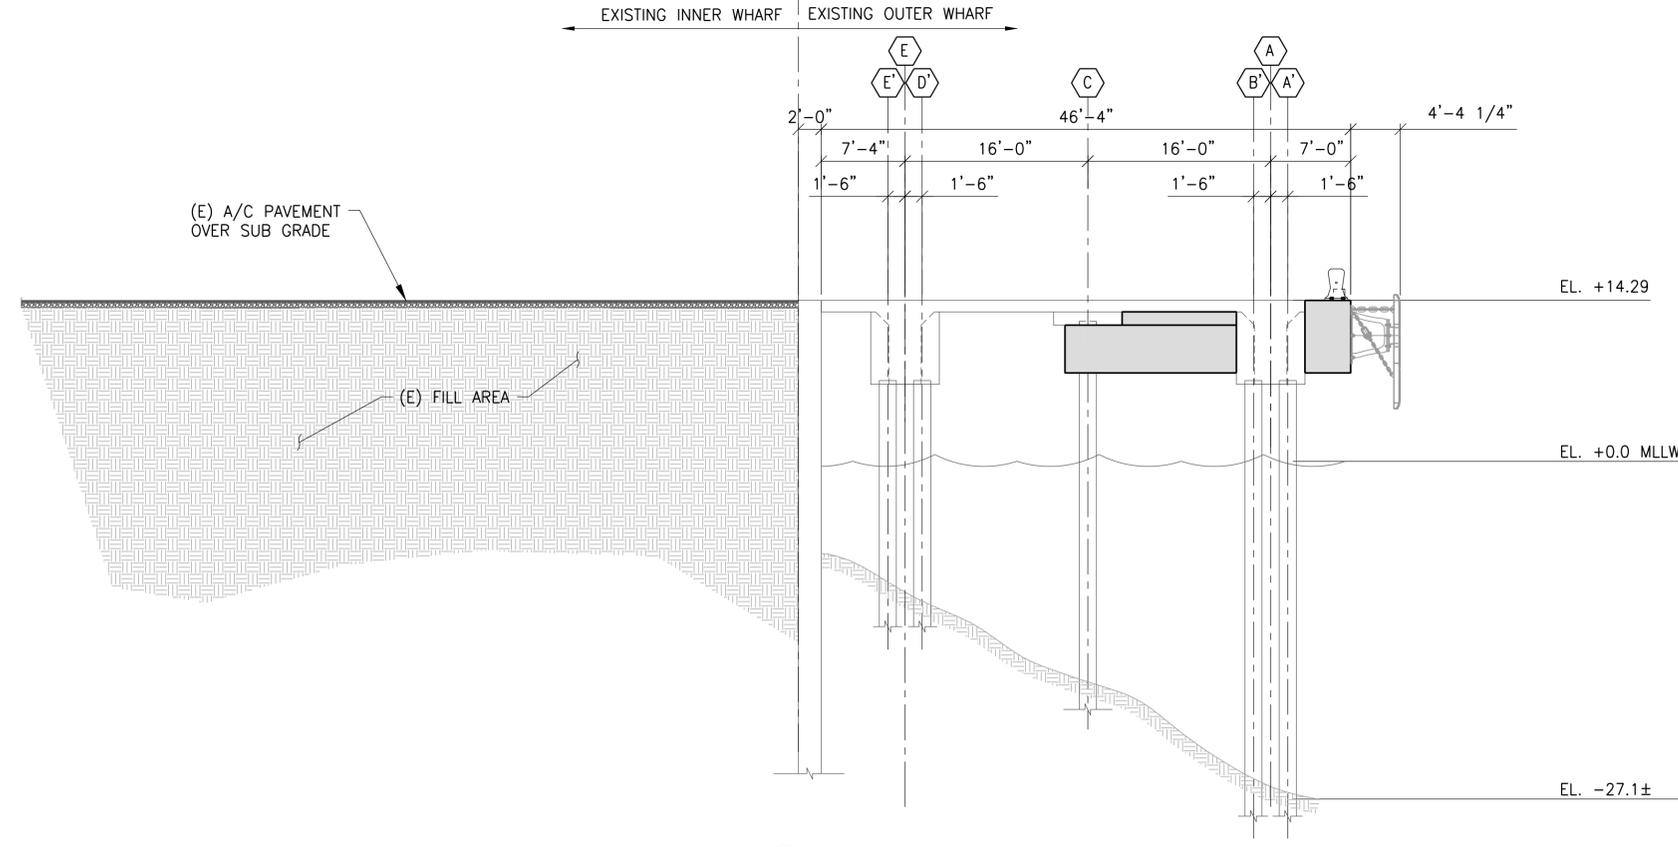
SECTION B
S1.2
1/8" - 1'-0"

SEE SECTION A/S1.2 FOR
INFORMATION NOT SHOWN
